**ANNUAL CCR LANDFILL INSPECTION
40 CFR §257.84(b)
30 TAC §352.841**

**FAYETTE POWER PROJECT
COMBUSTION BY-PRODUCTS LANDFILL
TX REGISTRATION No. CCR101
EPA IDENTIFICATION No. TXD083566547**

January 9, 2026

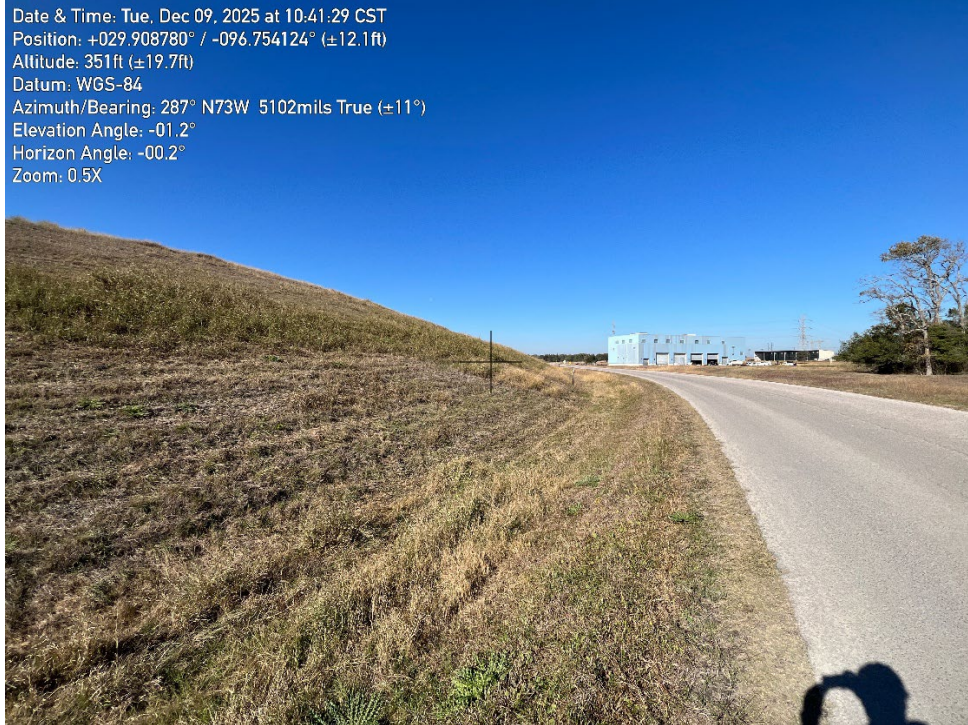
- (1) Overall, grass cover was in good condition throughout. The area was well mowed and was observed to have an average vegetation length of approximately 6-inches. There were no signs of animal damage or a history of such. The slopes appeared to be in alignment with the 3:1 design and no visual evidence of structural issues were observed. The structure was observed to be containing the CCR materials as designed.

Photo 1 – Cell 1 North Embankment, Facing Northwest

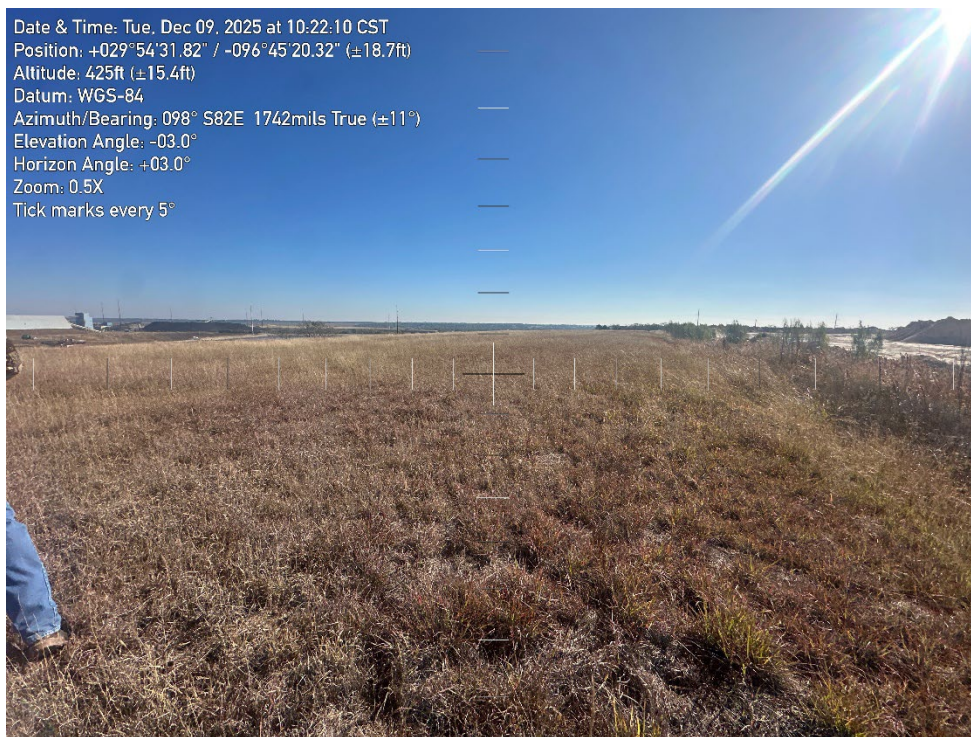
(1) Overall, grass cover was in good condition throughout. The area was well mowed and was observed to have an average vegetation length of approximately 6-inches. There were no signs of animal damage or a history of such. There was no visual evidence of structural issues observed. The structure was observed to be containing the CCR materials as designed.

Photo 2 – Cell 1 Capped Area (left) and Landfill Material (right edge), Facing Southeast

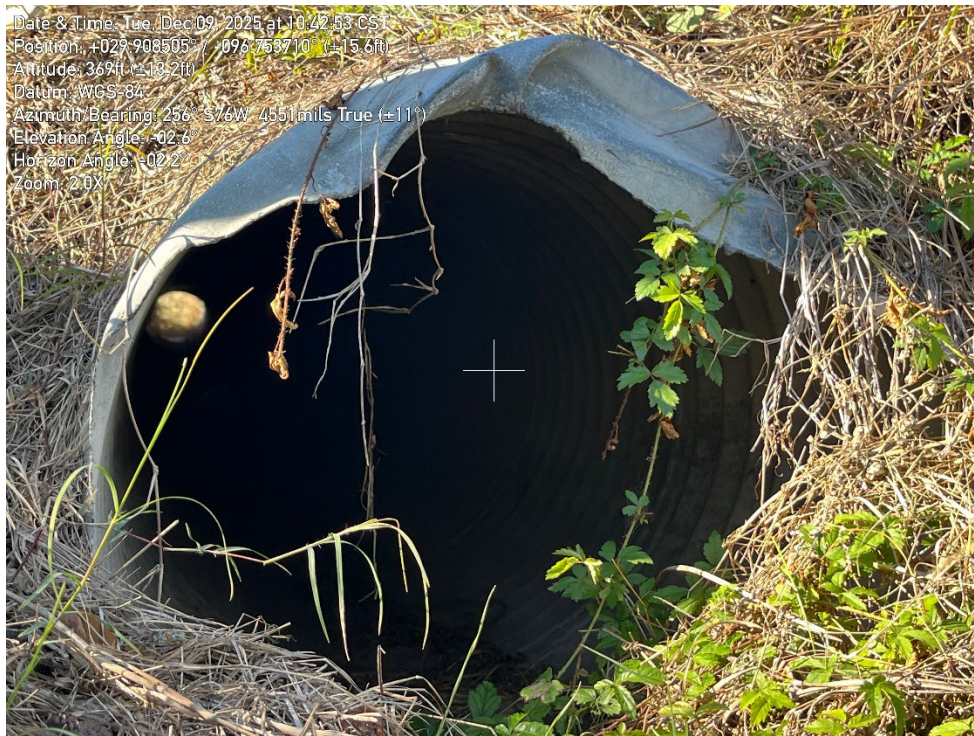
(1) All stormwater drainage channels and culverts were observed to be in good condition and appeared to be operating as designed. There were no conditions observed as disrupting or having the potential to disrupt the operation or safety of the CBL.

Photo 3 – Non-Contact Water Drainage Culvert at Northeast Corner of Cell 1, Facing Southwest

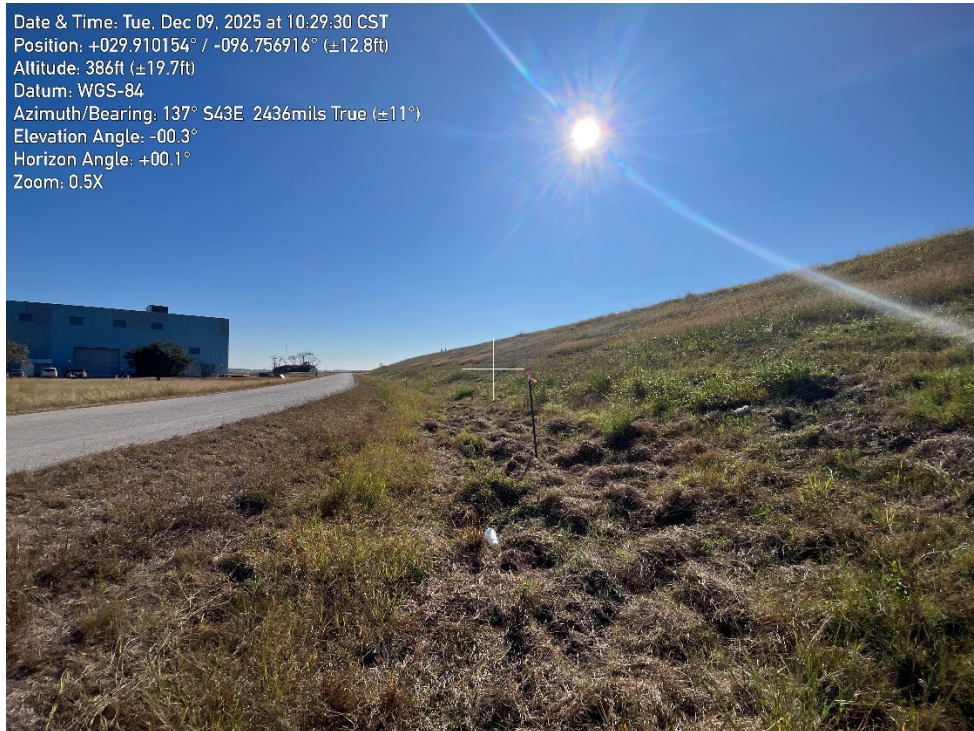
Photo 4 – Cell 1 North Embankment, Facing Southeast
