Watershed: Concho River

Segments: 1421, 1422, 1423, 1424, 1425

Water Bodies: Concho River (North, Middle and South), O. C. Fisher Reservoir, Lake Nasworthy, Twin Butte Reservoir

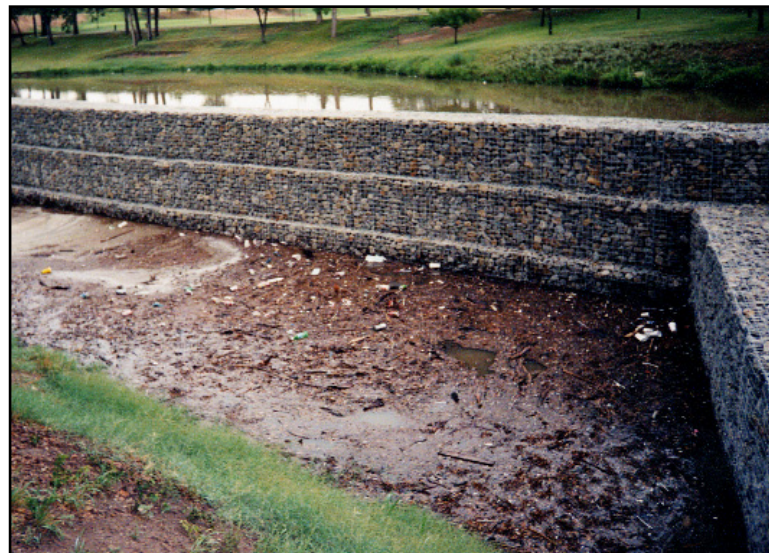
Sediment is prevented from entering the Concho River.

working with the City of San Angelo and securing Clean Water Act 319(h) grants from TCEQ (formerly TNRCC) to build structural BMP designed to filter out oil, grease, sediment and other pollutants found in urban runoff. Three projects have been initiated to improve NPS pollution in San Angelo.

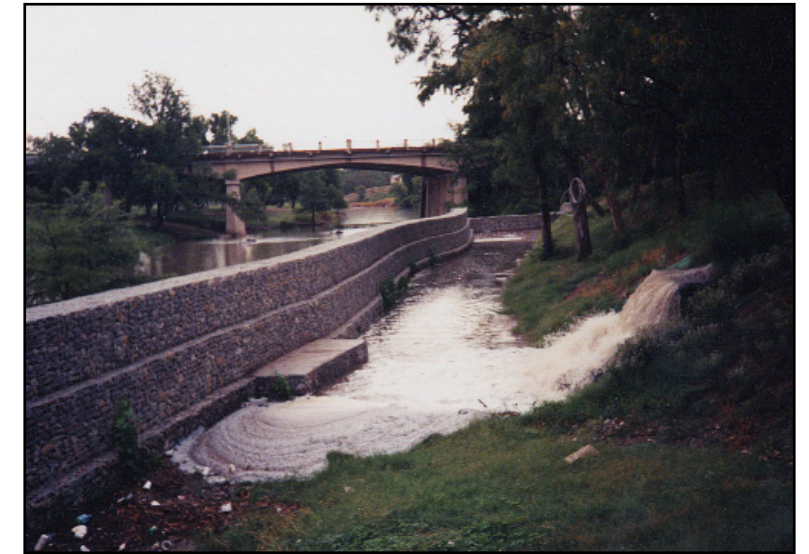
BMP outfall is on the Concho River in San Angelo
