2025 Colorado River Basin Highlights Report

A Characterization of Impaired Water Bodies in the
Lake Lyndon B. Johnson Watershed

PREPARED IN COOPERATION WITH THE
TEXAS COMMISSION ON ENVIRONMENTAL QUALITY

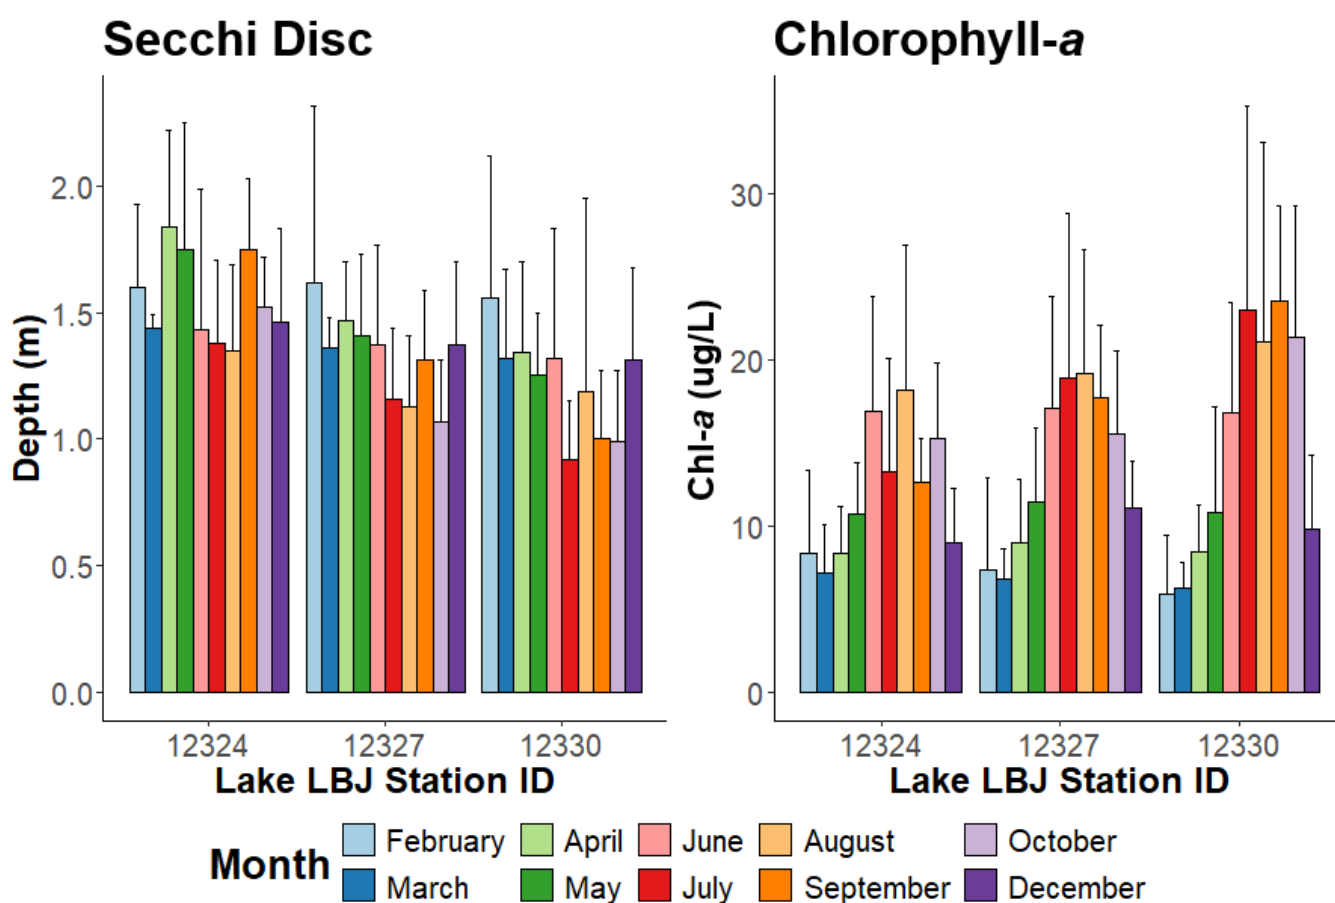
Figure 6. Secchi disc depth (m) and chlorophyll-*a* (µg/L) collected at Lake LBJ Stations 12324, 12327 and 12330. The bars represent monthly averages from Feb. 4, 2014, to Oct. 17, 2024. Standard error lines, shown as black lines above the monthly average bars, represents the variability of data for monthly Secchi disc depth and chlorophyll-*a* values.

Trend analysis for the past 10 years show minimal changes in chlorophyll-*a* and Secchi disc depths at monitoring stations 12324, 12327 and 12330. Significant changes in overall average values of chlorophyll-*a* and Secchi disc depth have not been observed from 2014 to 2024 in Lake LBJ. However, the observed values are still frequently above the Texas Surface Water Quality criteria thresholds. Notable changes in chlorophyll-*a* and Secchi disc patterns are observed immediately before, during and after the 2018 flood. Storm runoff during this historic event moved large amounts of water through Lake LBJ. Chlorophyll-*a* values remained lower on average in 2019 and 2020 before slowly rising again.

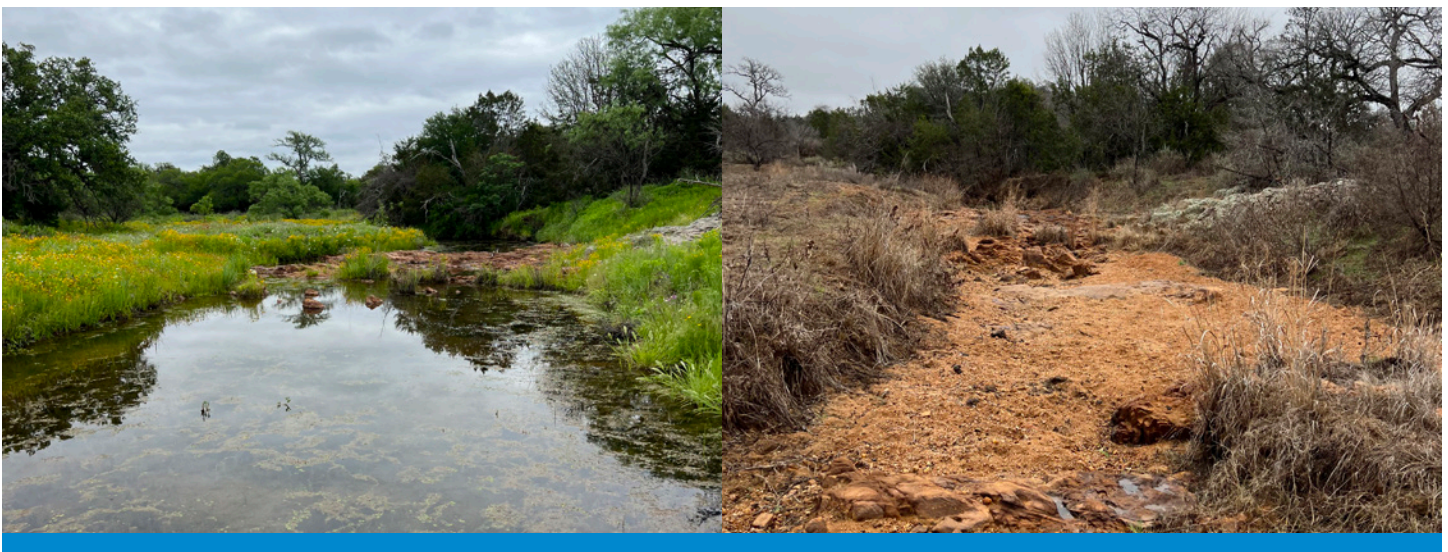
Figure 9. Photographs of Clear Creek Station 18710 site conditions when wet (left) on April 23, 2024, and dry (right) on Feb. 12, 2025.

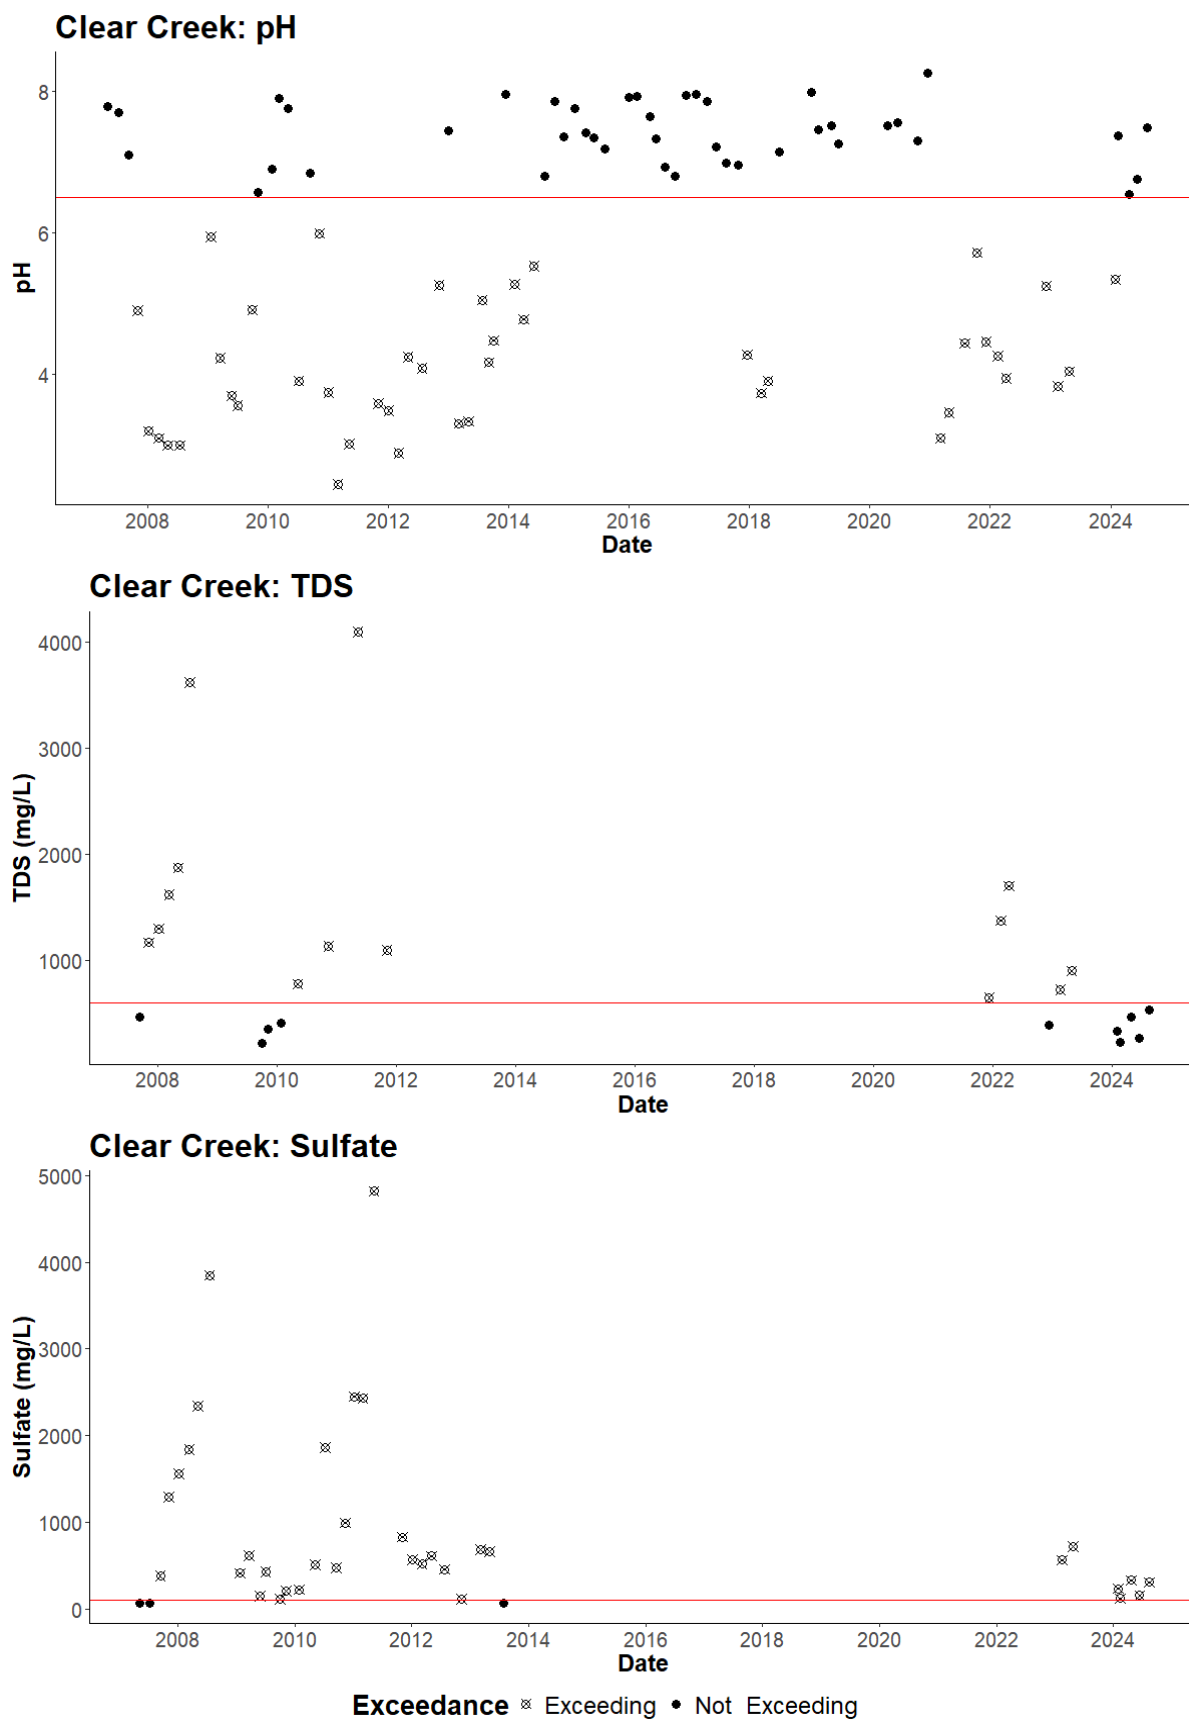
Figure 10. pH, total dissolved solids (TDS) (mg/L) and sulfate (mg/L) concentrations at Clear Creek Station 18710 from May 7, 2007, to Nov. 15, 2024. The red lines indicate the Texas Surface Water Quality criteria for each parameter. Values that exceed the criteria are represented with an open square containing an x. Values that do not exceed the criteria are represented with a solid circle.

A majority of Clear Creek Station 18710 data points for pH, TDS and sulfate values do not support the general use criteria set by the Texas Surface Water Quality Standards (Figure 10). For pH, values less than 6.5 do not meet the criteria standard. Criteria standards are not met for TDS and sulfate for values greater than 600.00 mg/L and 100.00 mg/L, respectively. These parameters are interconnected as acidic conditions, sulfate-rich sources and elevated TDS can collectively degrade water quality overtime.
