2012 Basin Summary Report

A Summary of Water Quality in the Colorado River Basin 🛹 2007 – 2011

Lower Colorado River Authority Upper Colorado River Authority Colorado River Municipal Water District

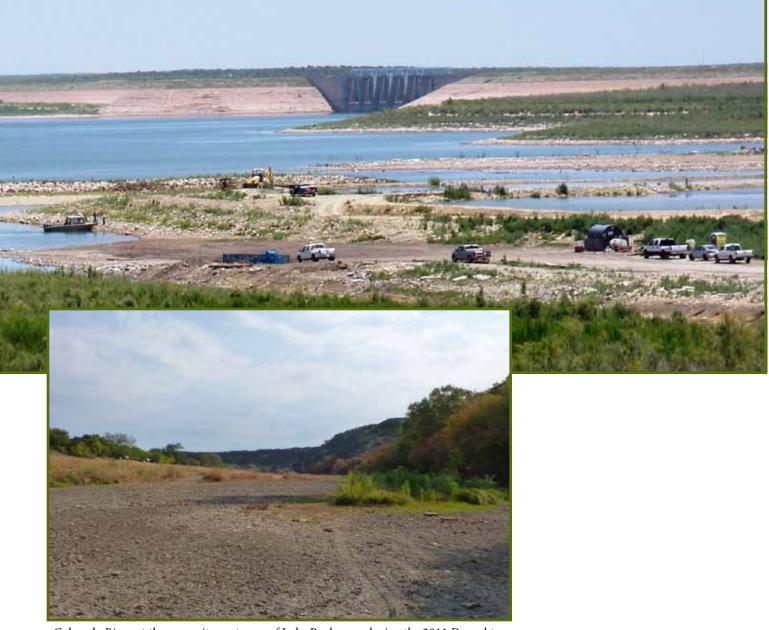
Colorado River at the same site upstream of Lake Buchanan during the 2011 Drought

These drought and low flow conditions typically concentrate dissolved solids and decrease dissolved oxygen levels in water. Water quality is also impacted when dry conditions are interrupted by intense flood events. Stormwater runoff increases bacteria levels and suspended solids until sustained stream flows dilute dissolved solids. This report cites weather and drought conditions as causes of water quality problems.

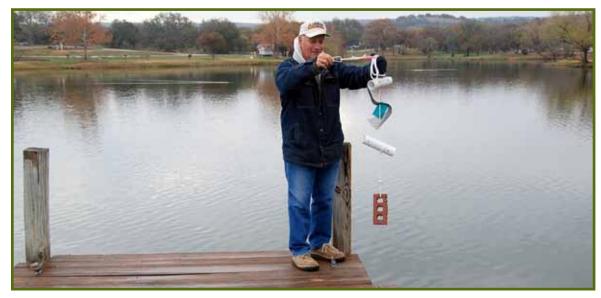
Volunteer monitor Phil Wyde installs a zebra mussel sampler on Inks Lake

In 2011, fourteen CRWN volunteers began monitoring the Highland Lakes for invasive zebra mussels. Zebra mussels have been in the northeastern United States since the 1980's, but have only recently been found in Texas. The zebra mussel watchers will provide early detection of the species which threatens aquatic ecosystems and water utilities.

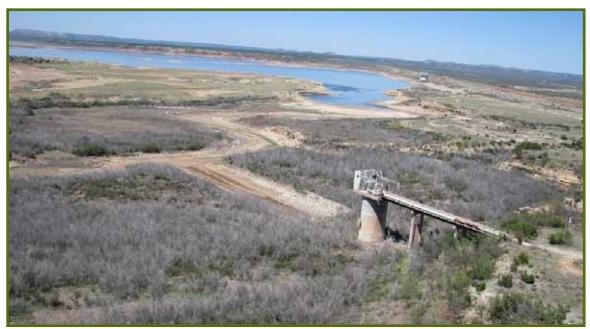
E.V. Spence Reservoir at 4 percent of capacity in April, 2010

Data collected from multiple sites on the reservoir indicate elevated levels of TDS and sulfate. Sources of TDS and sulfate include geologic formation and historical oil field contamination. Chlorophyll a levels and golden algae blooms reached concern status in the reservoir. Fish kills associated with golden algae occurred in the reservoir in 2008, 2009 and 2011. Repeated fish kills have essentially eliminated fish communities in the lake. Long-term drought and low reservoir levels continue to contribute to algal blooms.

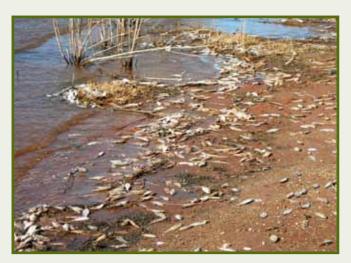
Golden algae fish kill on E.V. Spence Reservoir

Since 1985, Prymnesium parvum, or golden algae, has caused a number of fish kills in Texas water bodies. While golden algae can occur in stock tanks and reservoirs, it is usually kept in check by competition with healthy populations of red and green algae. A bloom of golden algae is often triggered by significant temperature swings, cloudy weather or rising salinity levels. A minor bloom may kill or harm some fish, but serious kills can result when golden algae increases dramatically and produces

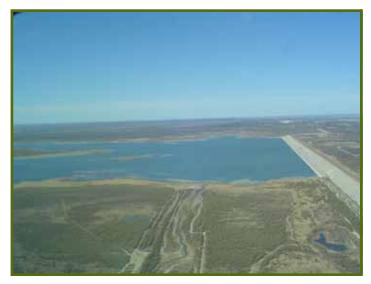
Twin Buttes Reservoir at less than 10% of capacity

Trend analyses indicate improving water quality (Figures 31-34). The reservoir received significant runoff inflows at the end of 2004. The resulting dilution caused decreases in chloride and sulfate subsequent sampling events. If reservoir levels continue to decline from diminishing inflows, use and evaporation, water quality can be expected to consequently decline.

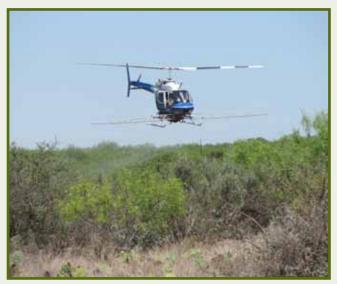
Aerial application of herbicide on Twin Buttes Reservoir

UCRA conducted an ongoing water enhancement program through control of invasive brush species project in and around Twin Buttes Reservoir. The project was carried out in partnership with United States Bureau of Reclamation, City of San Angelo, and TSSWCB. It was completed in early summer of 2012. A total of 1200 acres of saltcedar, 2,700 acres of willow baccharis, and 5250 acres of mesguite were treated by aerial application of herbicide.

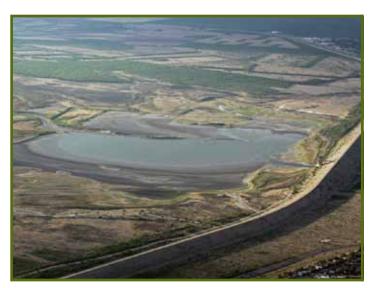
Lake O.C. Fisher at less than 1% of capacity in May, 2011

The lake currently meets all surface water quality standards, but data show a concern status for ammonia, chlorophyll a, depressed dissolved oxygen and orthophosphorus. These concerns are related to the extreme low levels of the lake and the associated poor water quality resulting from the process of the lake drying-up.

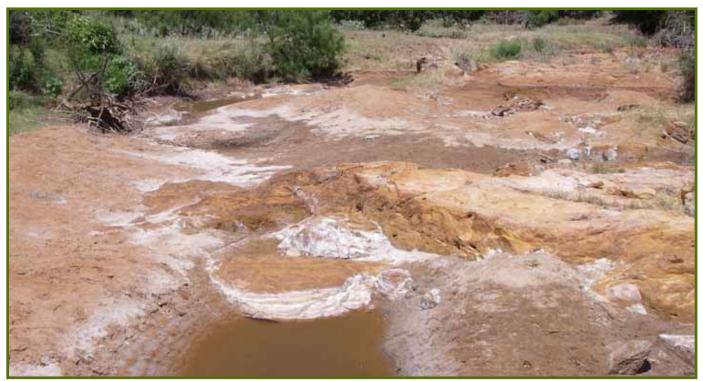
Salts left in Clear Creek during the 2011 drought

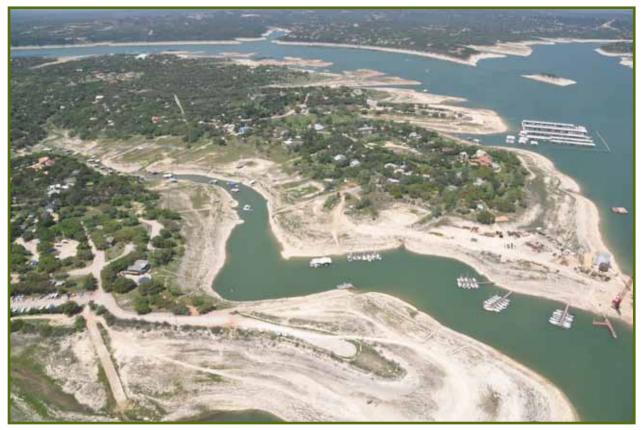
Lake Travis at 47 percent of capacity during the 2011 drought

Lack of rainfall between 2008 and 2011 lowered the lake to levels not seen since the drought of record during the 1950s. In 2011, inflows to the Highland Lakes were only 25 percent of the historical average, the lowest since Lake Travis was created.

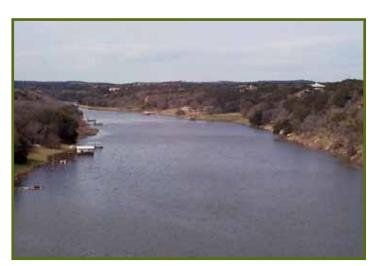
Pedernales River at Highway 71 in 2007

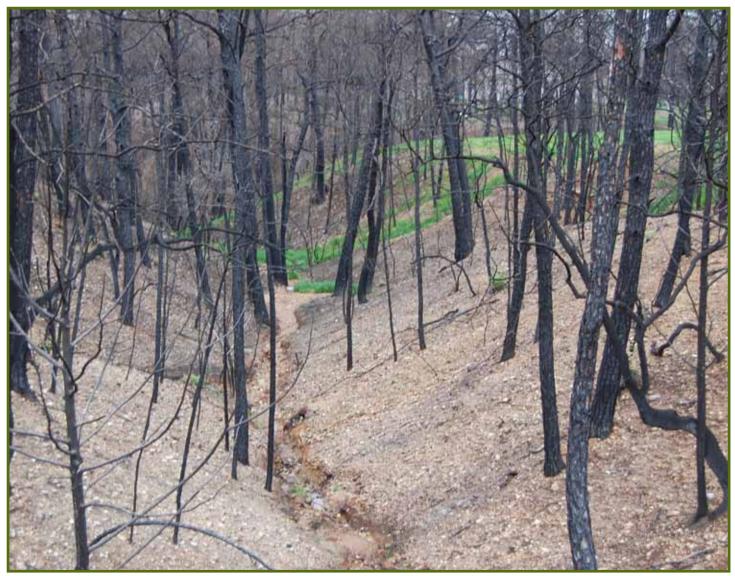
Copperas Creek in Bastrop State Park after the Bastrop County Complex Fire

On Labor Day Weekend 2011, wildfires began near Hwy. 290 and the town of Paige. A separate wildfire began off FM 1441 near Hwy. 21. As a result of strong, gusty winds in excess of 30 mph and ongoing drought, the wildfires quickly joined and continued to burn, moving in a southeasterly direction. Ultimately the Bastrop County Complex Fire scorched over 34,000 acres and destroyed 1,600 homes. Much of the area known as Lost Pines, including habitat for the endangered Houston Toad and Bastrop State Park was lost. Recovery of this unique ecosystem will be measured in years. In response to this natural disaster, LCRA developed a water quality monitoring plan in order to assess the impact to Alum Creek and the Colorado River. The plan identified ambient and stormwater monitoring for approximately 185 parameters including routine water chemistry, metals, semi-volatile organic compounds and volatile organic compounds. Monitoring stations were located at the Colorado River at Bastrop (upstream control Point), Colorado River at Colovista (where fire reached the river), Colorado River at Smithville (downstream of all the fire activity), and Alum Creek (tributary watershed where 80% of the fire occurred).
