# 2017 BASIN SUMMARY REPORT

A Summary of Water Quality Activities  
in the Colorado River Basin (2012-2016)

This report, which summarizes water quality activities in the Colorado River basin between January 2012 and December 2016, was prepared by the Lower Colorado River Authority (LCRA) and Upper Colorado River Authority (UCRA) with contributions from the City of Austin. The report was financed through grants from the Texas Commission on Environmental Quality (TCEQ).

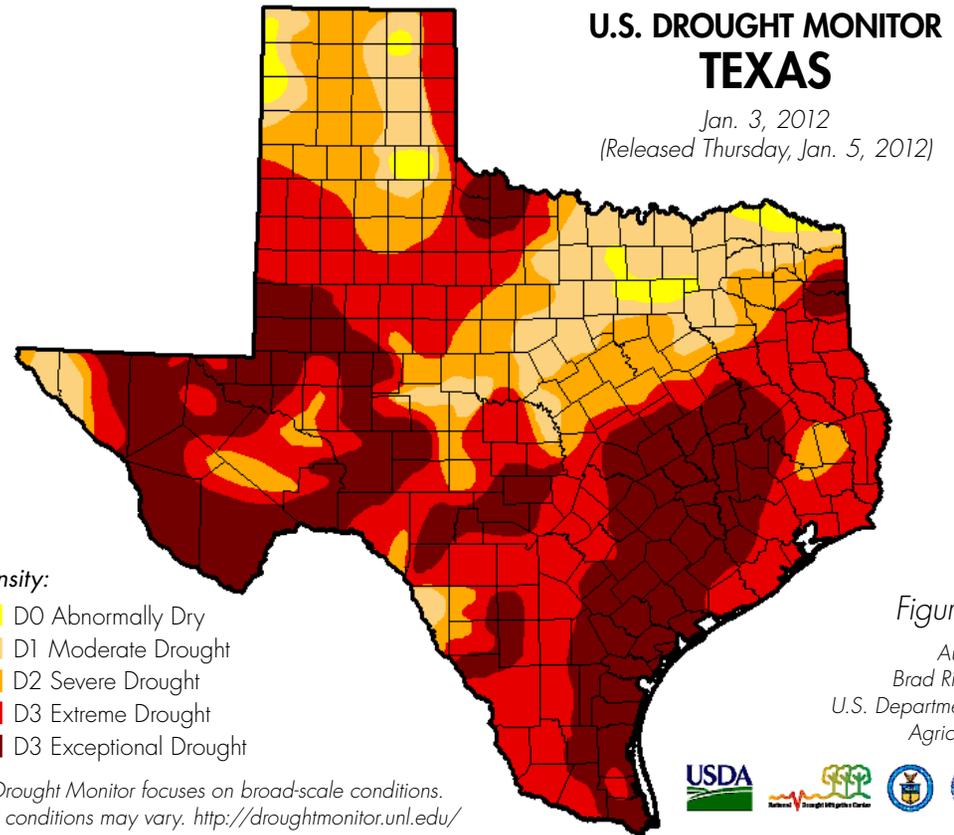
*Figure 5. According to the U.S Drought Monitor, all of Texas was in some stage of drought in January 2012. Most of the Colorado River basin experienced extreme to exceptional drought conditions from 2012 through 2015.*

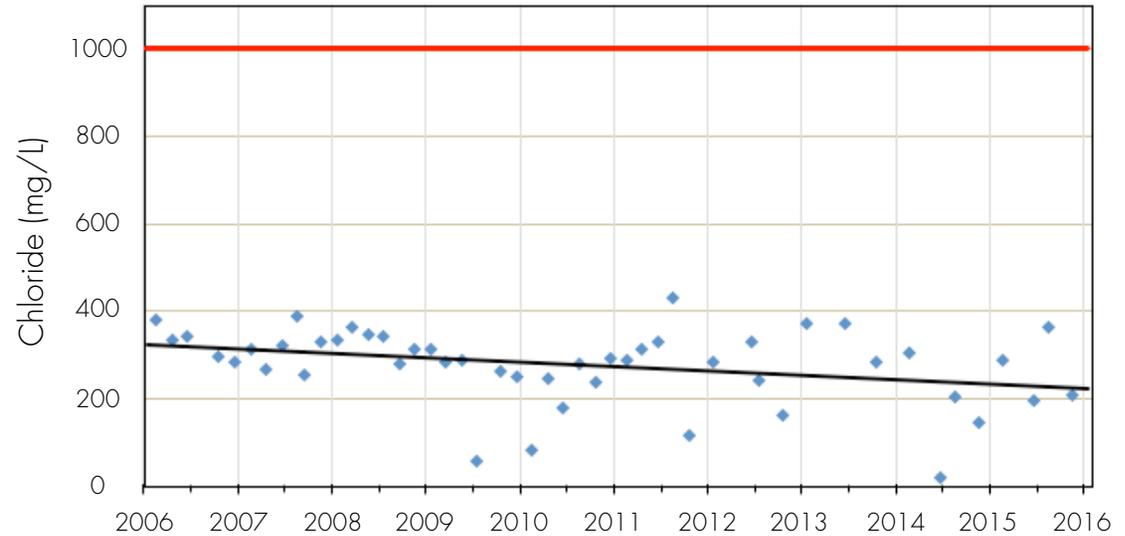
Figure 14. Chloride Trend / Segment 1426C

Figure 14 presents one statistically significant trend analysis performed on the 2014 Integrated Report data. It shows a declining trend in chloride. The cause of this improving trend in chloride is unknown, but may be attributable to increased flows.

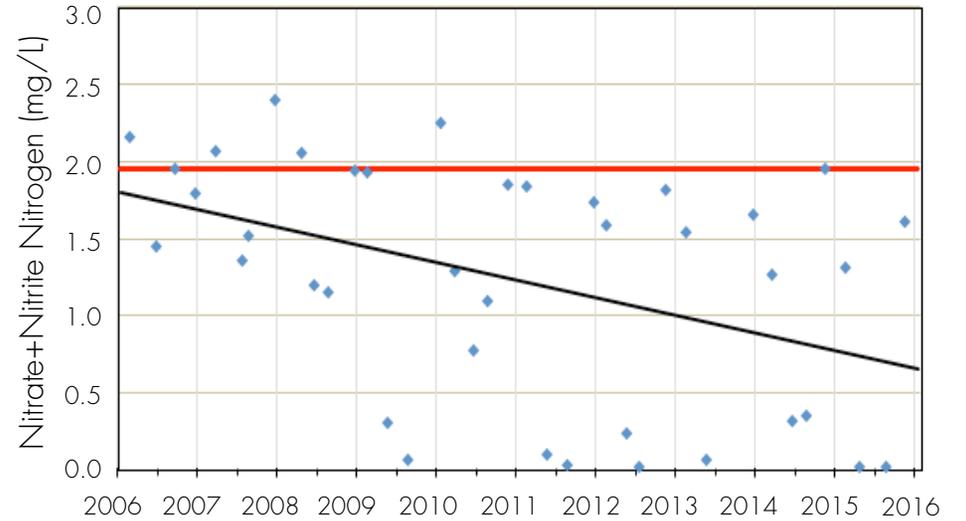
Figure 38. Nitrate+Nitrite Nitrogen Trend / Segment 1423A

The downward trending nitrogen levels include a wide range of numbers. The cause of the swings or the source of the nitrogen is unknown. It may be related to seasonality because the spring and summer quarters exhibit lower levels than the last and first quarter measurements. This was the case beginning in 2009 and continuing throughout the rest of the reporting period (Figure 38).

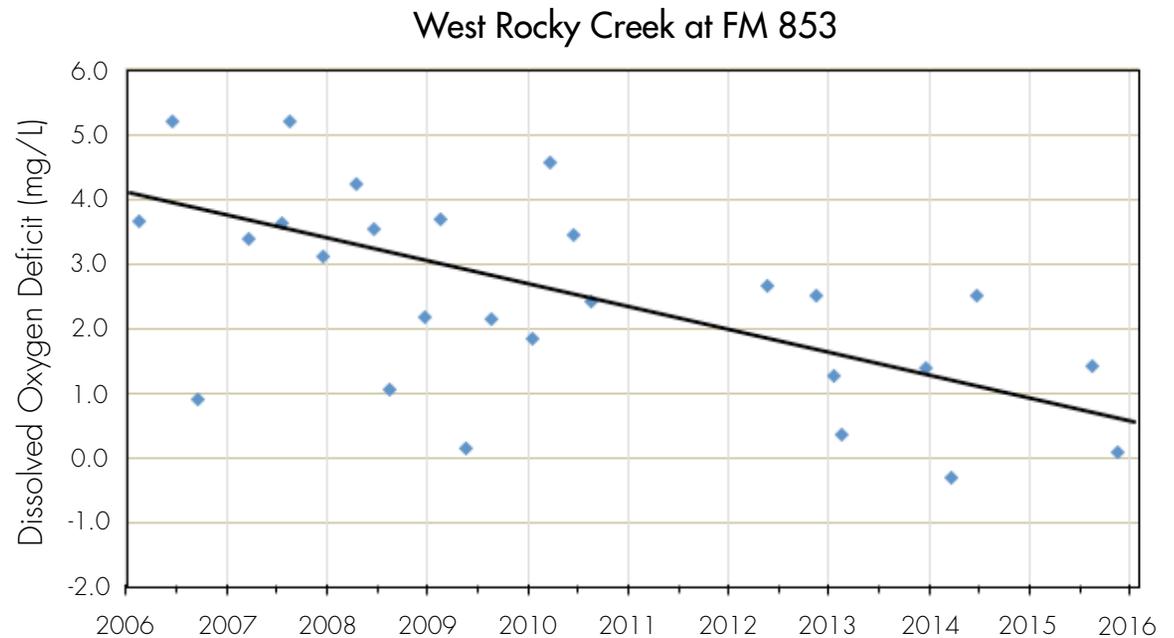
Figure 44. Dissolved Oxygen Deficit Trend / Segment 1424

Dissolved oxygen deficit and dissolved oxygen showed significant trends (Figures 44 and 45). The analyses indicate that while dissolved oxygen is improving, dissolved oxygen deficit is trending down. The reason for these trends is unknown.
