Texas Clean Rivers Program 2011 Basin Highlights Report

A Characterization of Impaired Water Bodies in the Colorado River Basin

June, 2011

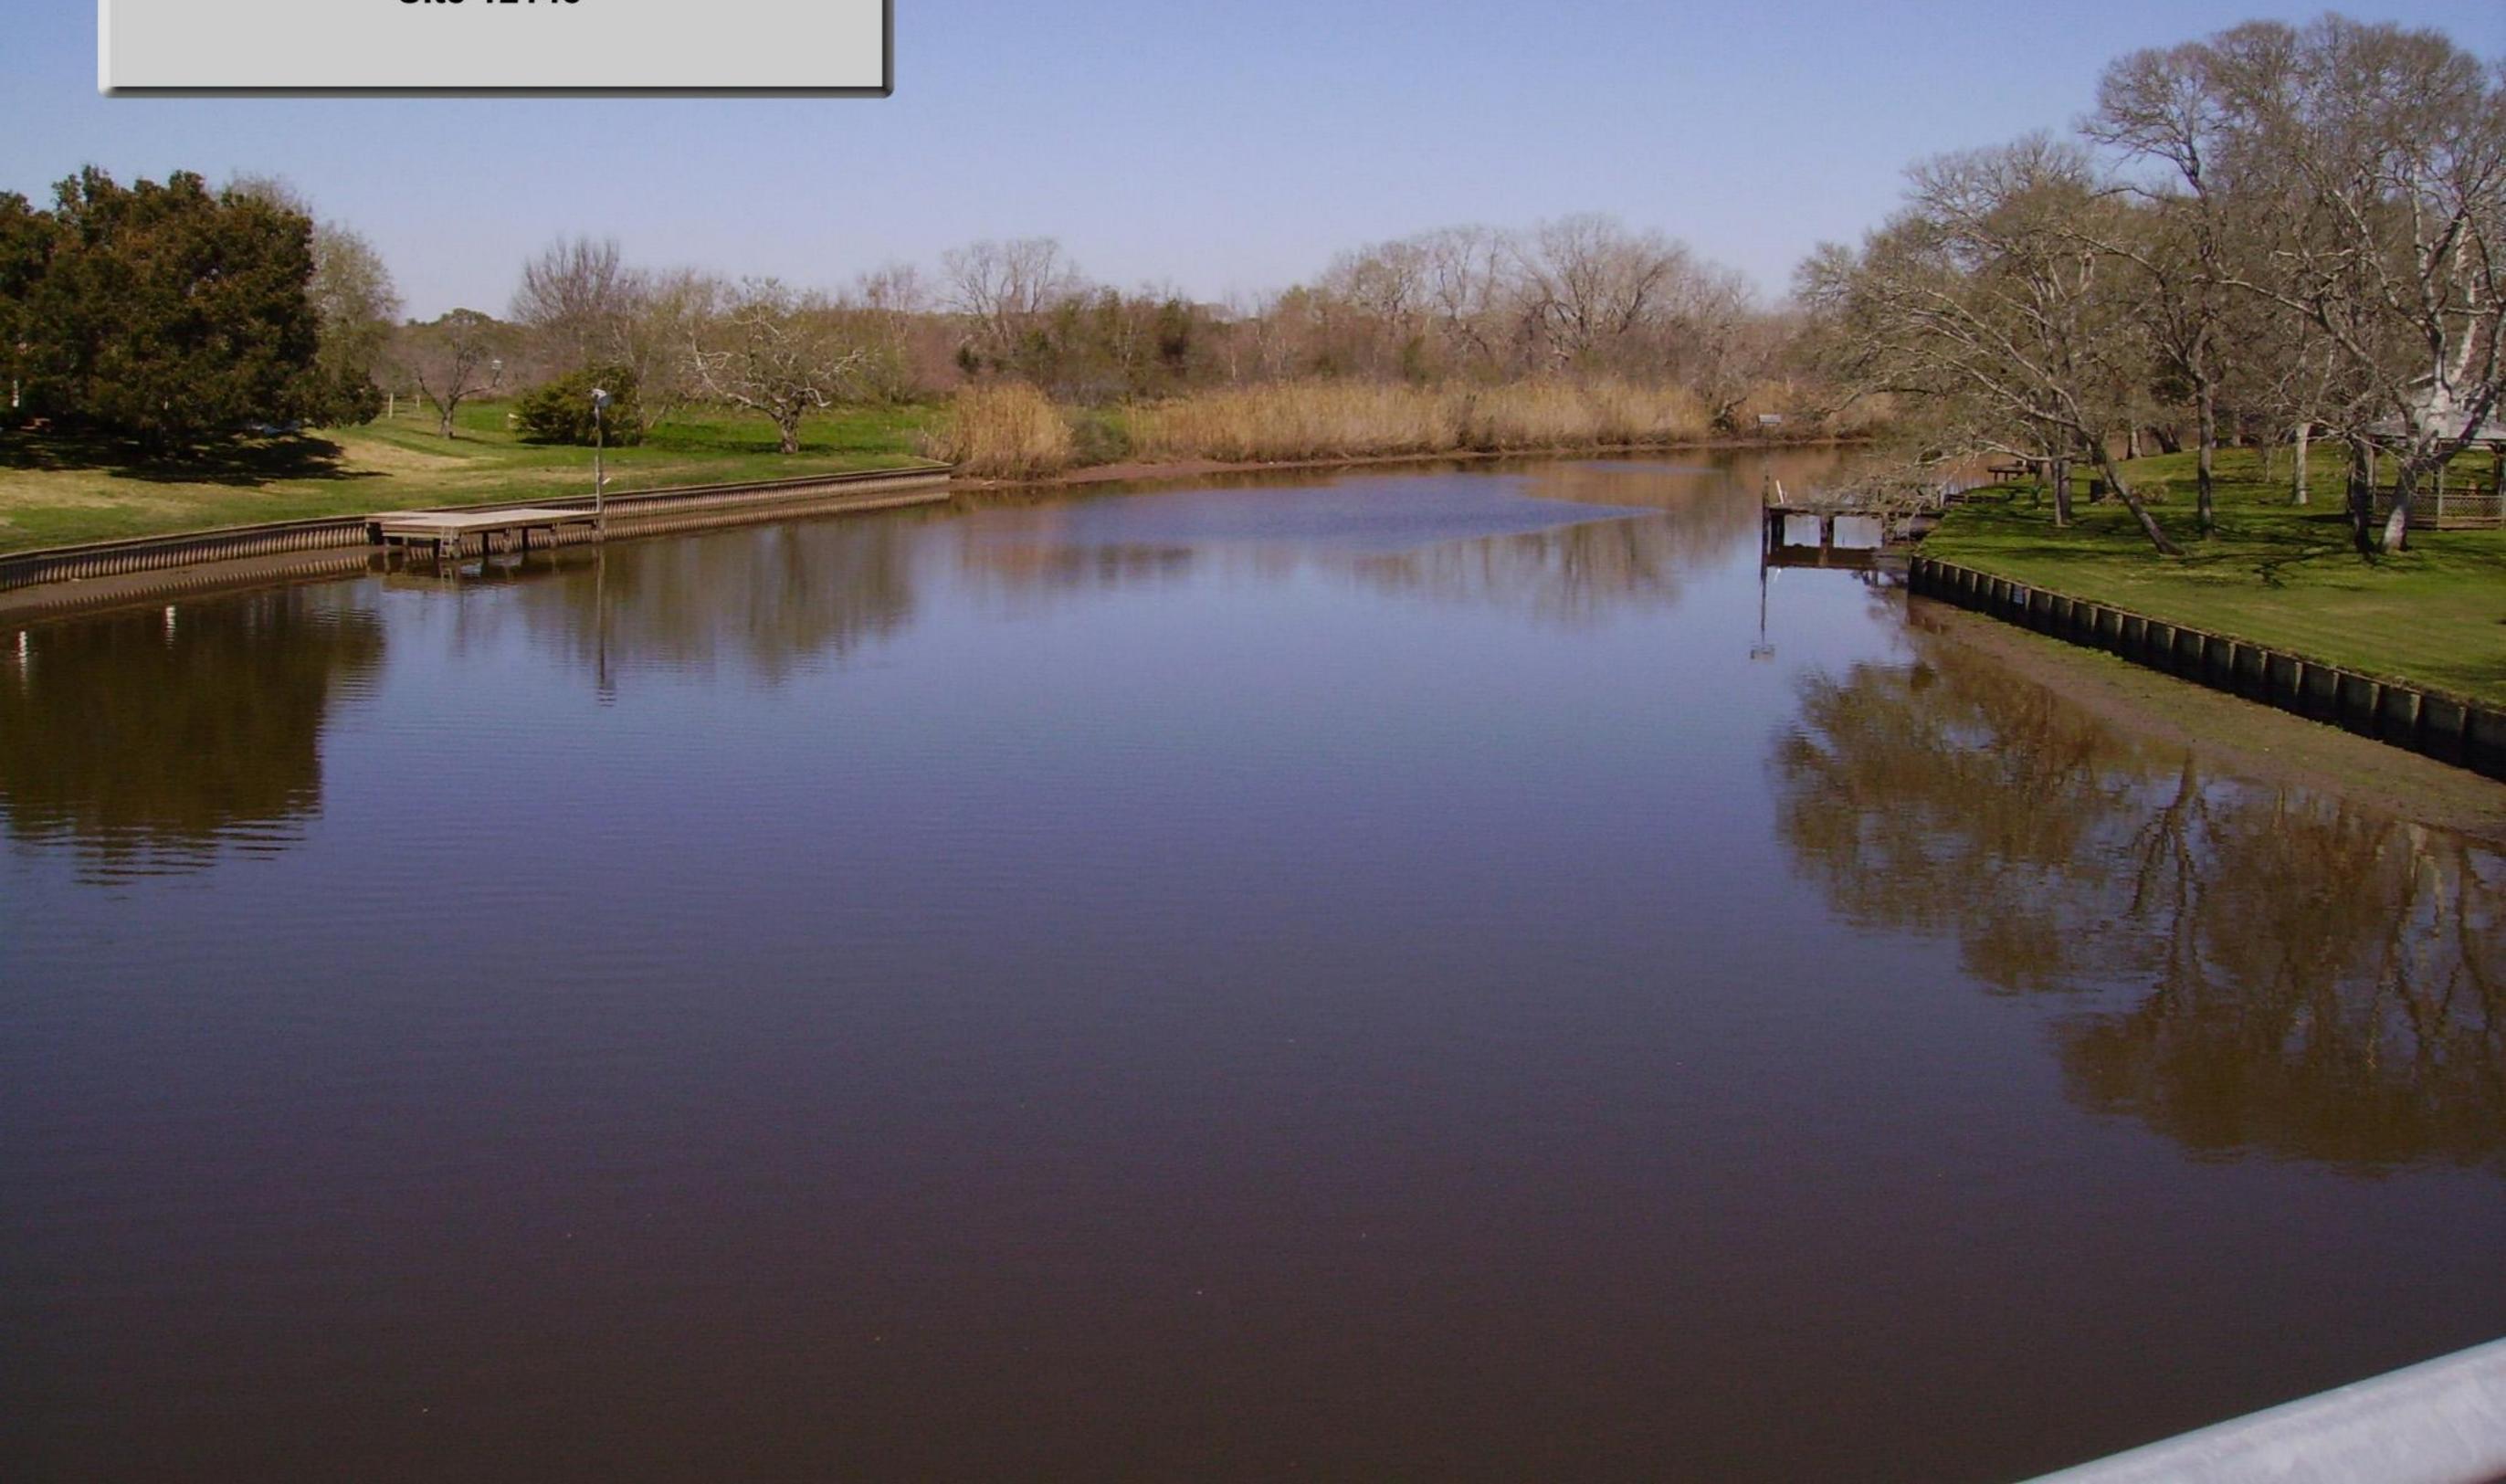
**Fig. 3 - Segment 1304
Caney Creek Tidal**

Site 12148

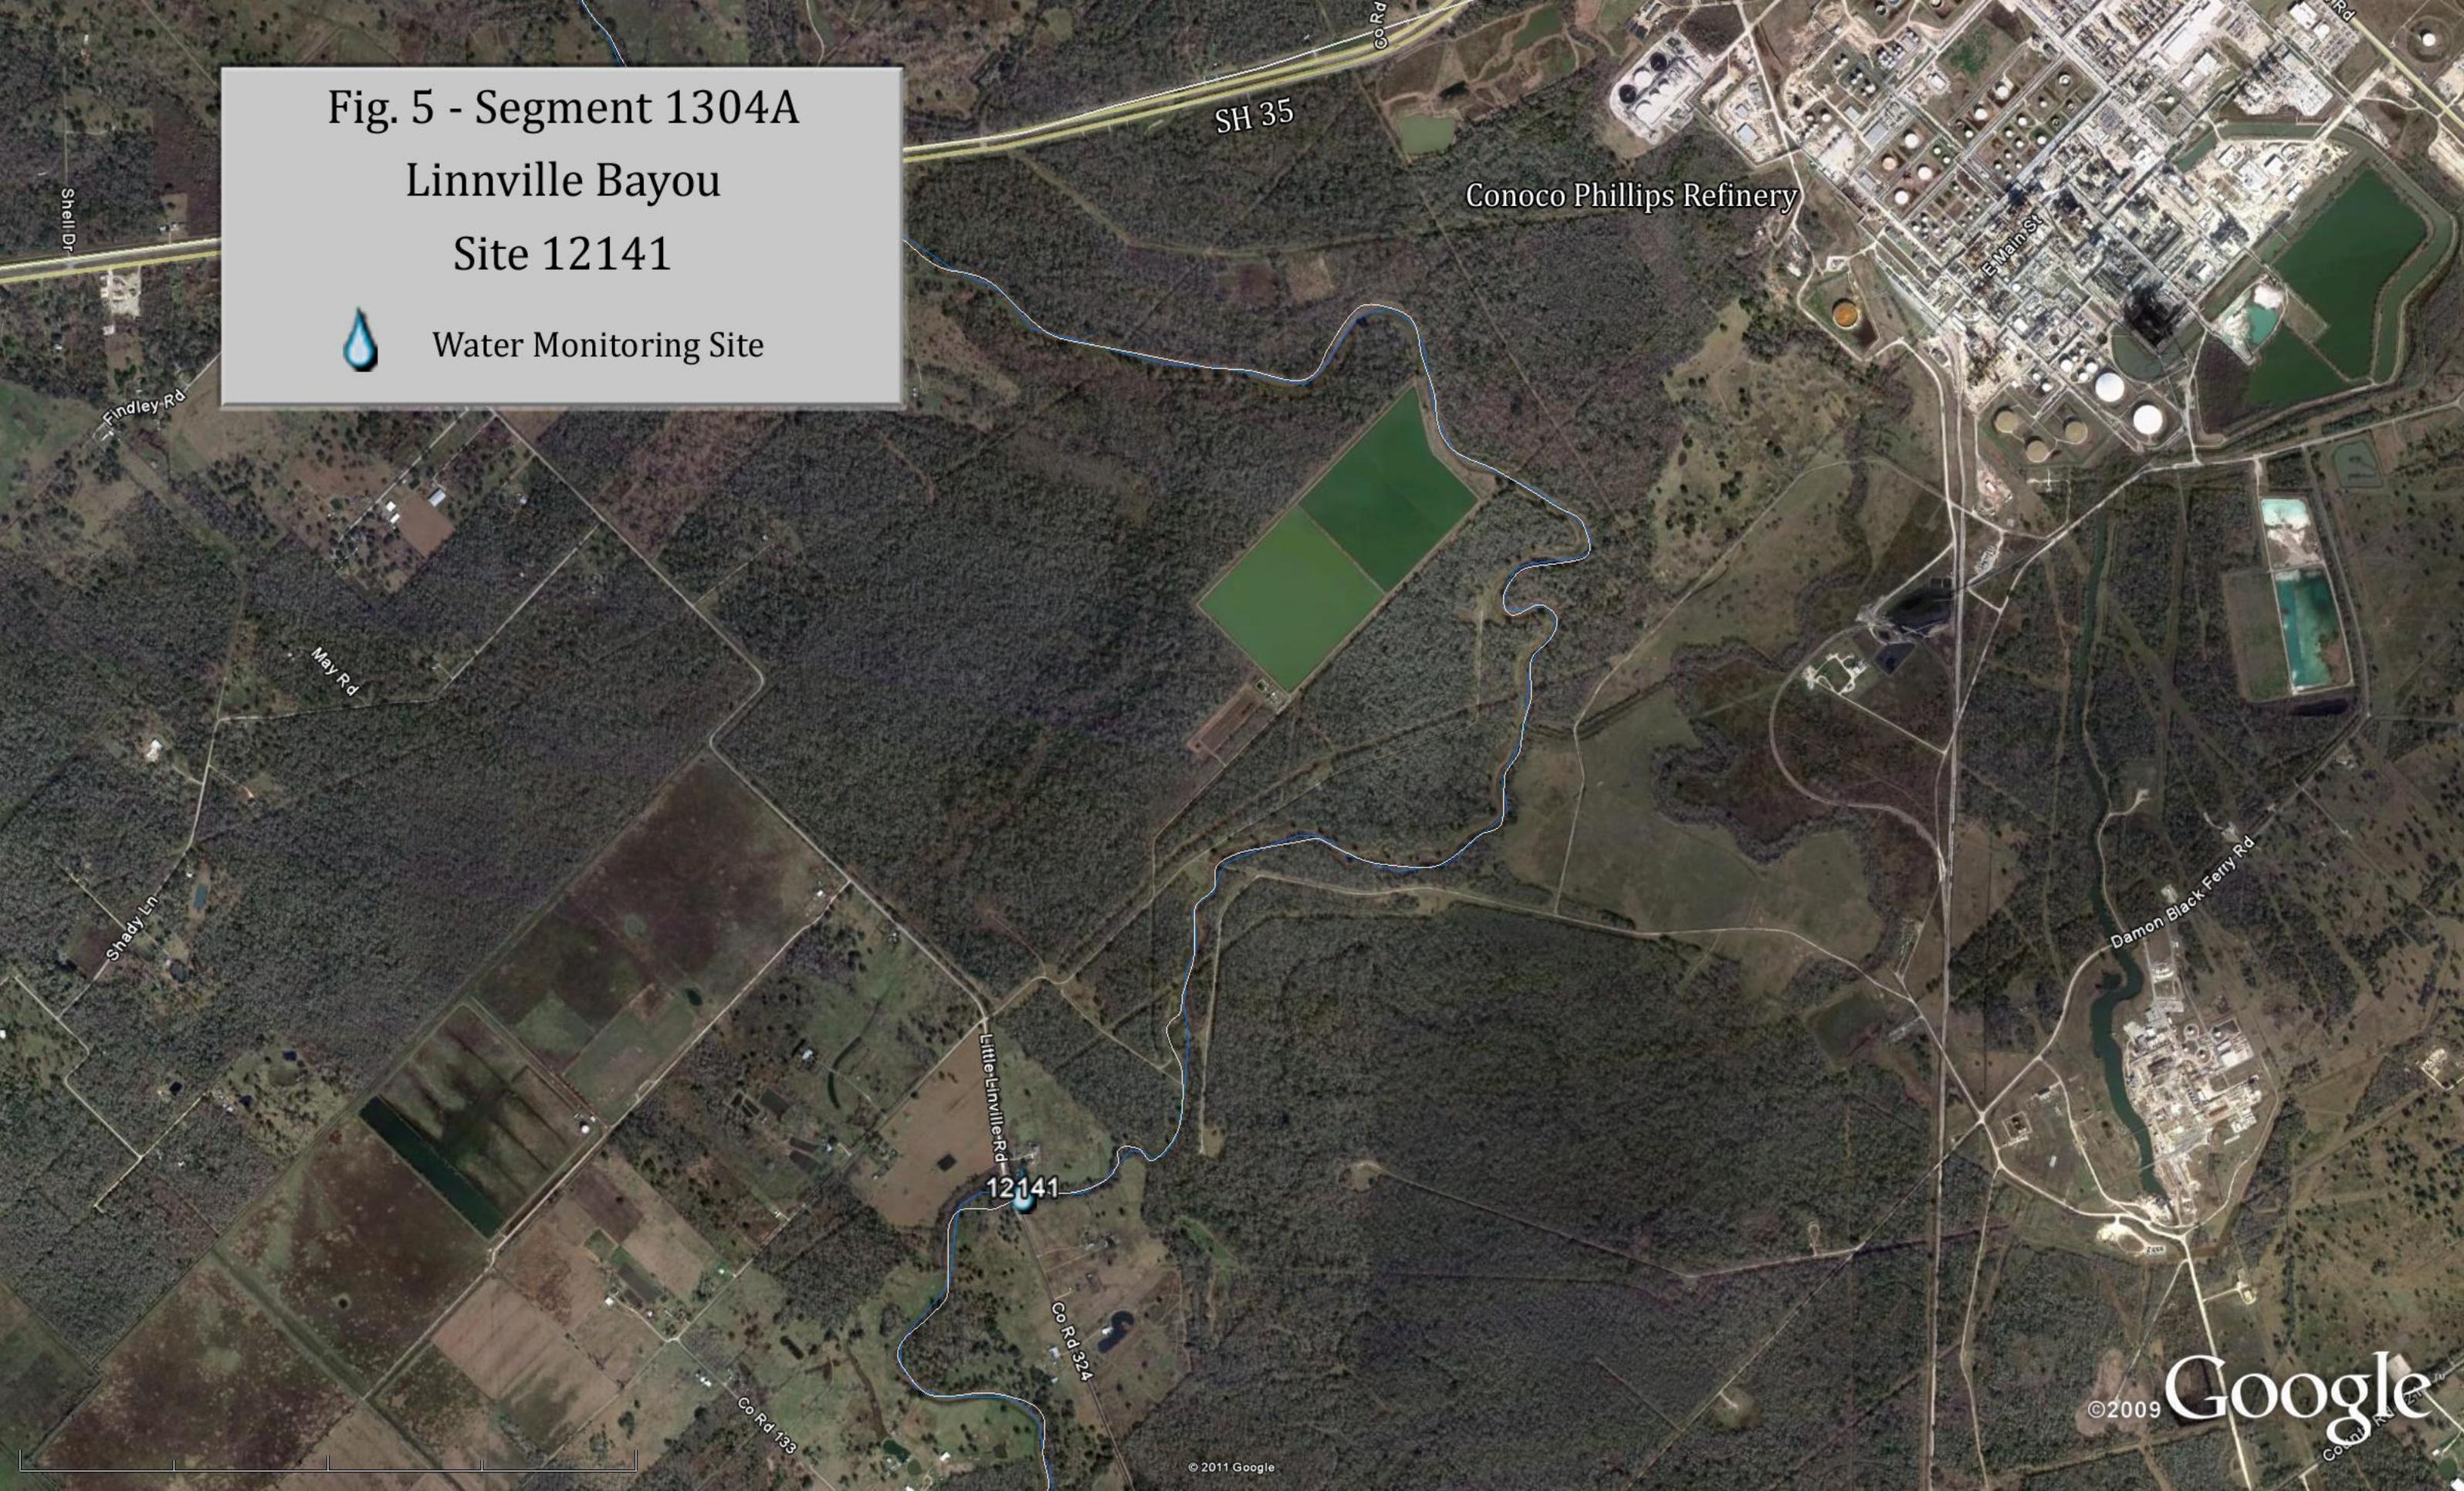
**Fig. 6 - Segment 1304A
Linnville Bayou
Site 12141**

According to TCEQ permit documents, Little Linnville Bayou receives storm water from the refinery. But there's no hydrologic connection between Little Linnville Bayou and Site 12141 where the bacteria impairment was found.

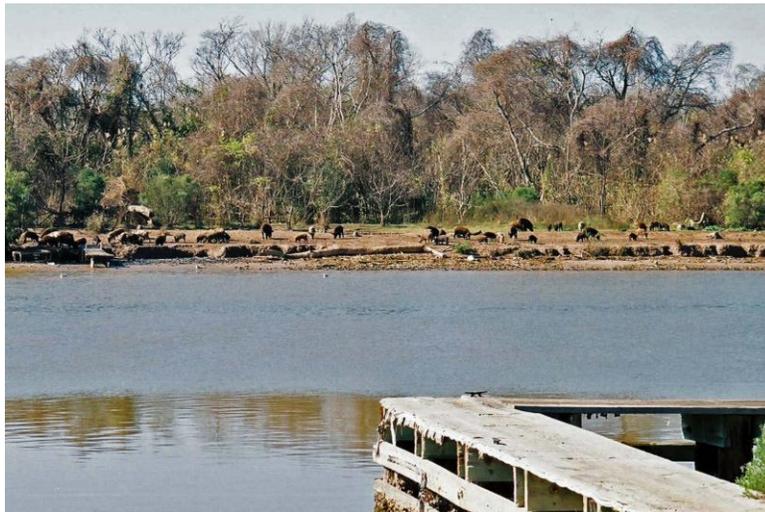
Fig. 12 - Feral Hogs on segment 1401 near Matagorda, Texas (Photo: Brian Koch)

Continue communication with TCEQ to evaluate current EPA-approved *Enterococcus* methods and 35 MPN criteria.
Communicate with TCEQ and Texas State Soil and Water Conservation Board about potential for a WPP.

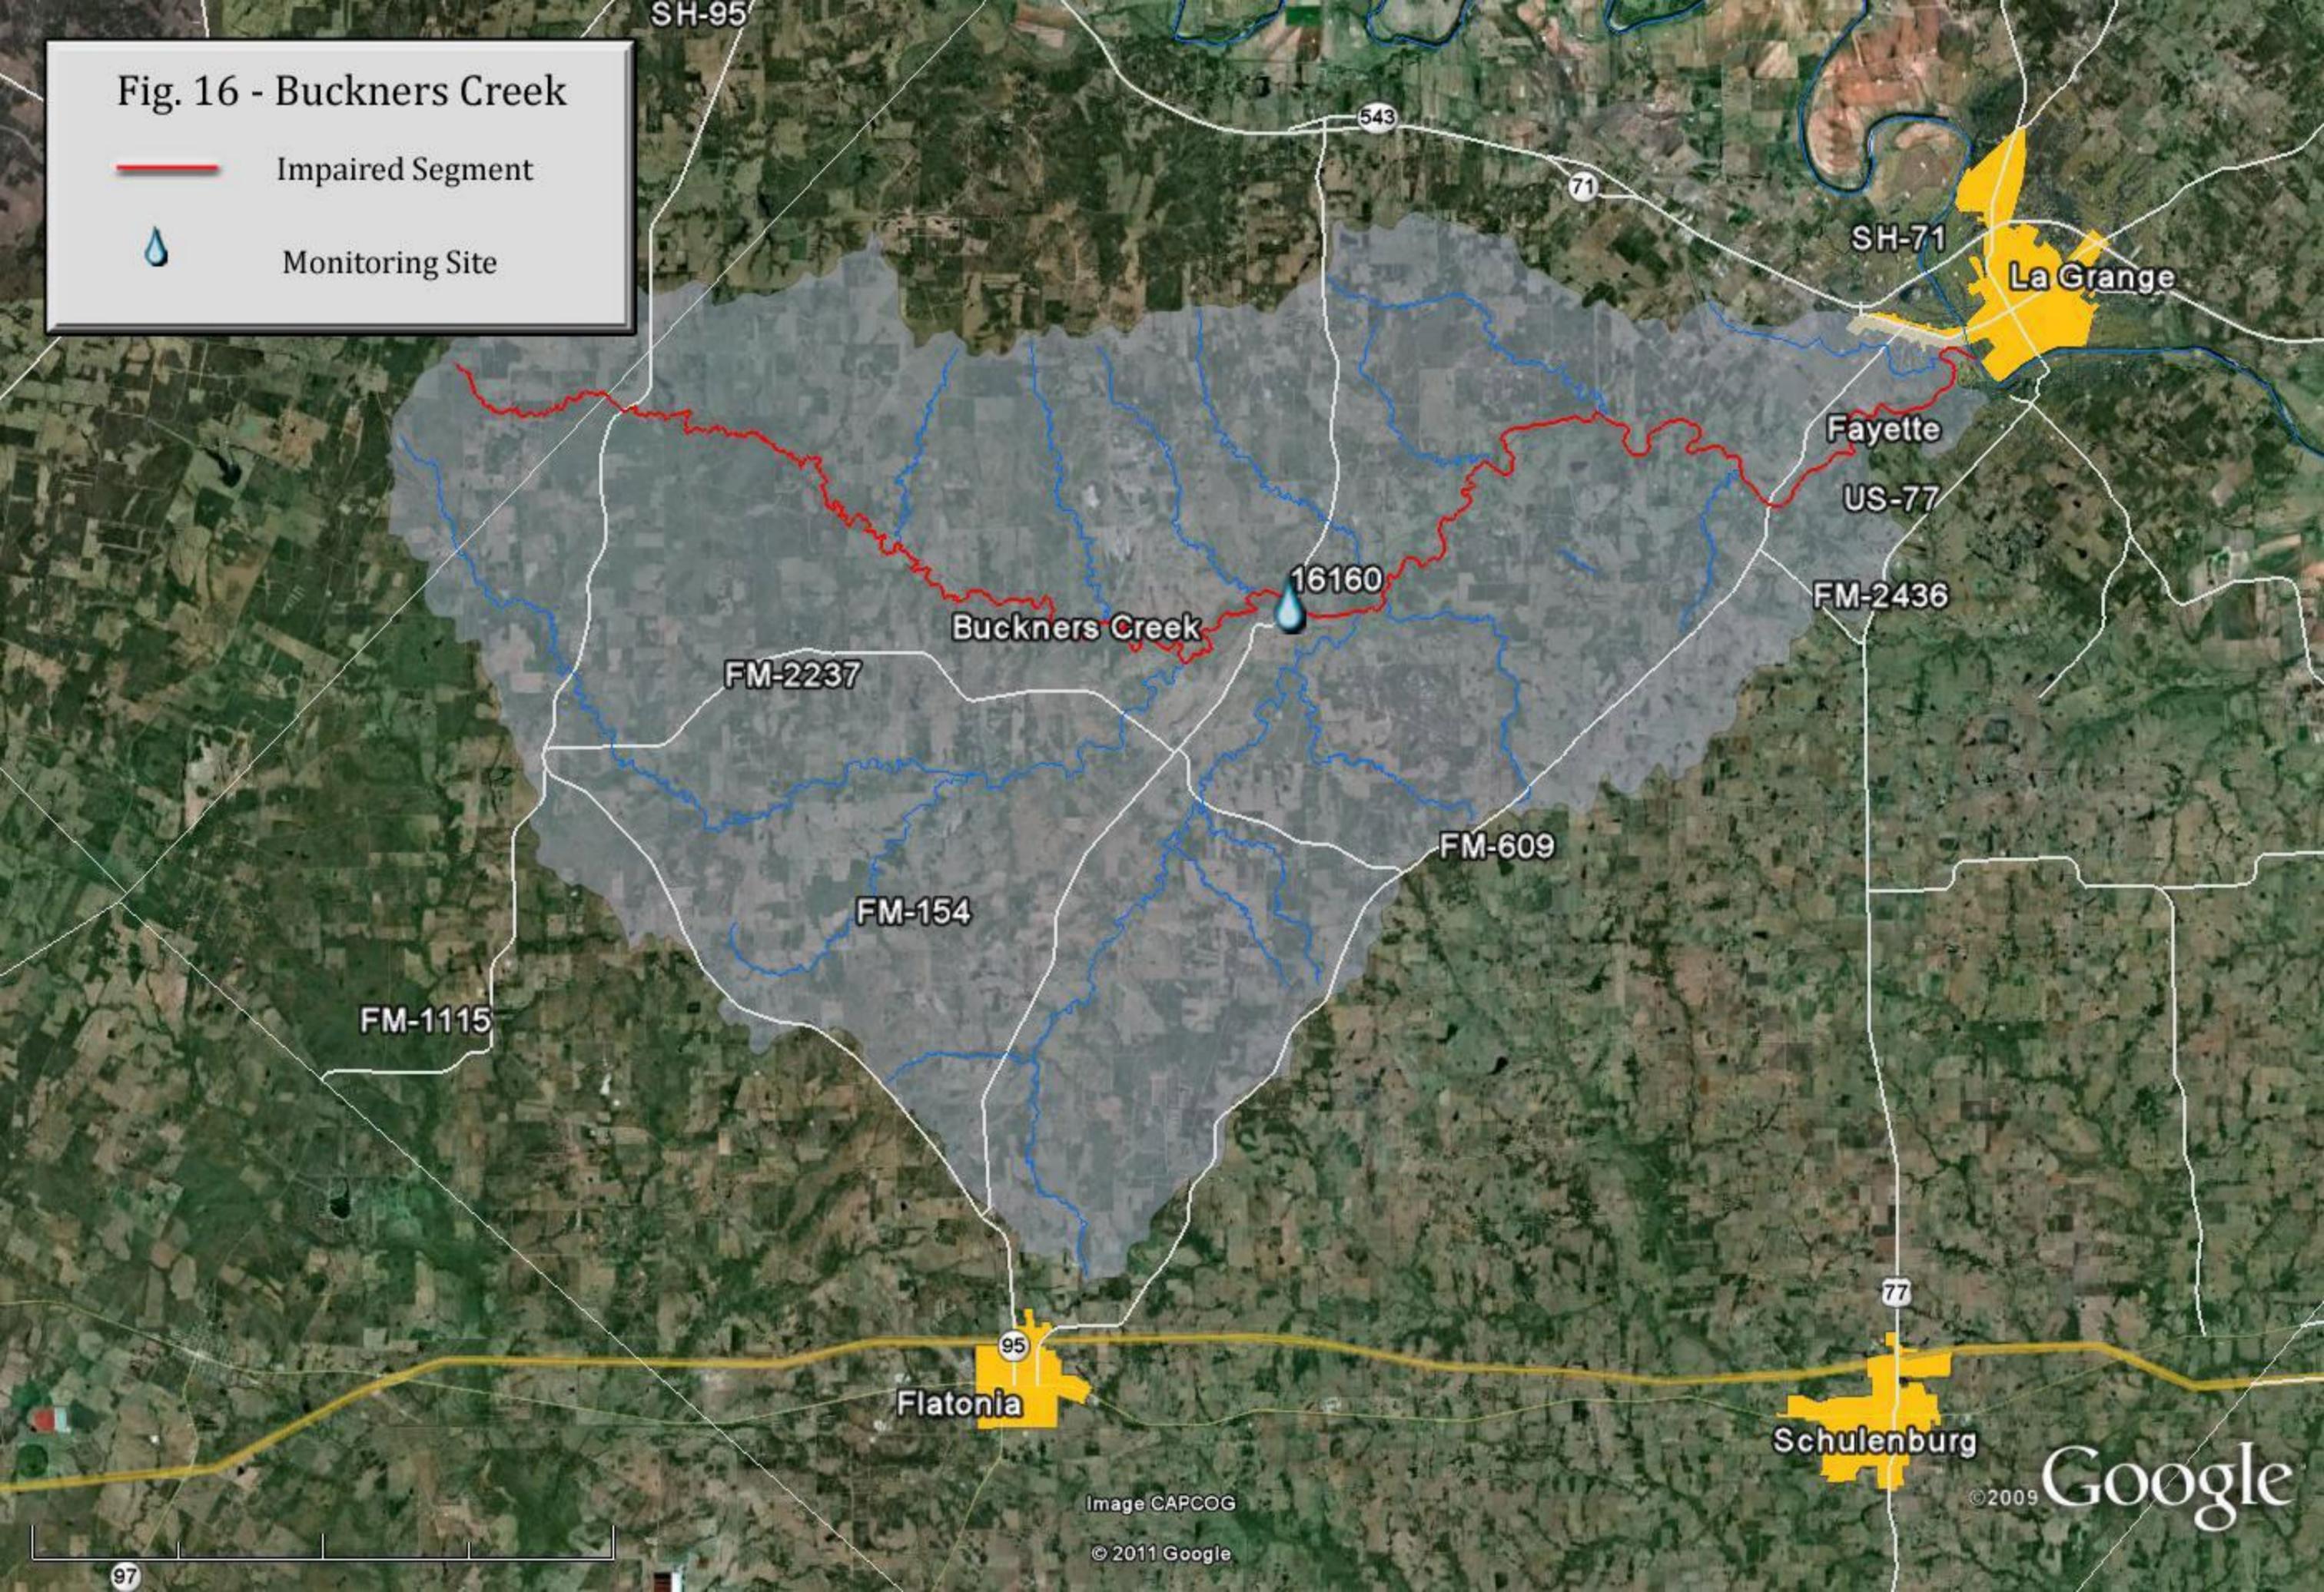
Fig. 17 - Segment 1402C
Buckners Creek
Site 16160

Decomposition of organic matter is a likely cause of low DO in the stream. However further study is necessary to isolate potential sources.

Perform reconnaissance on the creek to help determine potential causes of low dissolved oxygen

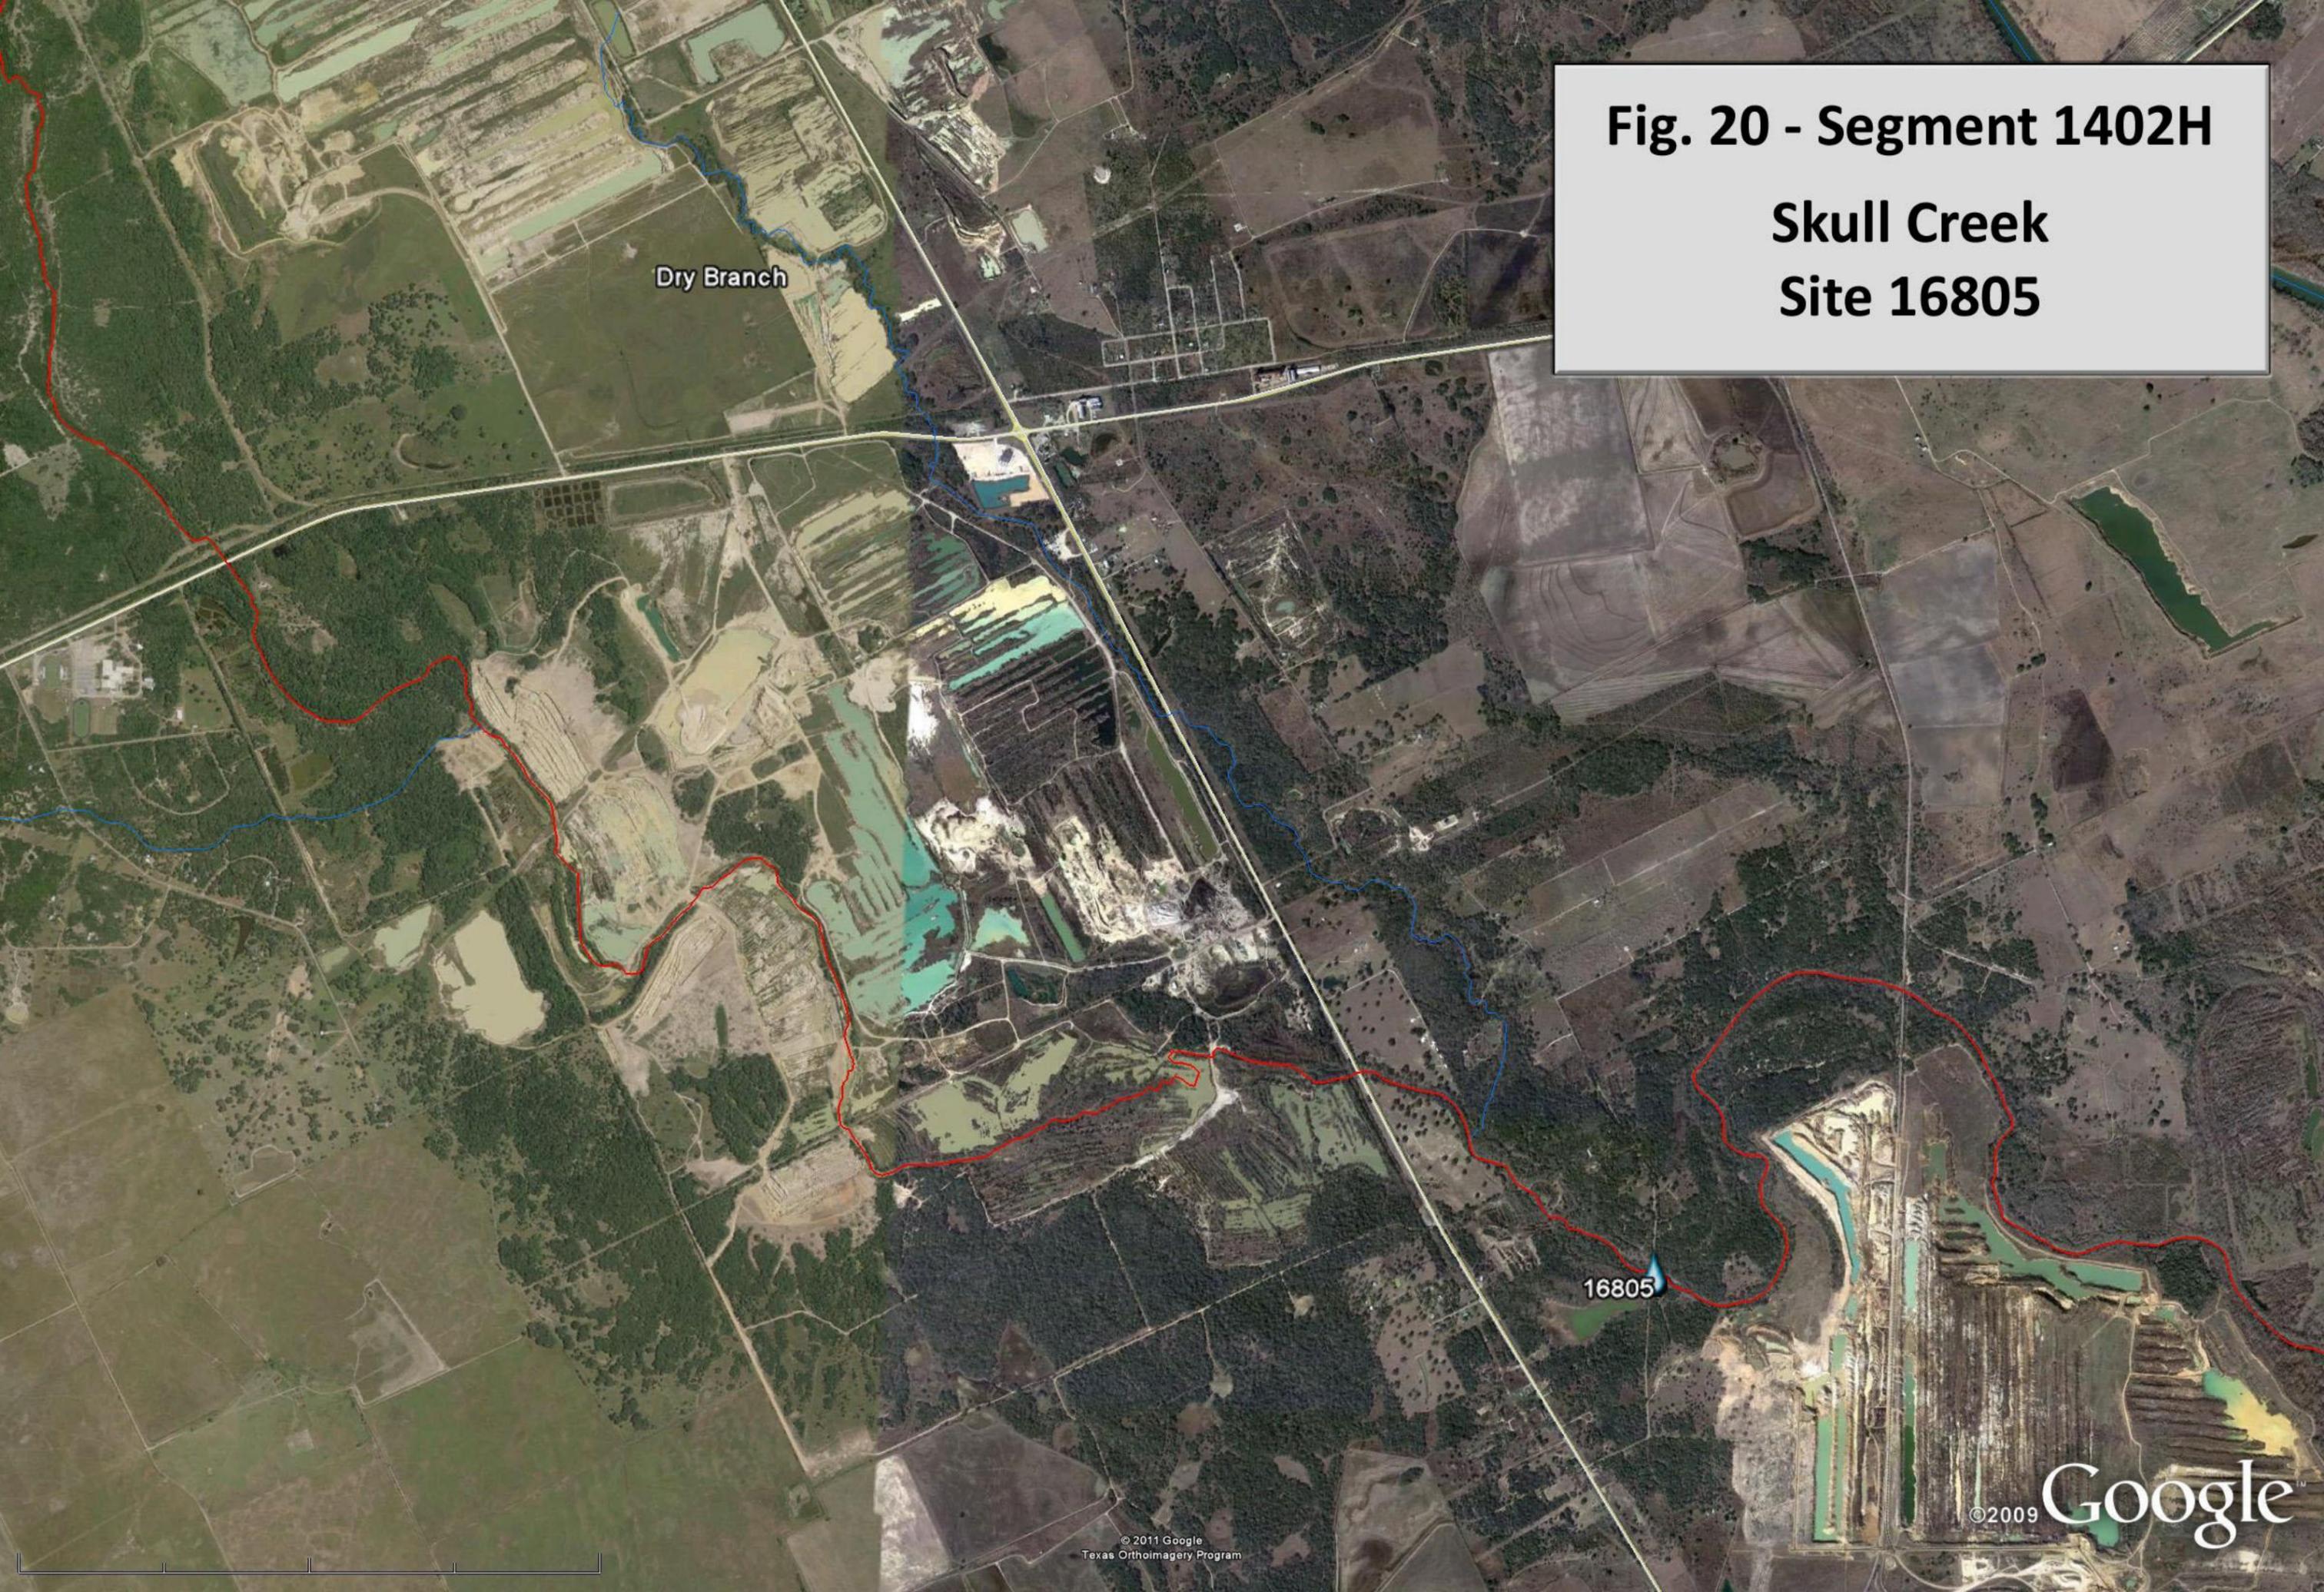
**Fig. 21 - Segment 1402H
Skull Creek
Site 16805**

Decomposition of organic matter coupled with sluggish flow regimes is a likely cause of low DO in the stream. Cattle, deer, feral hog and other wildlife likely contribute bacteria to the creek. Further study is needed to determine sources of pollutants.

TCEQ Region 12 completed ALM that found that the creek supports a diverse aquatic community despite chronic low dissolved oxygen levels and upstream gravel mines affect water clarity. Fish, macroinvertebrate and habitat samples indicate a high aquatic life use.

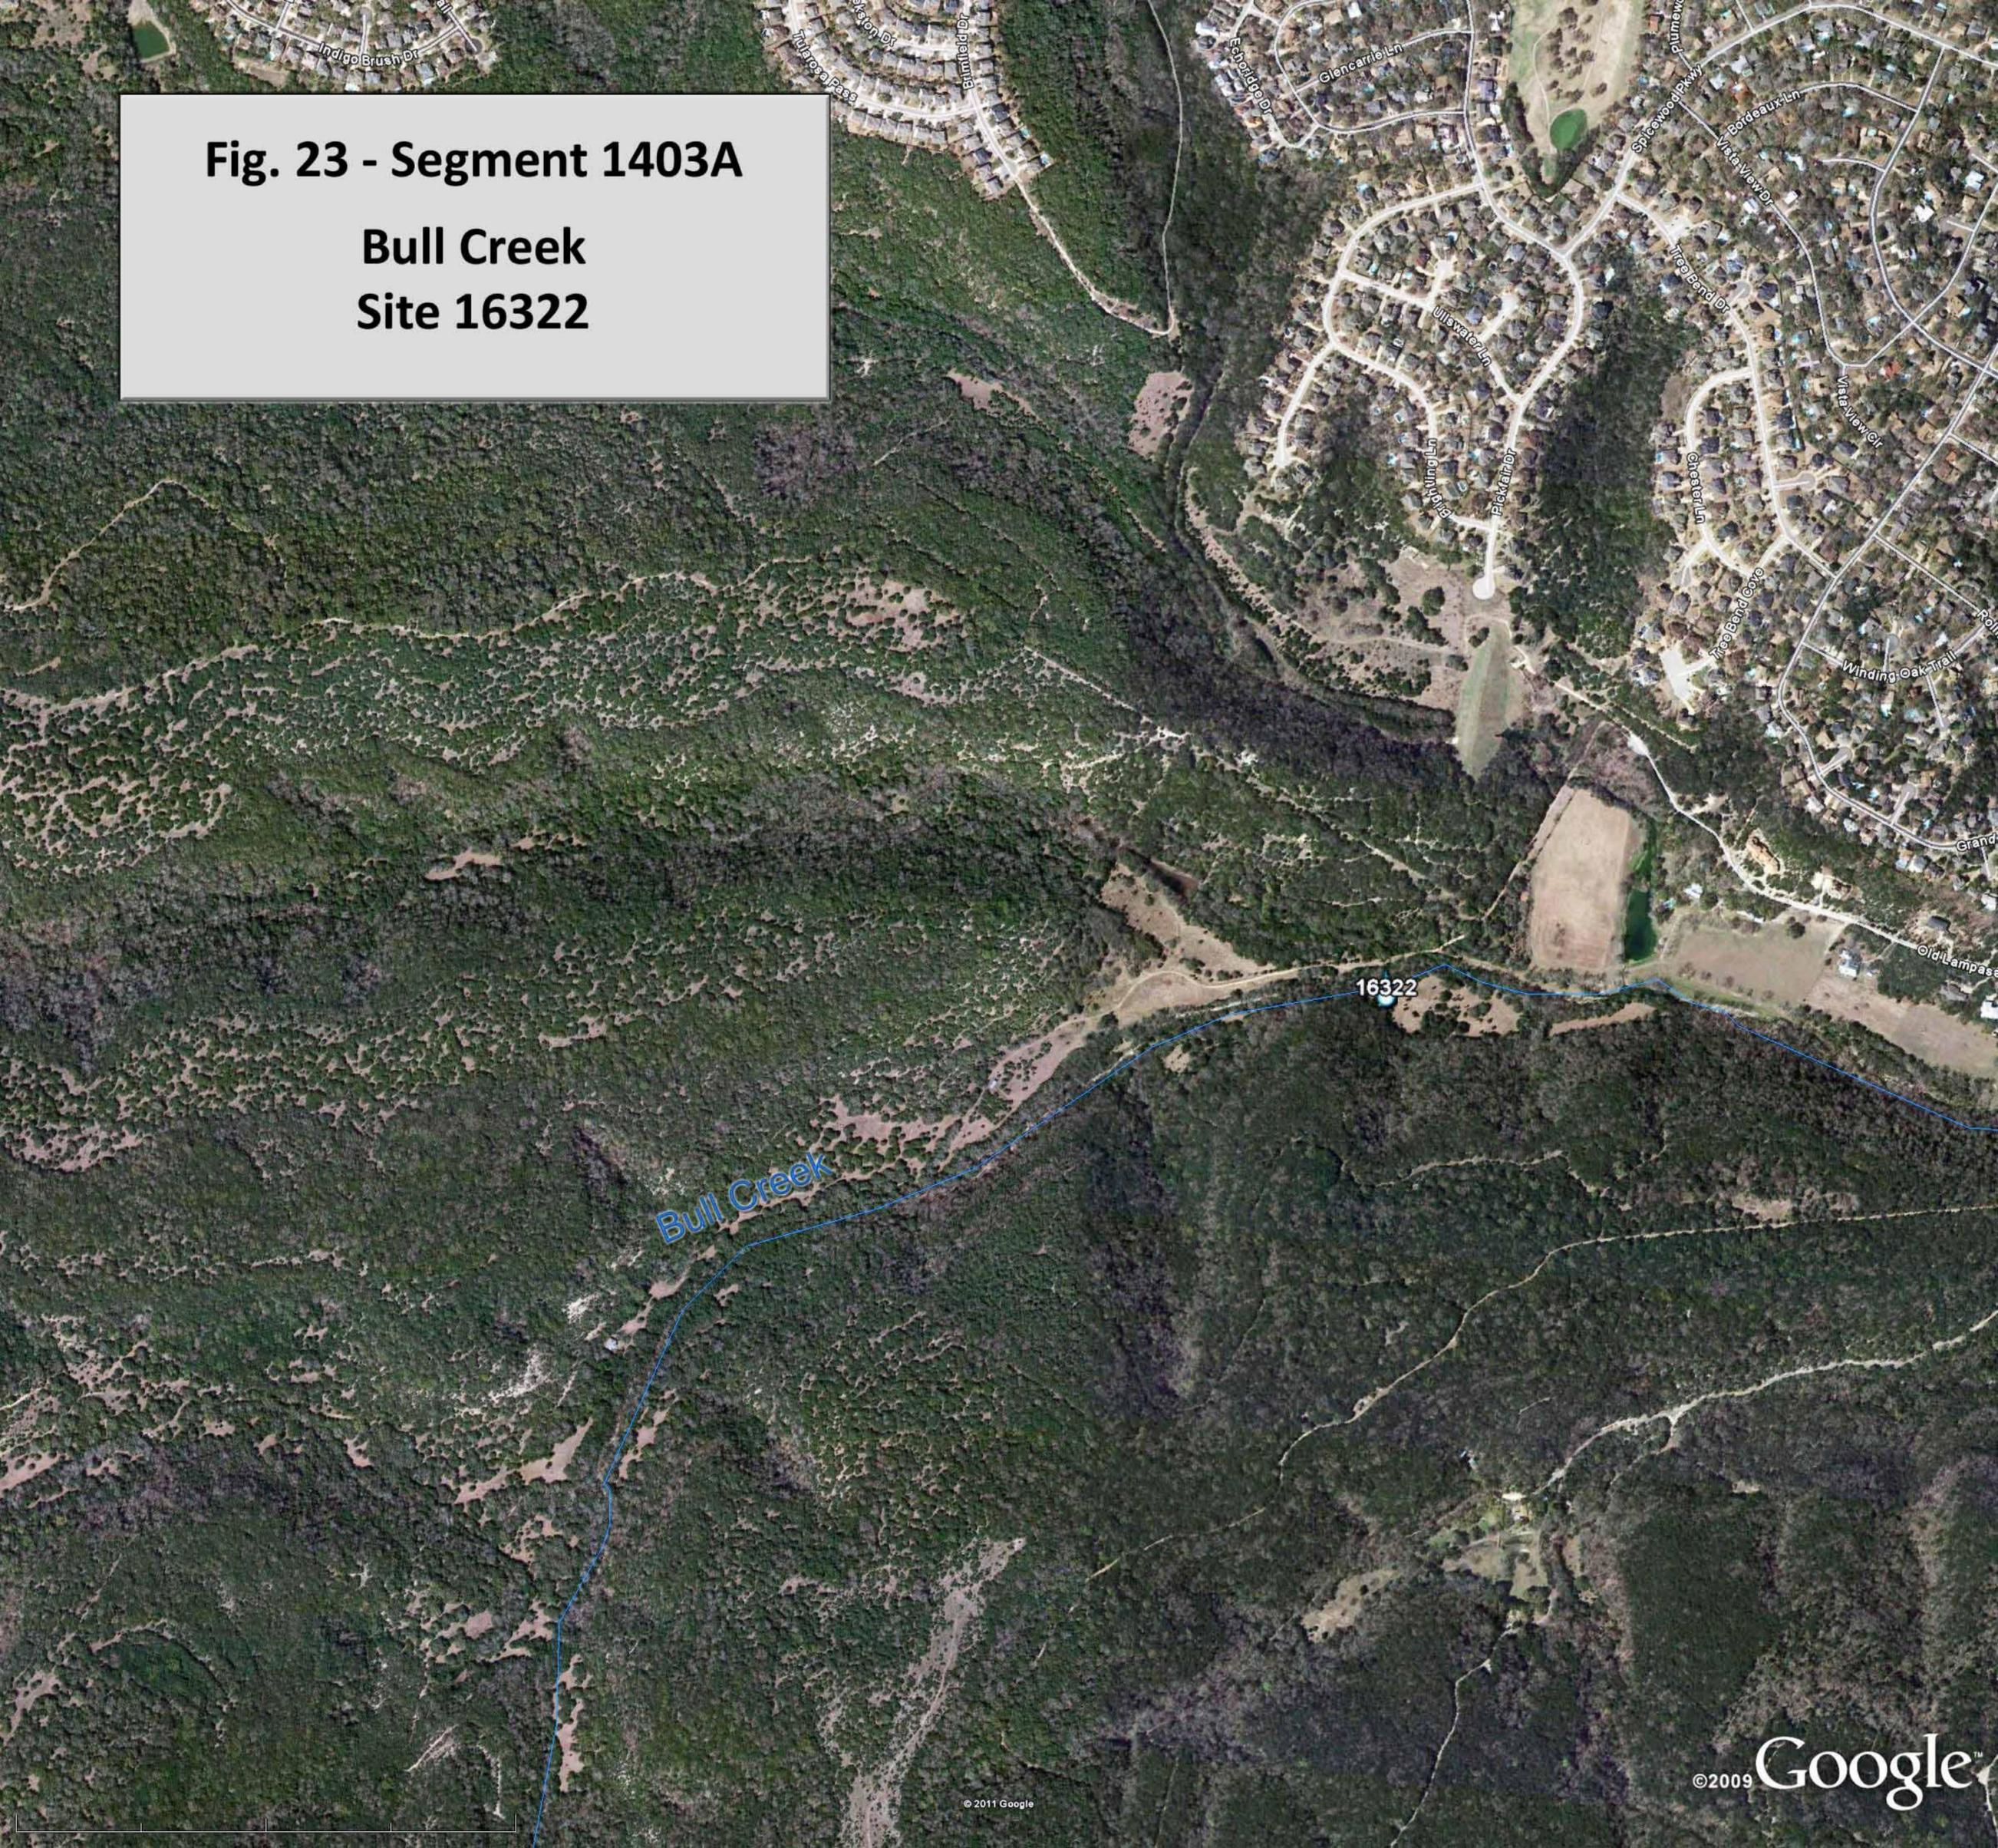
Fig. 23 - Segment 1403A

The impaired AU, 1403A_05, begins from the Spicewood Springs Rd. crossing near the Oak Grove cemetery upstream to the end of segment. Data responsible for the listing are from Site 16322 (Fig 23), referred to by COA monitoring staff as Bull Creek Tributary 7 at the Franklin Tract. The monitoring site is located with COA Water Quality Protection Lands; preserve lands permanently protected from future development. The stream maintains a population of the threatened Jollyville Plateau salamander (*Eurycea nana*).
