Texas Clean Rivers Program 2011 Basin Highlights Report

A Characterization of Impaired Water Bodies in the Colorado River Basin

June, 2011

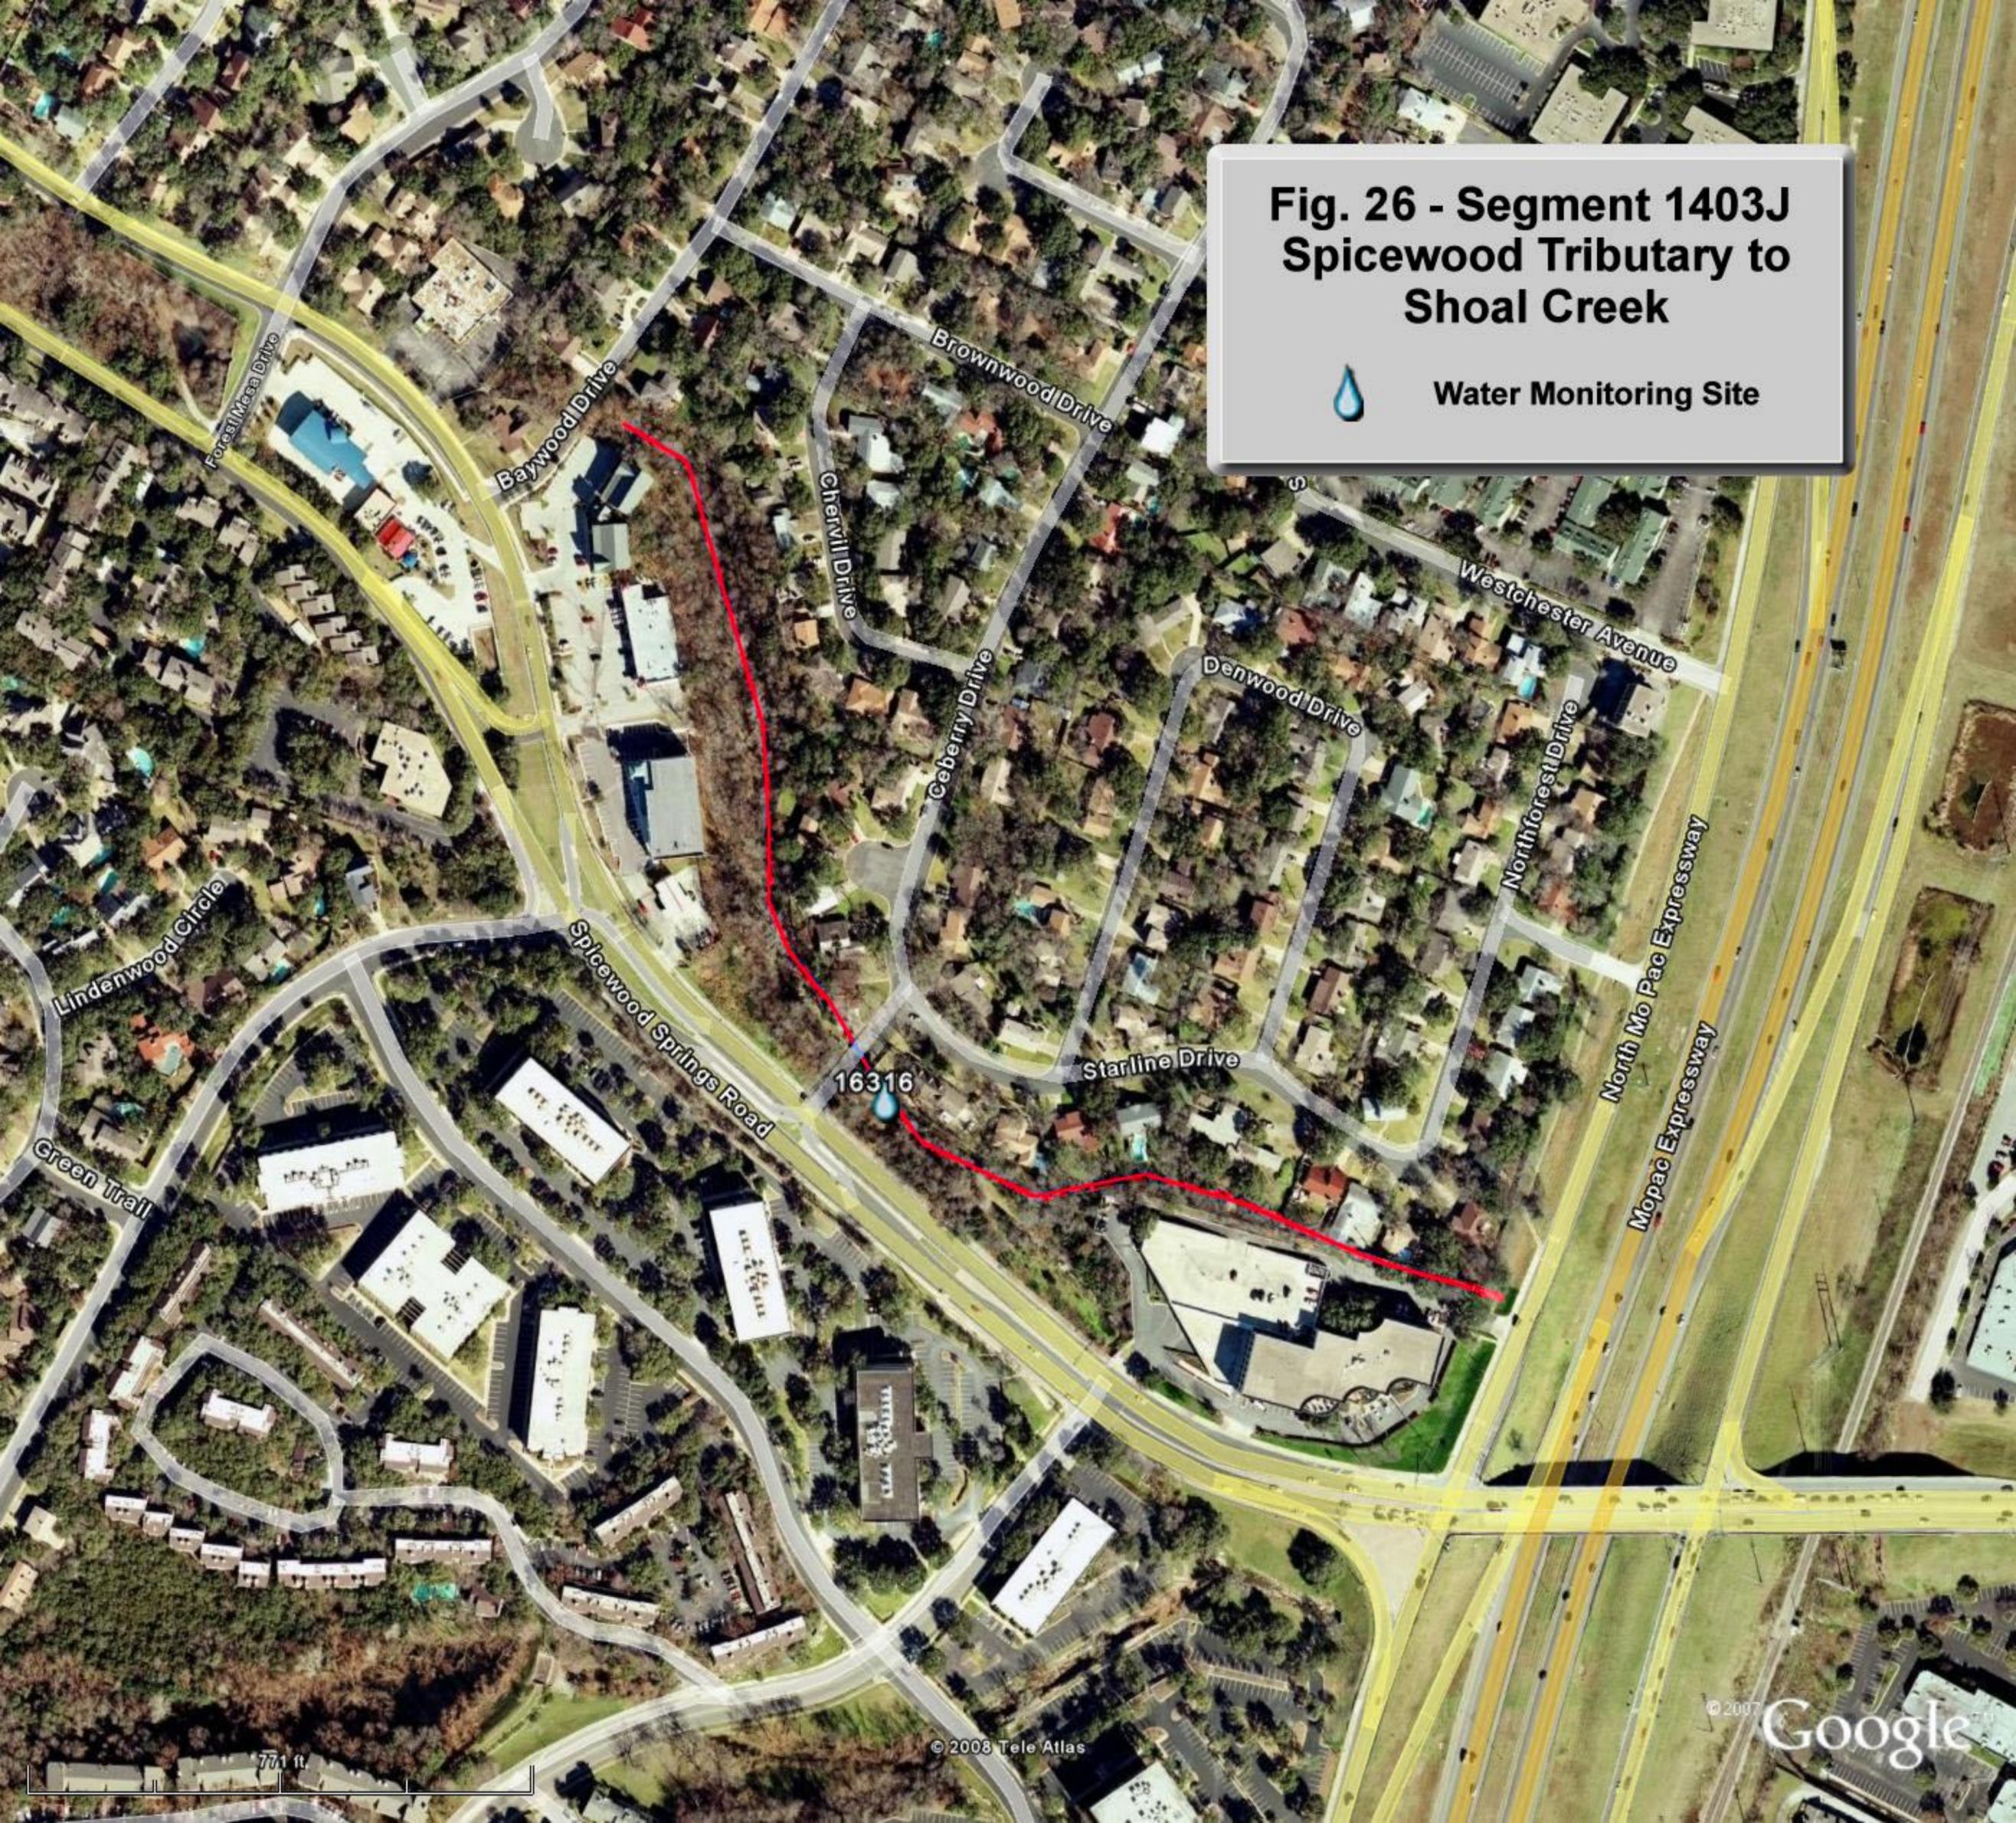
**Fig. 27 - Segment 1403J
Spicewood Tributary
to Shoal Creek**

Wastewater lines cross and run longitudinally in the small tributary. COA staff has reported high bacteria counts, algae and sewage from leaking lines at the site during some monitoring events. There are domestic pets in the yards of some residences that border the stream which could also be a source of fecal contamination in the creek. Elevated stream nutrient concentrations suggest that wastewater is a likely source of fecal contamination at this site.

Evaluate wastewater collection infrastructure
Survey the watershed to verify potential sources of bacteria.
Recommend TCEQ rename the tributary under Segment 1429.
Communicate with TCEQ about the potential to perform a contact recreation use attainability analysis to determine the appropriate contact recreation use of the water body.

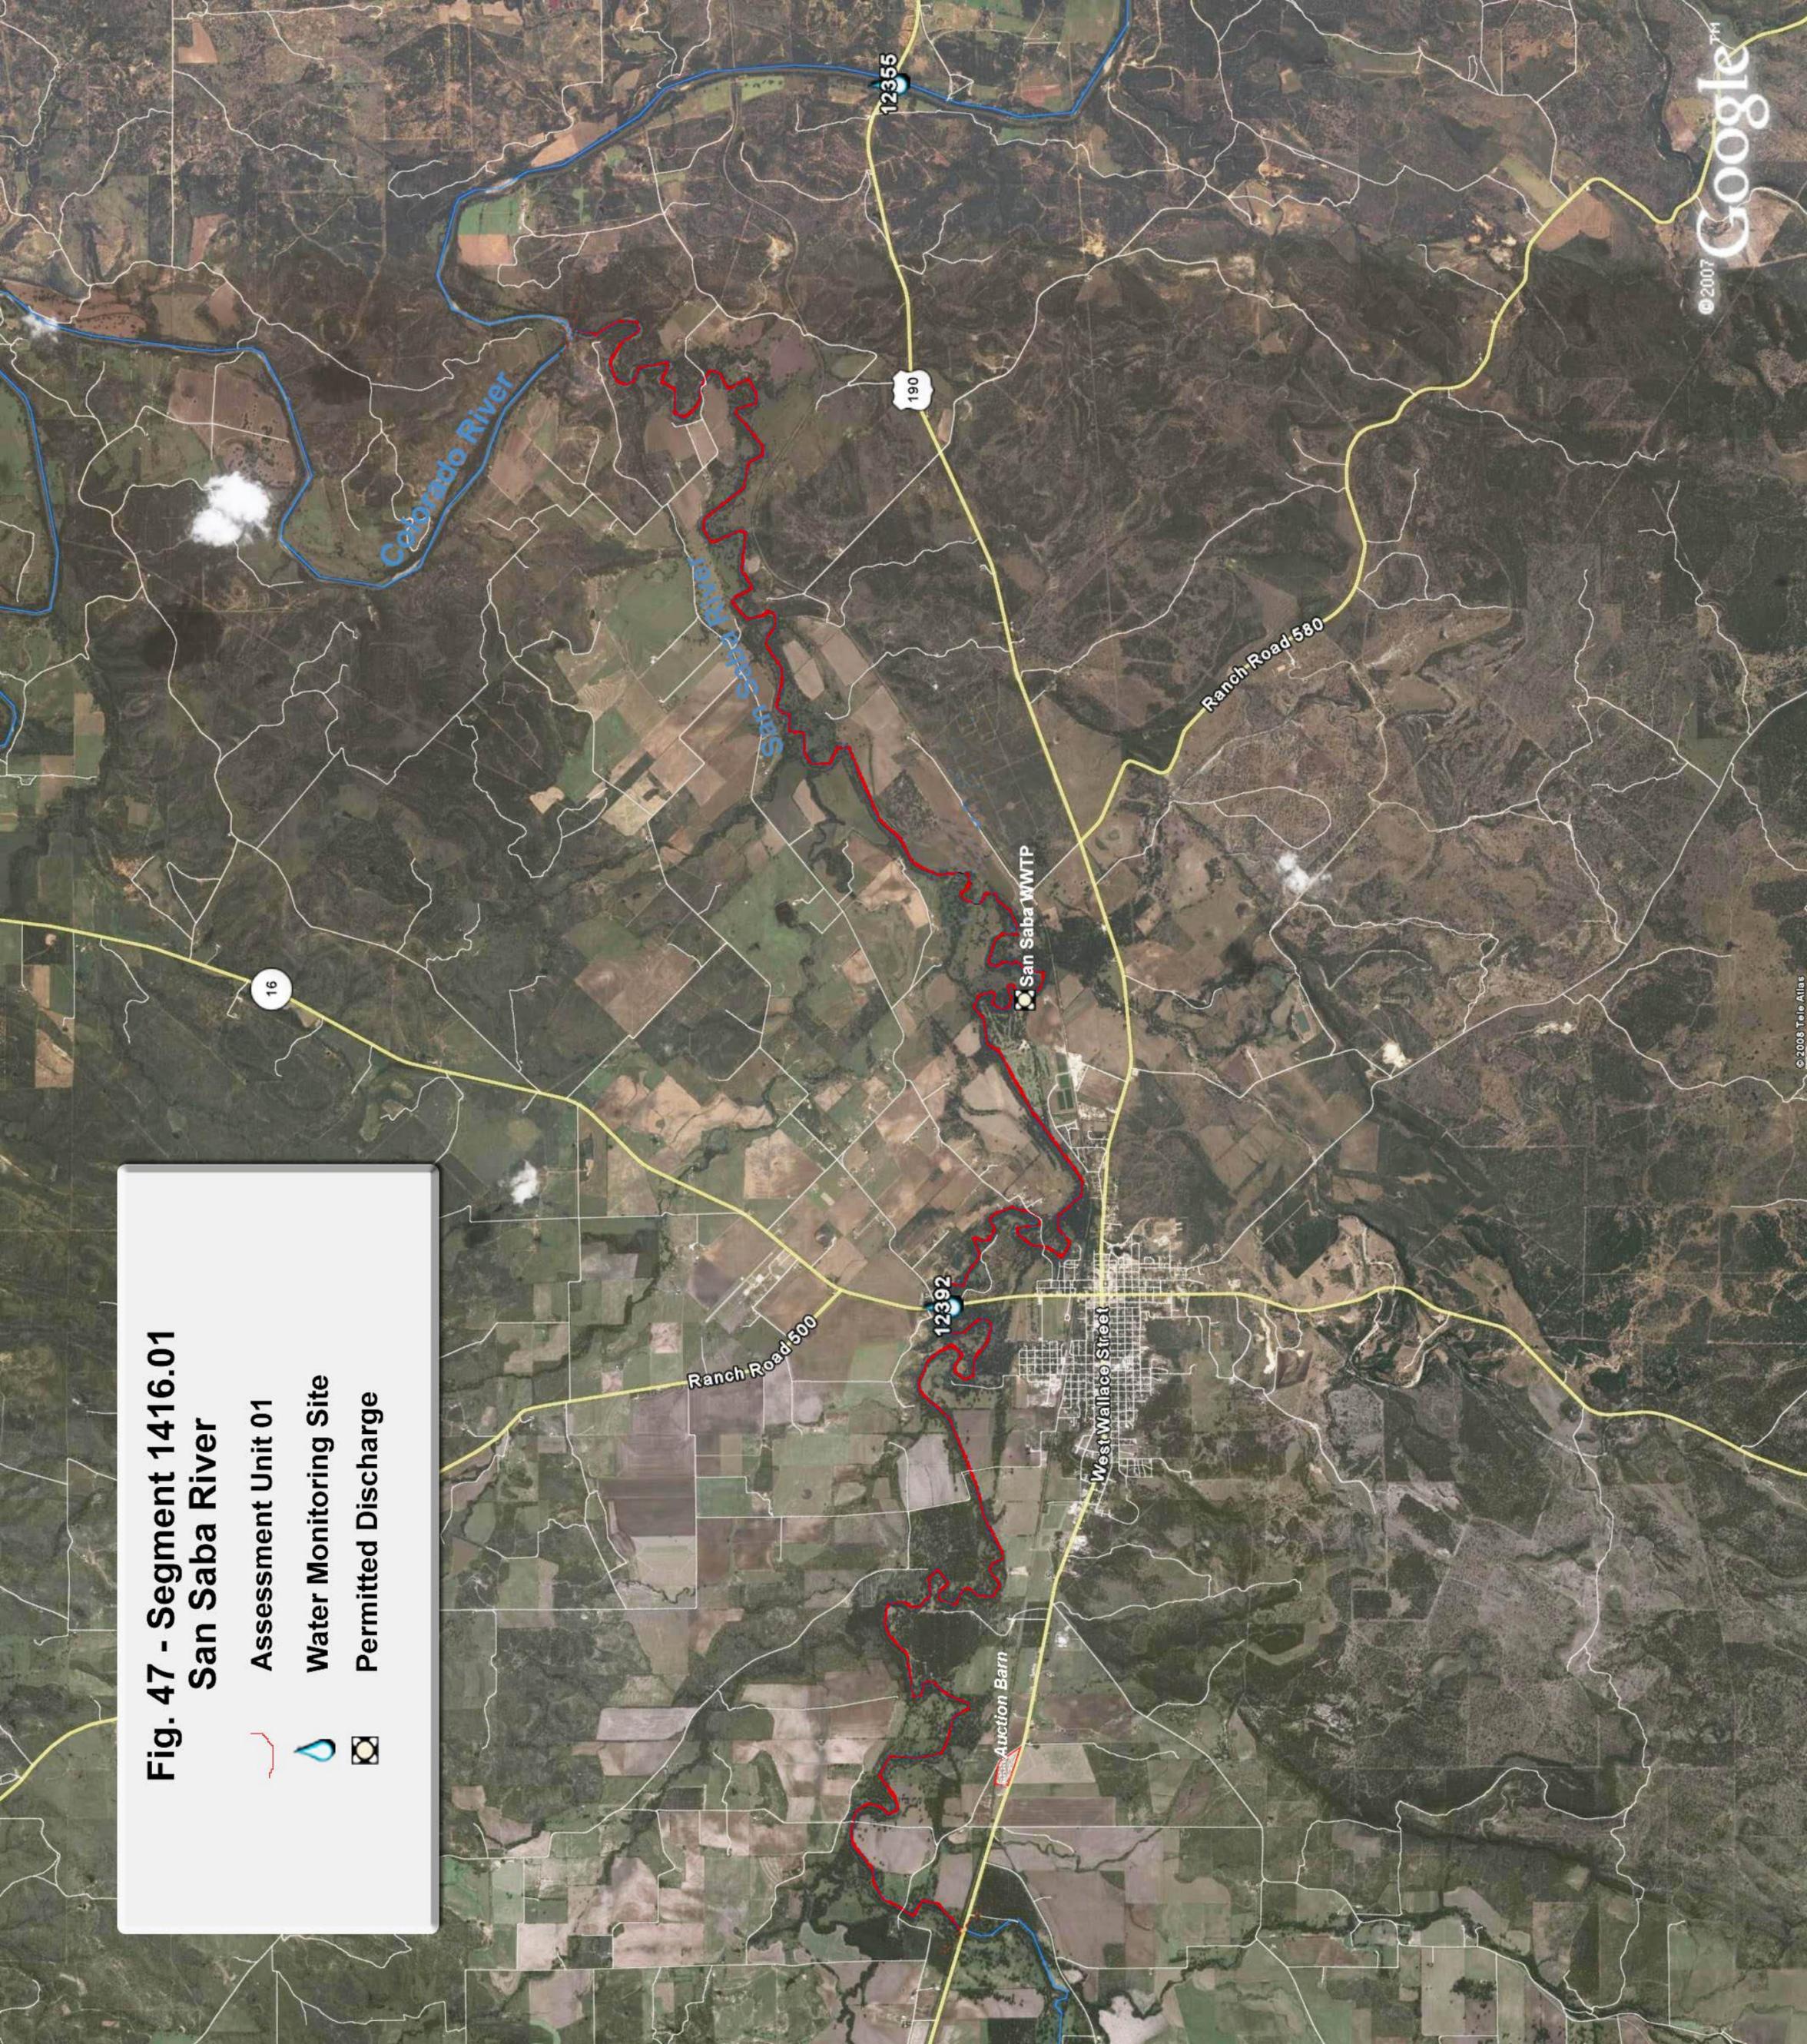
Fig. 48 - Drainage from San Saba into Site 12392

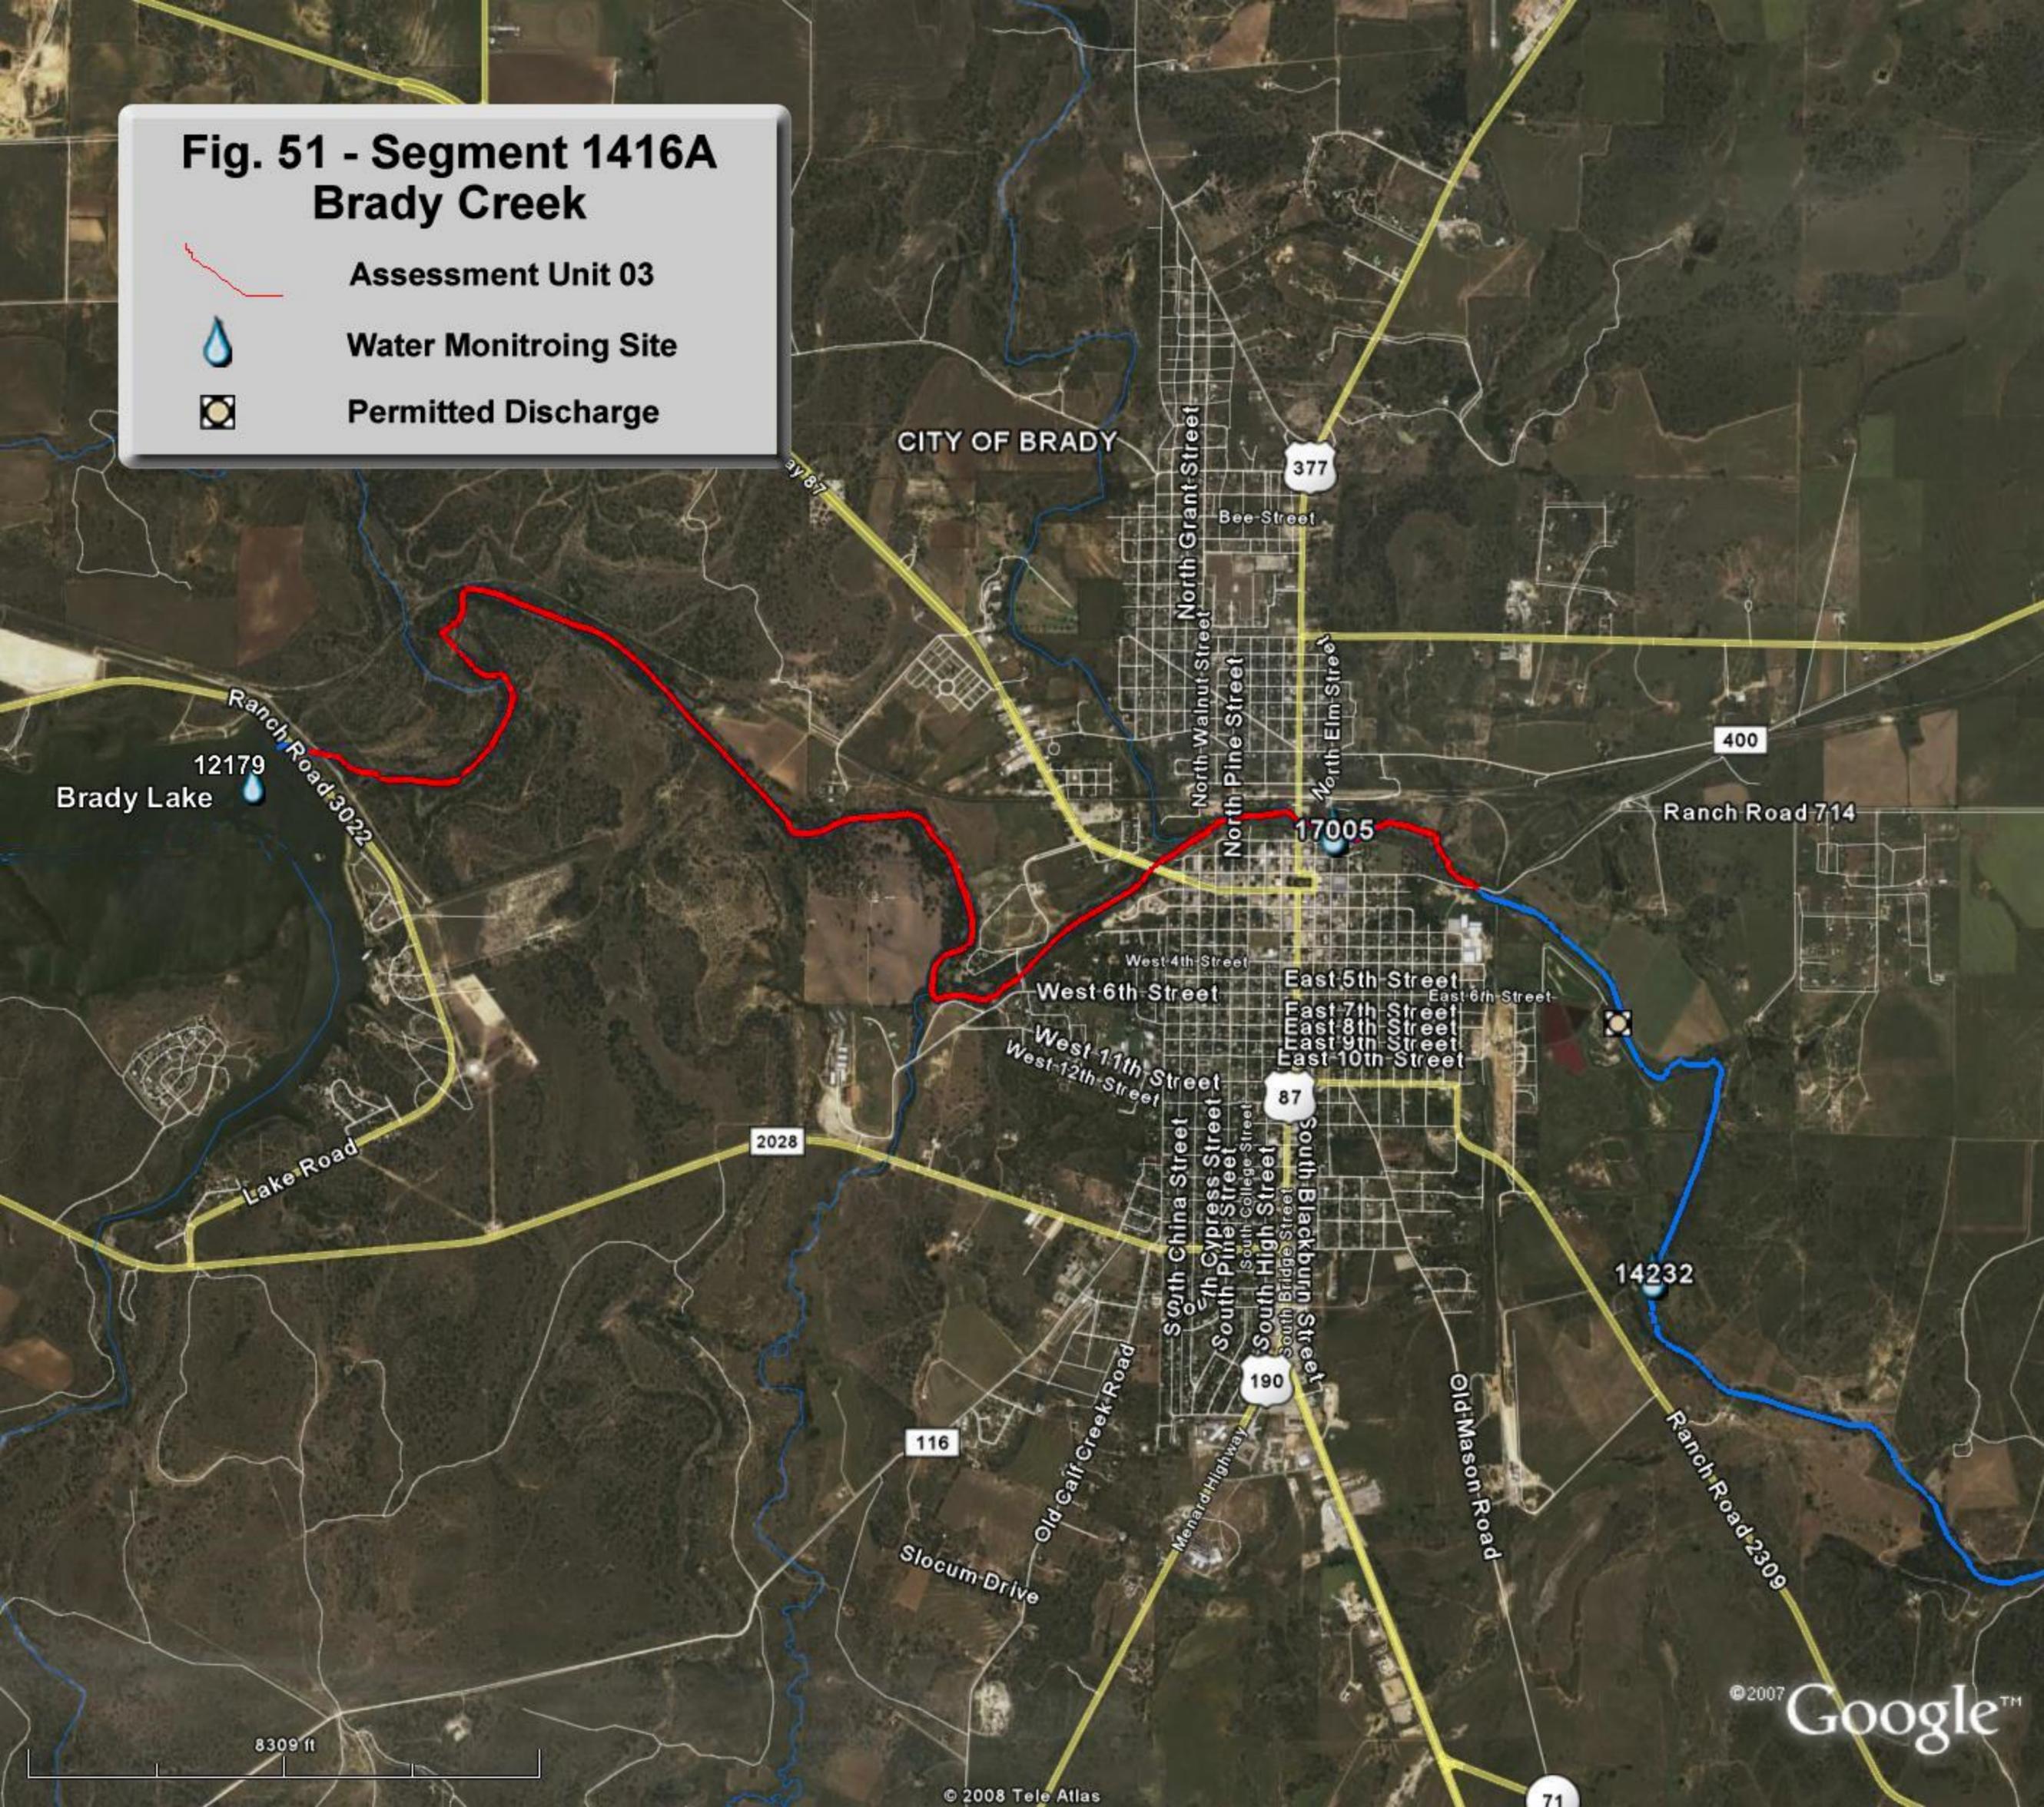
**Fig. 52 - Segment 1416A
Brady Creek Site 17005**

Agricultural Influences -Farmland two miles upstream of Site 17005 is planted in row crops providing the potential for nutrient contributions from tilled soil and fertilizer. Further monitoring and investigation is needed to determine how much, if any, of the excessive nutrient levels found in town come from the upstream farms.

Because monitoring resources were moved from Site 17005 to Site 14232 (Fig. 51) in 2007, reestablish Site 17005 or another site in AU 02 to determine if dissolved oxygen conditions have improved in the assessment unit as a result of the WPP implementation. Or work with TCEQ staff to determine if data from Site 14232 can be used to delist.

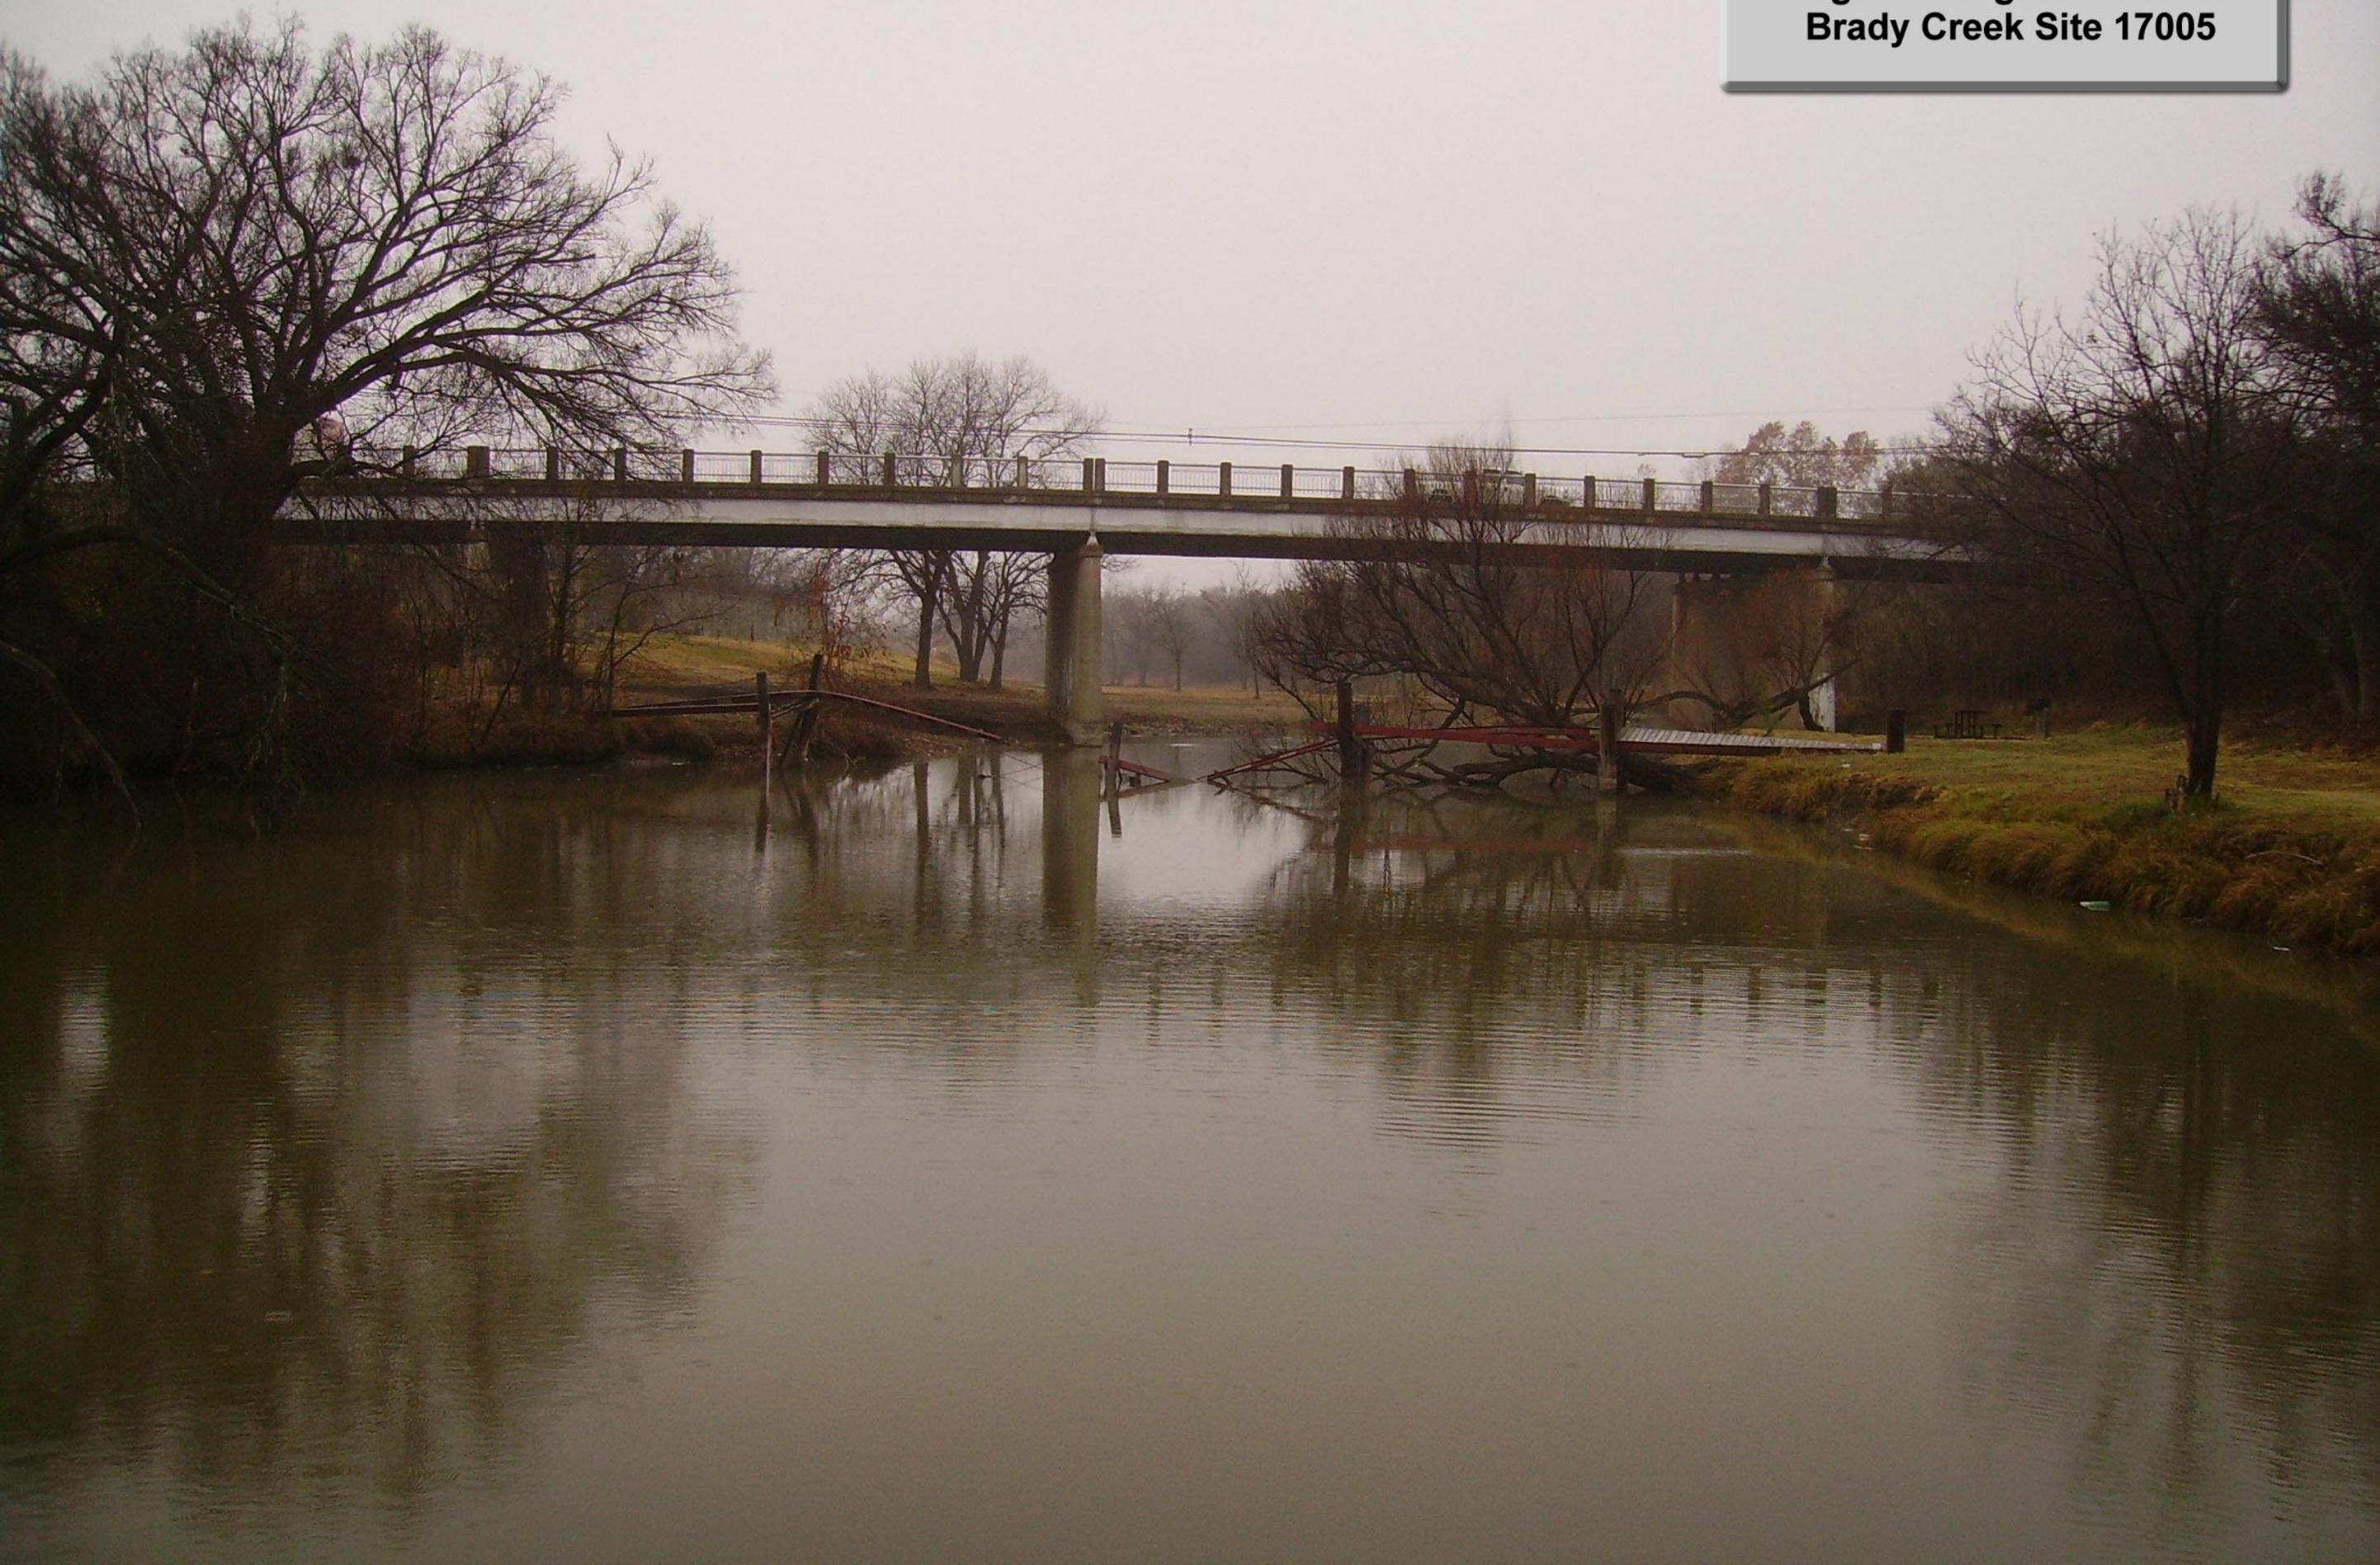
Brady Lake Dam, which is located just upstream of 1416A.03, restricts flow to the creek. In-stream flows are further reduced by several low water dams in the city. During the summer, the dams create stagnant pools, where elevated nutrients contribute to algal blooms which results in extreme fluctuations of dissolved oxygen levels. Site 17005 is in such a pool (Fig. 52).

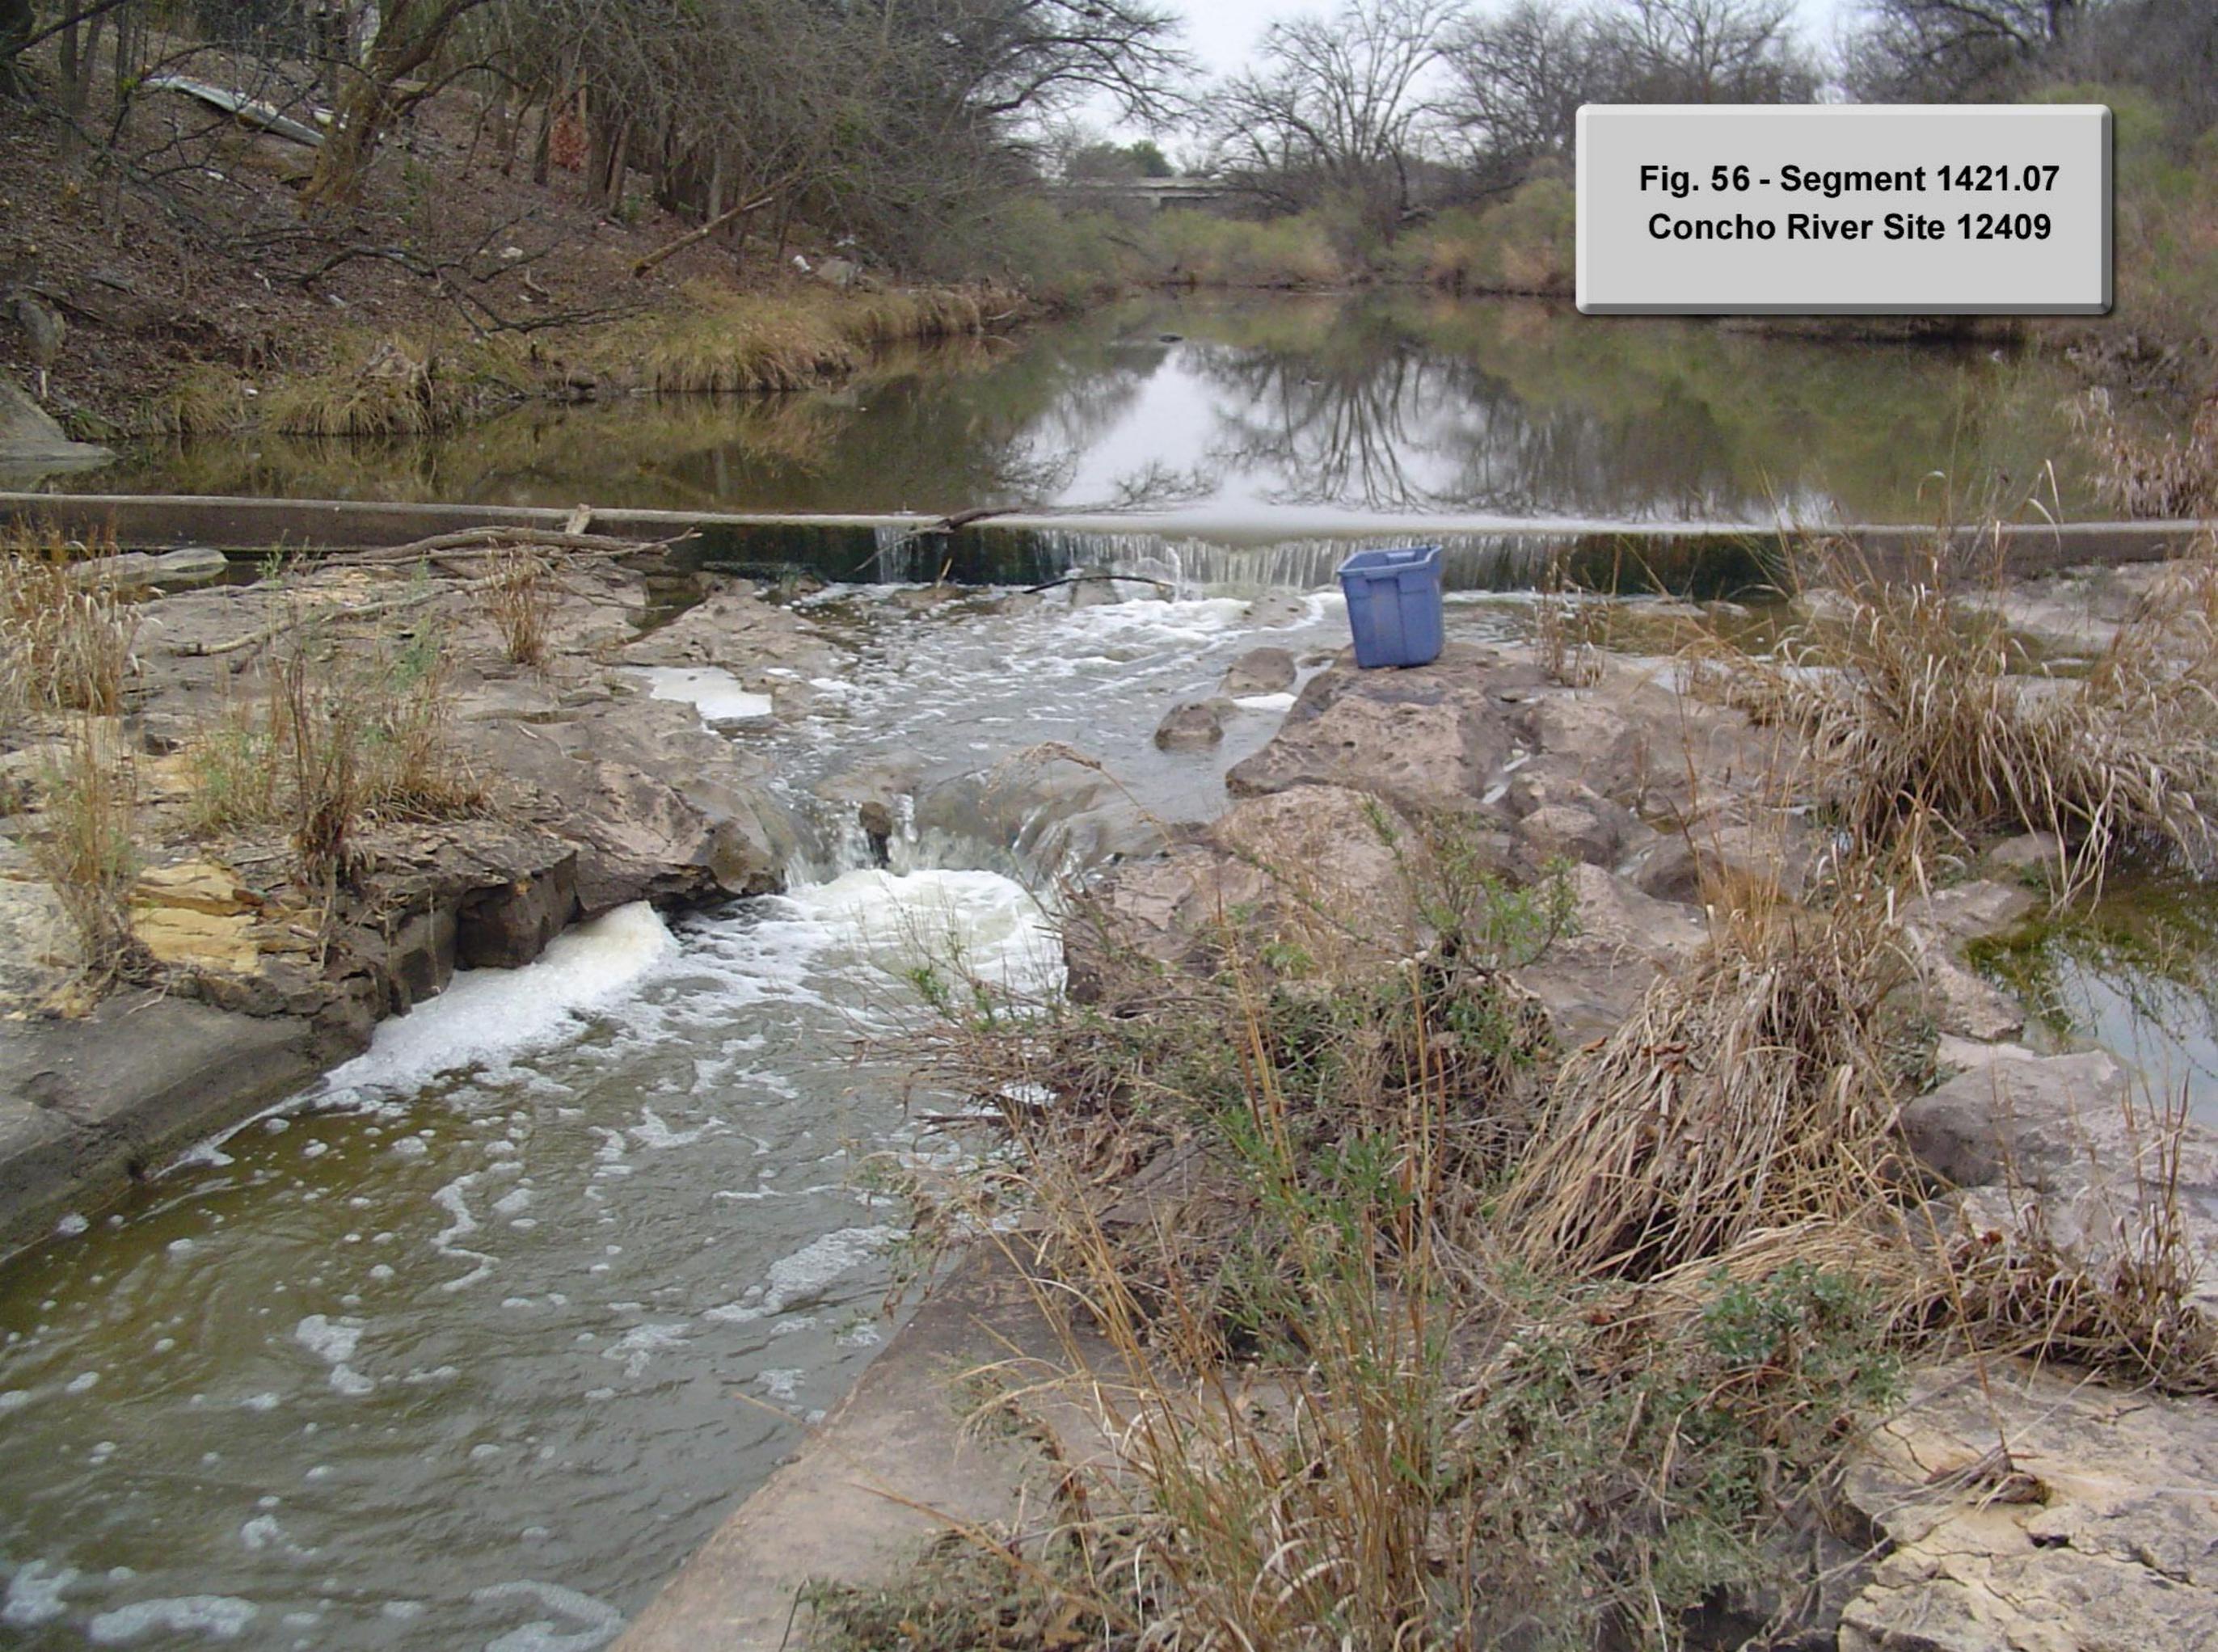
**Fig. 56 - Segment 1421.07
Concho River Site 12409**

AU 1421_07 was first placed on the 2002 303(d) List for not supporting its designated aquatic life use based on an impaired benthic macroinvertebrate community. Four monitoring events performed by UCRA from Site 12409 (Fig. 56) between March 1, 1996, and February 28, 2001, were assessed by TCEQ. The average Index of Biological Integrity (IBI) score was 18. A score of 29 is required to meet a high aquatic life use. Without additional data collection, the segment has remained on subsequent 303(d) lists as a carry forward.

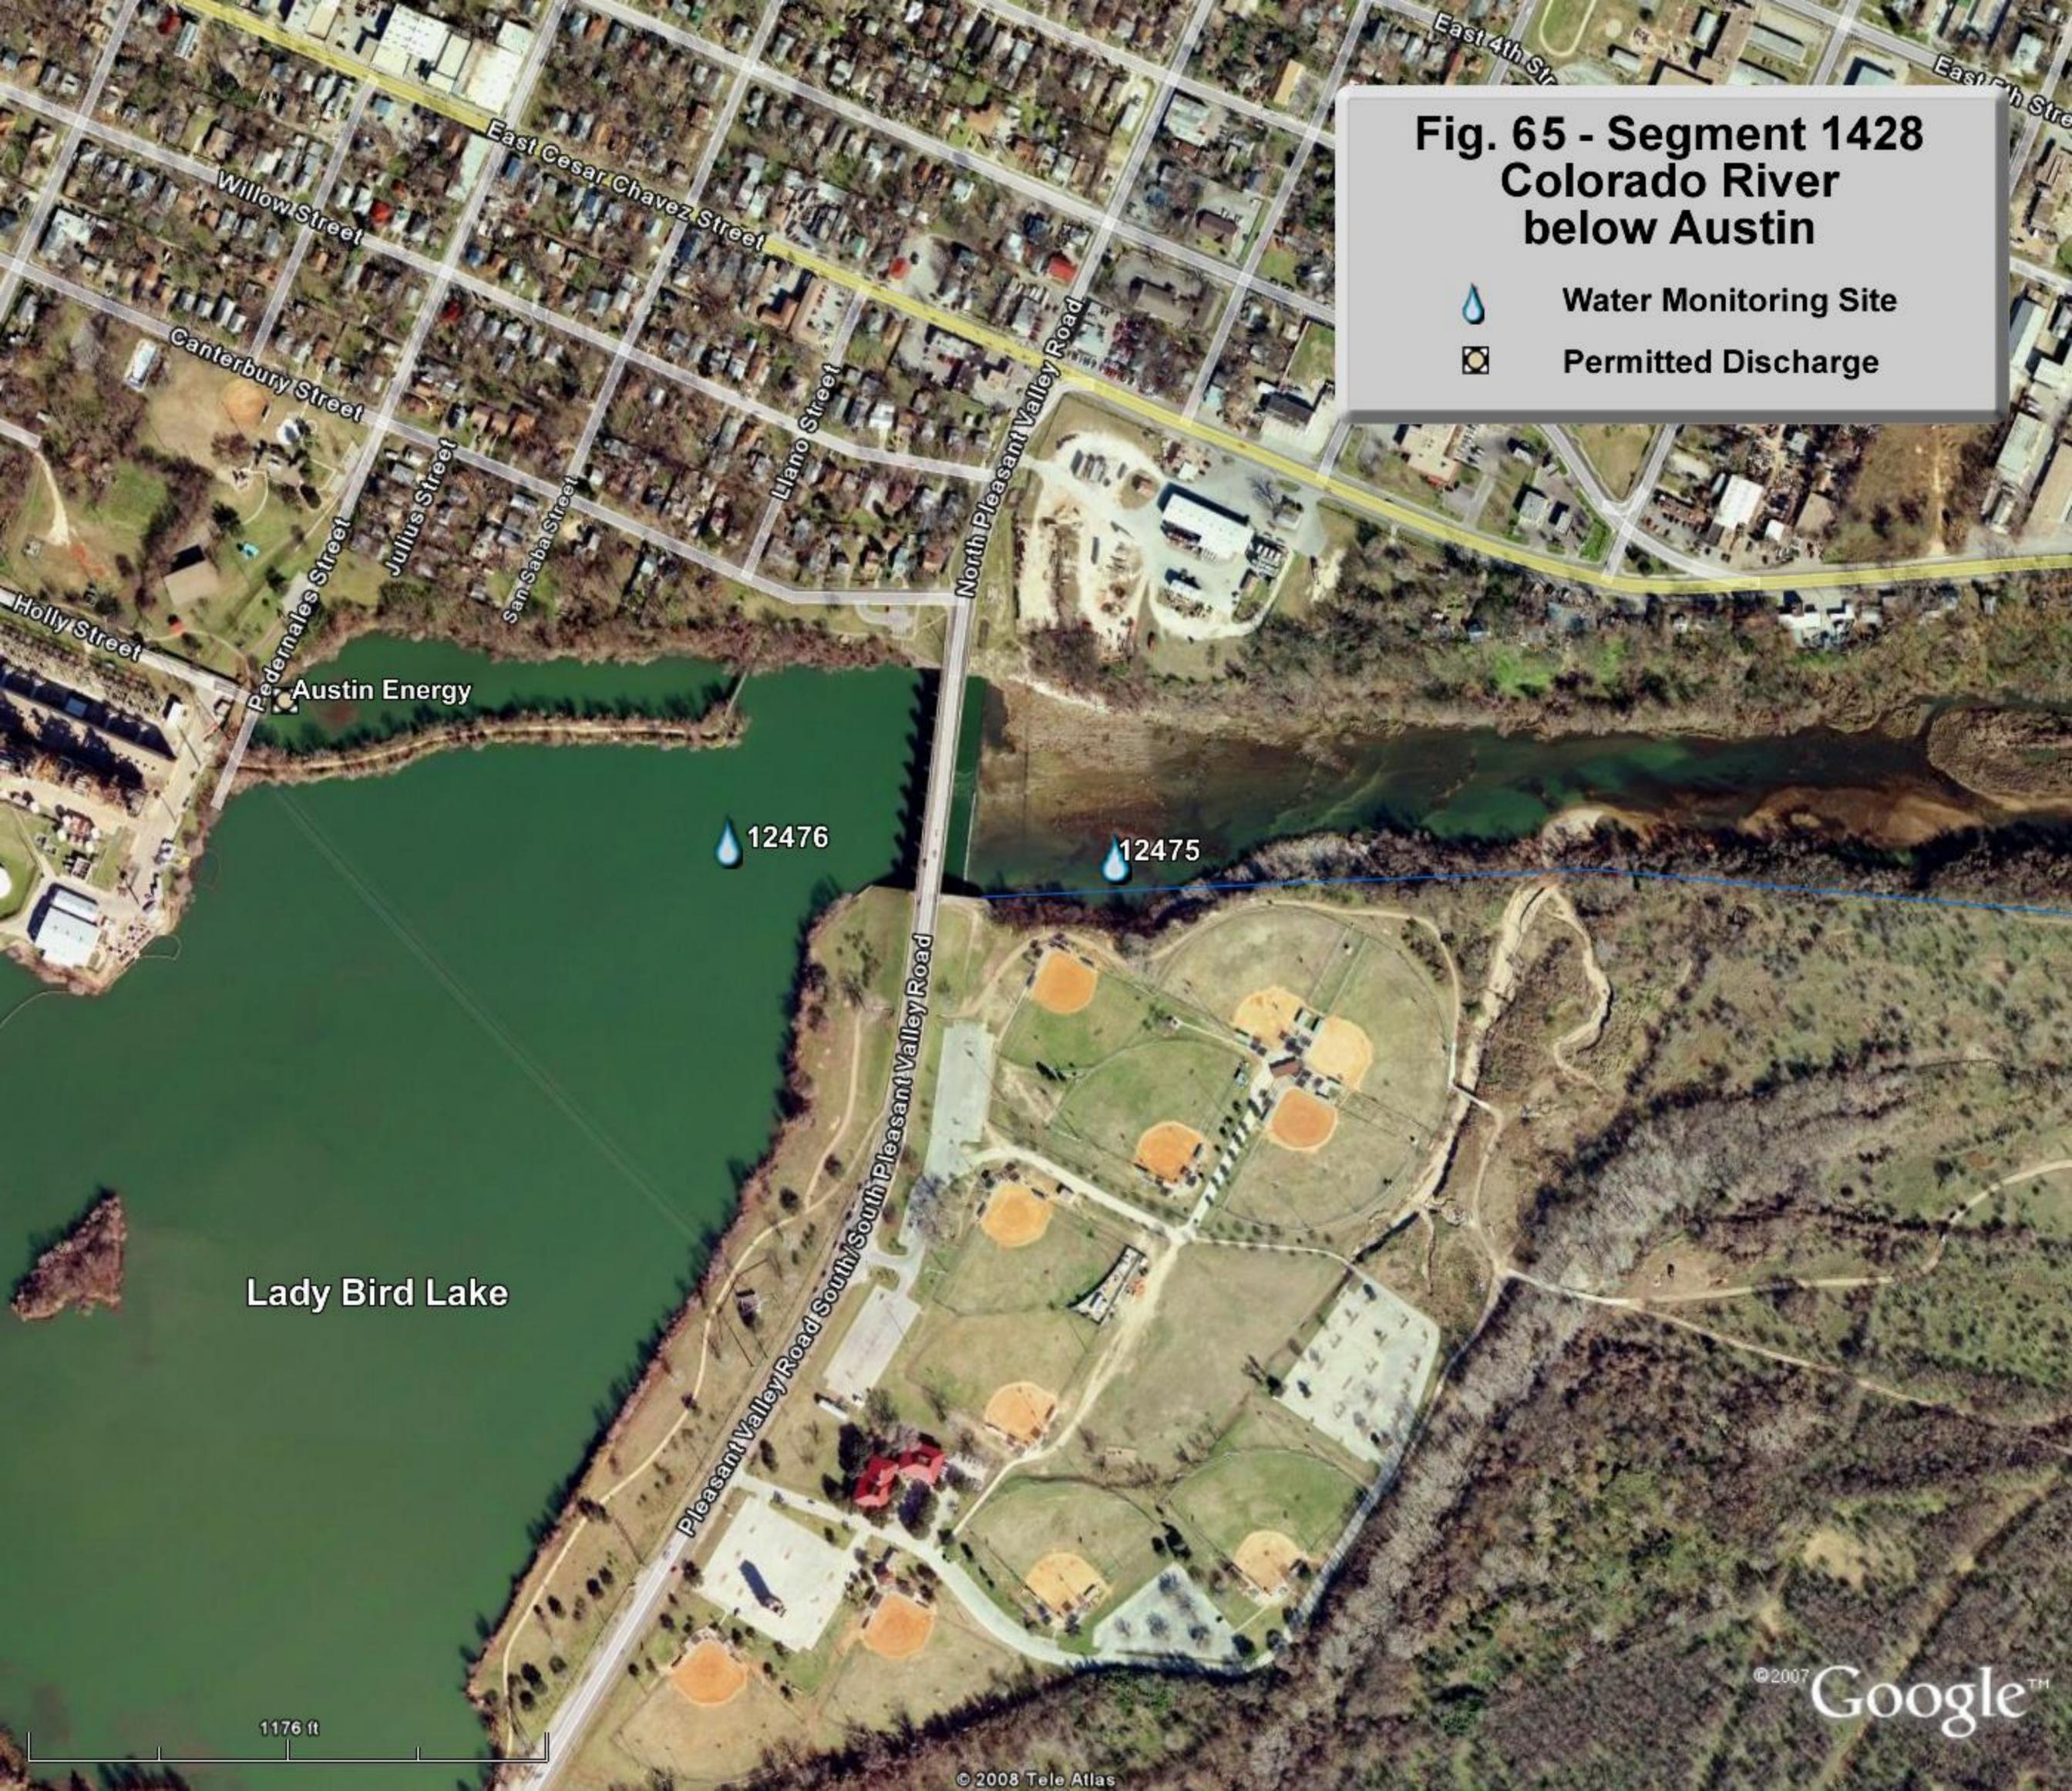
**Fig. 66 - Segment 1428
Colorado River Site 12475**

The most likely cause of elevated bacteria at Site 12475 is leaking wastewater lines. An eight-inch sewer line located on the south side of the river was discovered to be failing in 1988 and again in 1994. A 1995 LCRA report titled *Longhorn Dam Fecal Coliform Study* attributed high levels of bacteria in the river to the leaking wastewater lines.
