Texas Clean Rivers Program 2011 Basin Highlights Report

A Characterization of Impaired Water Bodies in the Colorado River Basin

June, 2011

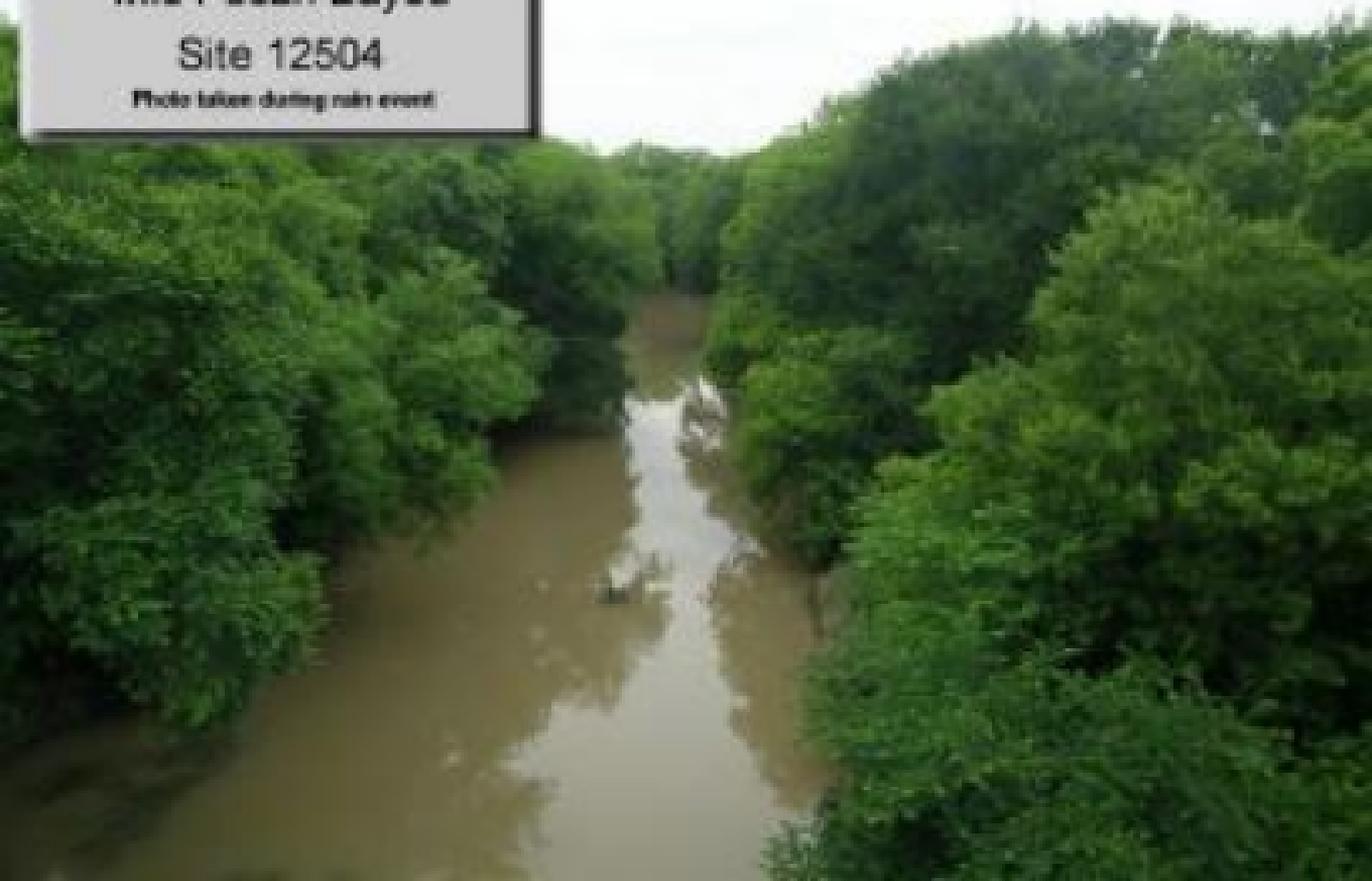
Fig. 85 - Segment 1431
Mid Pecan Bayou
Site 12504

Photo taken during rain event
