June 3, 2022

SUBJECT: New Coal Combustion Residuals (CCR) Registration No. CCR101  
Lower Colorado River Authority – La Grange, Fayette County, Texas  
Industrial Solid Waste Registration No. 31575  
EPA Identification No. TXD083566547  
Tracking No. 27214088; RN100226844/CN600253637

# LCRA Fayette Power Project Figure 4 Surrounding Features Map

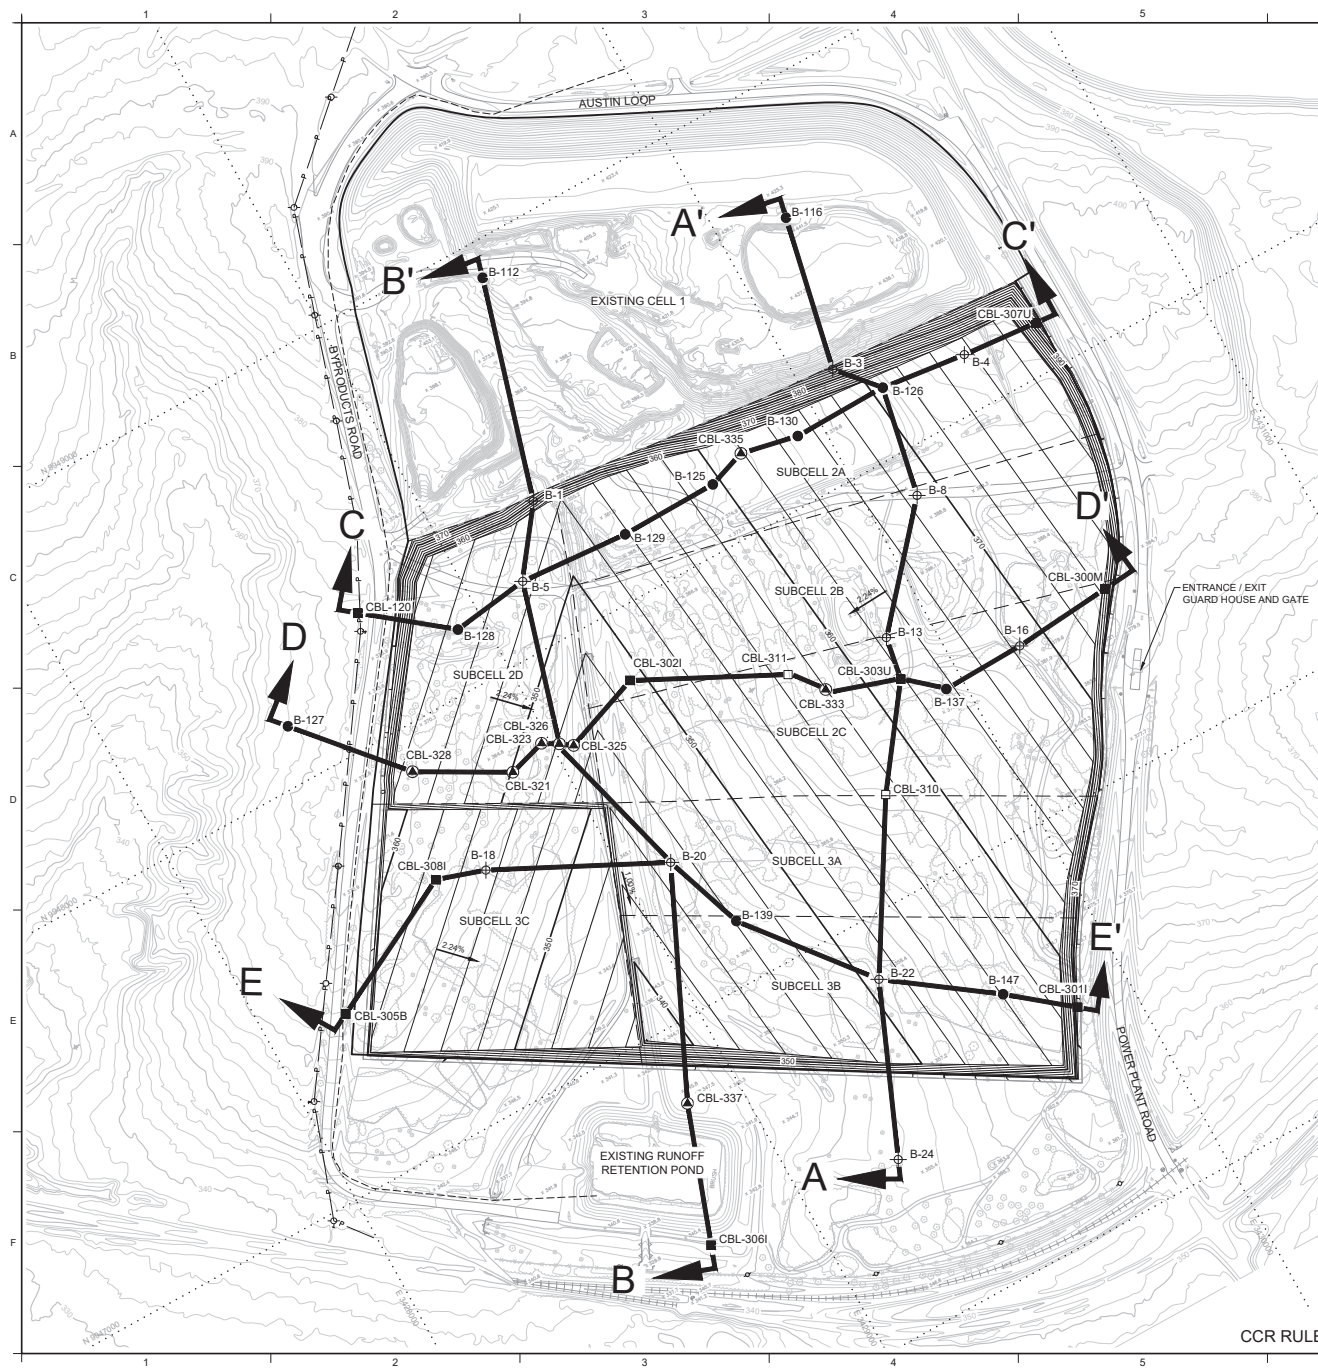
- LEGEND**
- EXISTING GROUND ELEVATION CONTOUR (FT. MSL) (NOTE 1)
  - EXISTING ROAD
  - EXISTING FENCE
  - EXISTING BUILDING
  - COORDINATE GRID
  - SUBCELL BOUNDARY
  - PROPOSED TOP OF LINER (FT. MSL) (NOTE 2)
  - LANDFILL LIMIT
  - 1983 MCLELLAND ENGINEERS, INC. BORINGS
  - 1992 JONES AND NEUSE, INC. BORINGS
  - 2011 AMEC GEOMATRIX BORINGS
  - 2012 AMEC GEOMATRIX DPT BORINGS
  - 2013 GEOSYNTEC DPT BORINGS

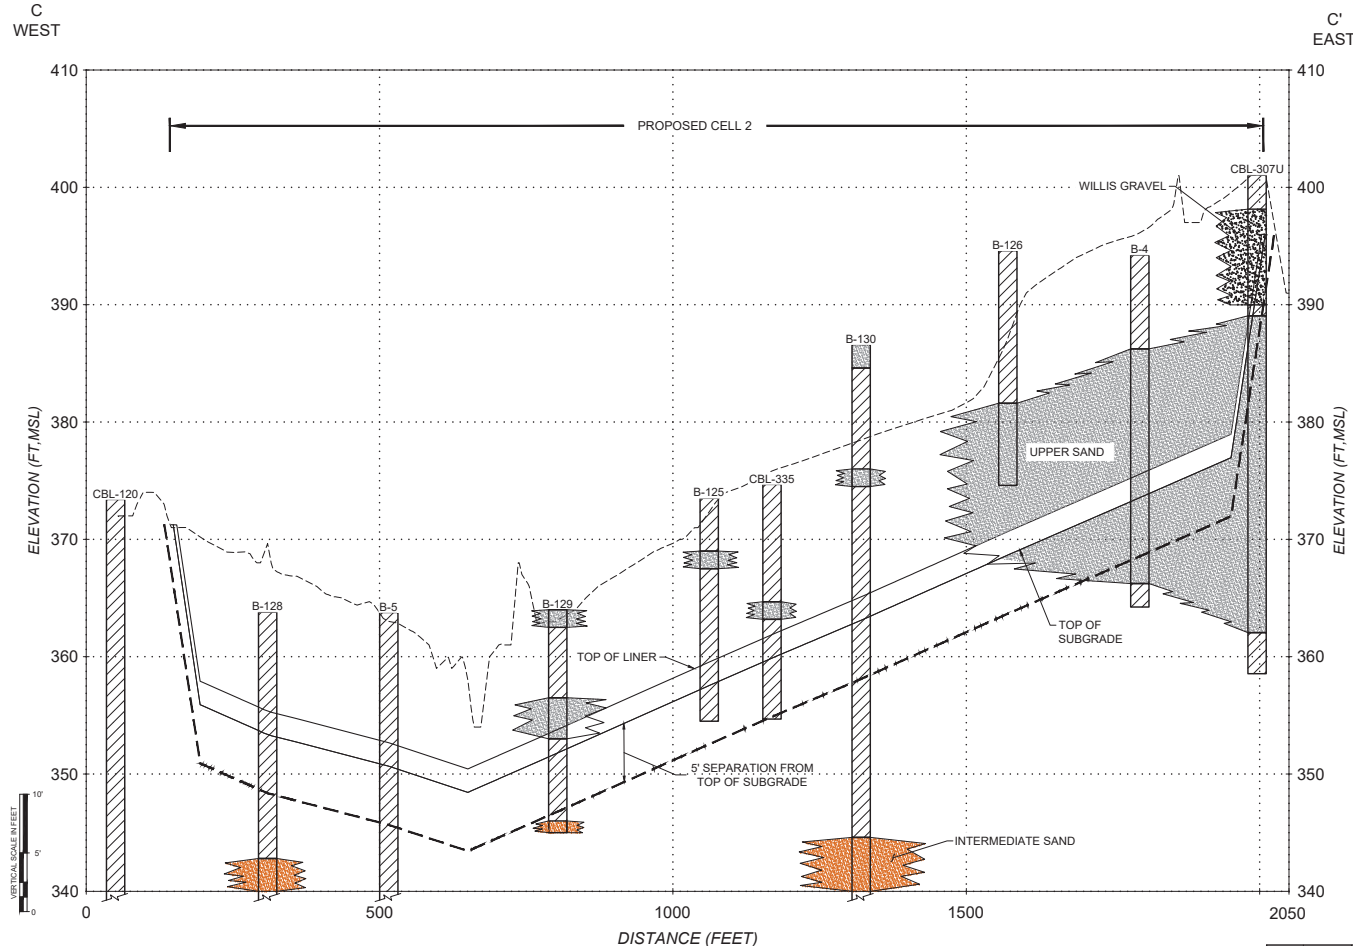
SECT C  
HORIZONTAL: 1"=100'  
VERTICAL: 1"=5'

NOTE:  
1. SLOPES AND LAYER THICKNESS MAY APPEAR DISTORTED ON THESE CROSS SECTIONS DUE TO THE EXAGGERATED VERTICAL SCALE AND THE SKEWED ANGLE AT WHICH THE SECTIONS WERE CUT COMPARED TO THE THREE-DIMENSIONAL SLOPE DIRECTIONS.

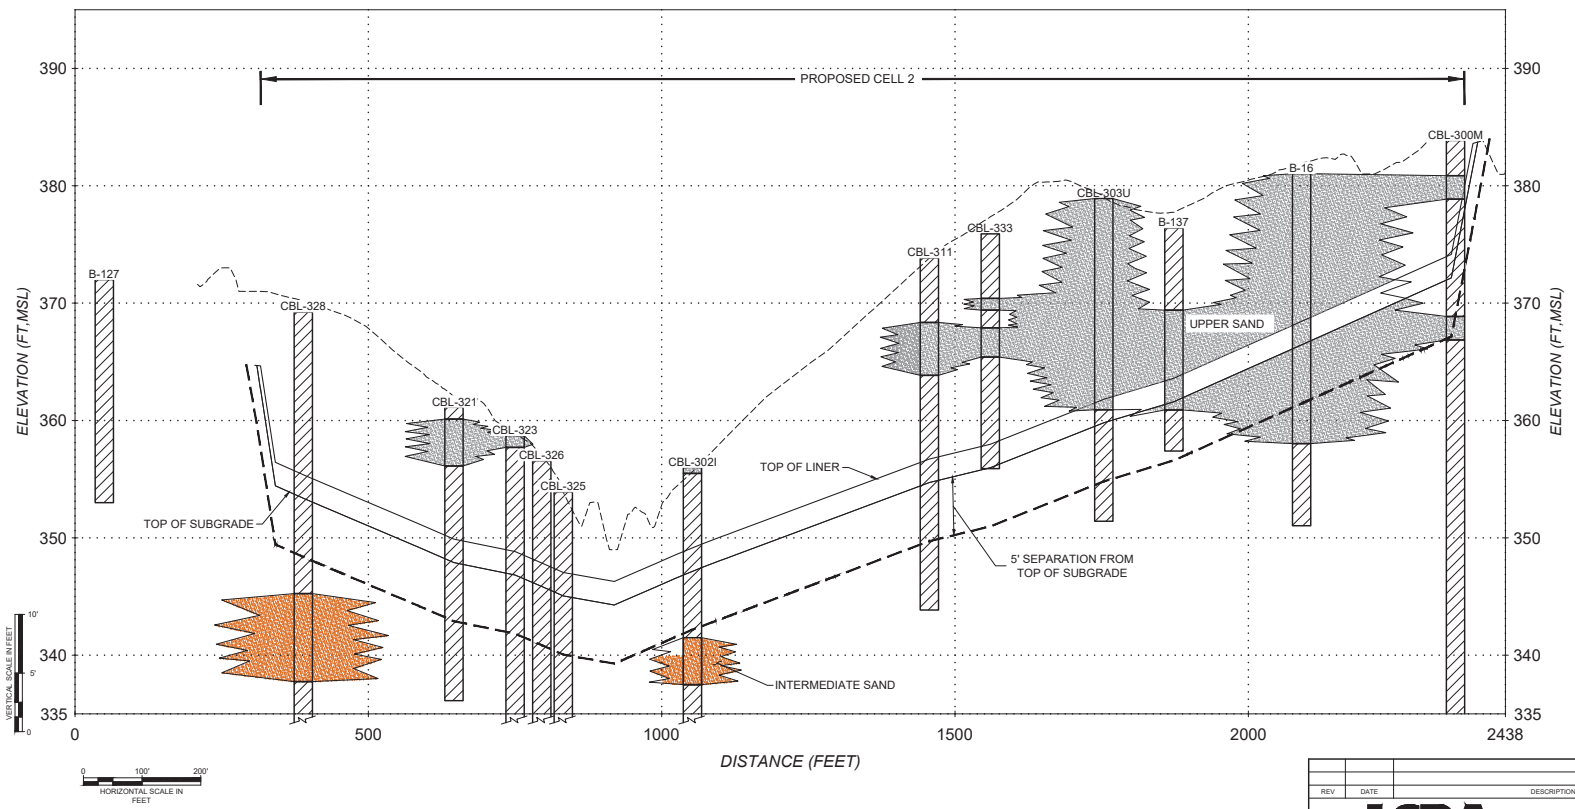
SECTION D  
HORIZONTAL: 1" = 100'  
VERTICAL: 1" = 5'

NOTE:  
1. SLOPES AND LAYER THICKNESS MAY APPEAR DISTORTED ON THESE CROSS SECTIONS DUE TO THE EXAGGERATED VERTICAL SCALE AND THE SKEWED ANGLE AT WHICH THE SECTIONS WERE CUT COMPARED TO THE THREE-DIMENSIONAL SLOPE DIRECTIONS.

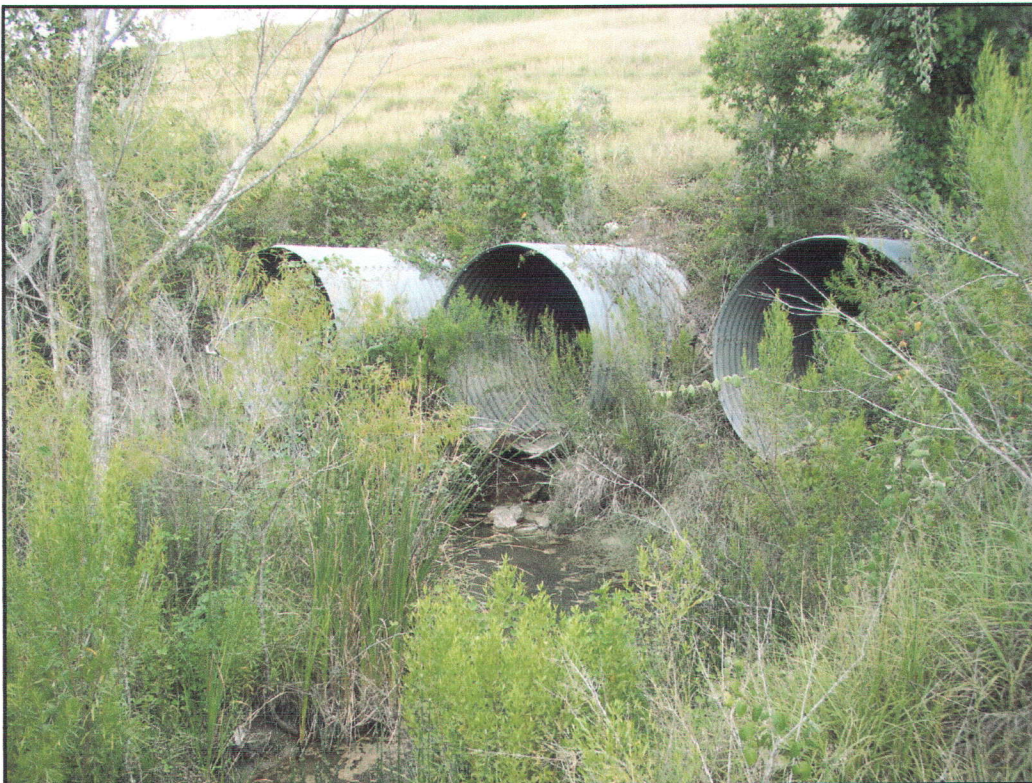
**PHOTO 6: RAIL LINE CULVERT WITH WETLAND VEGETATION**

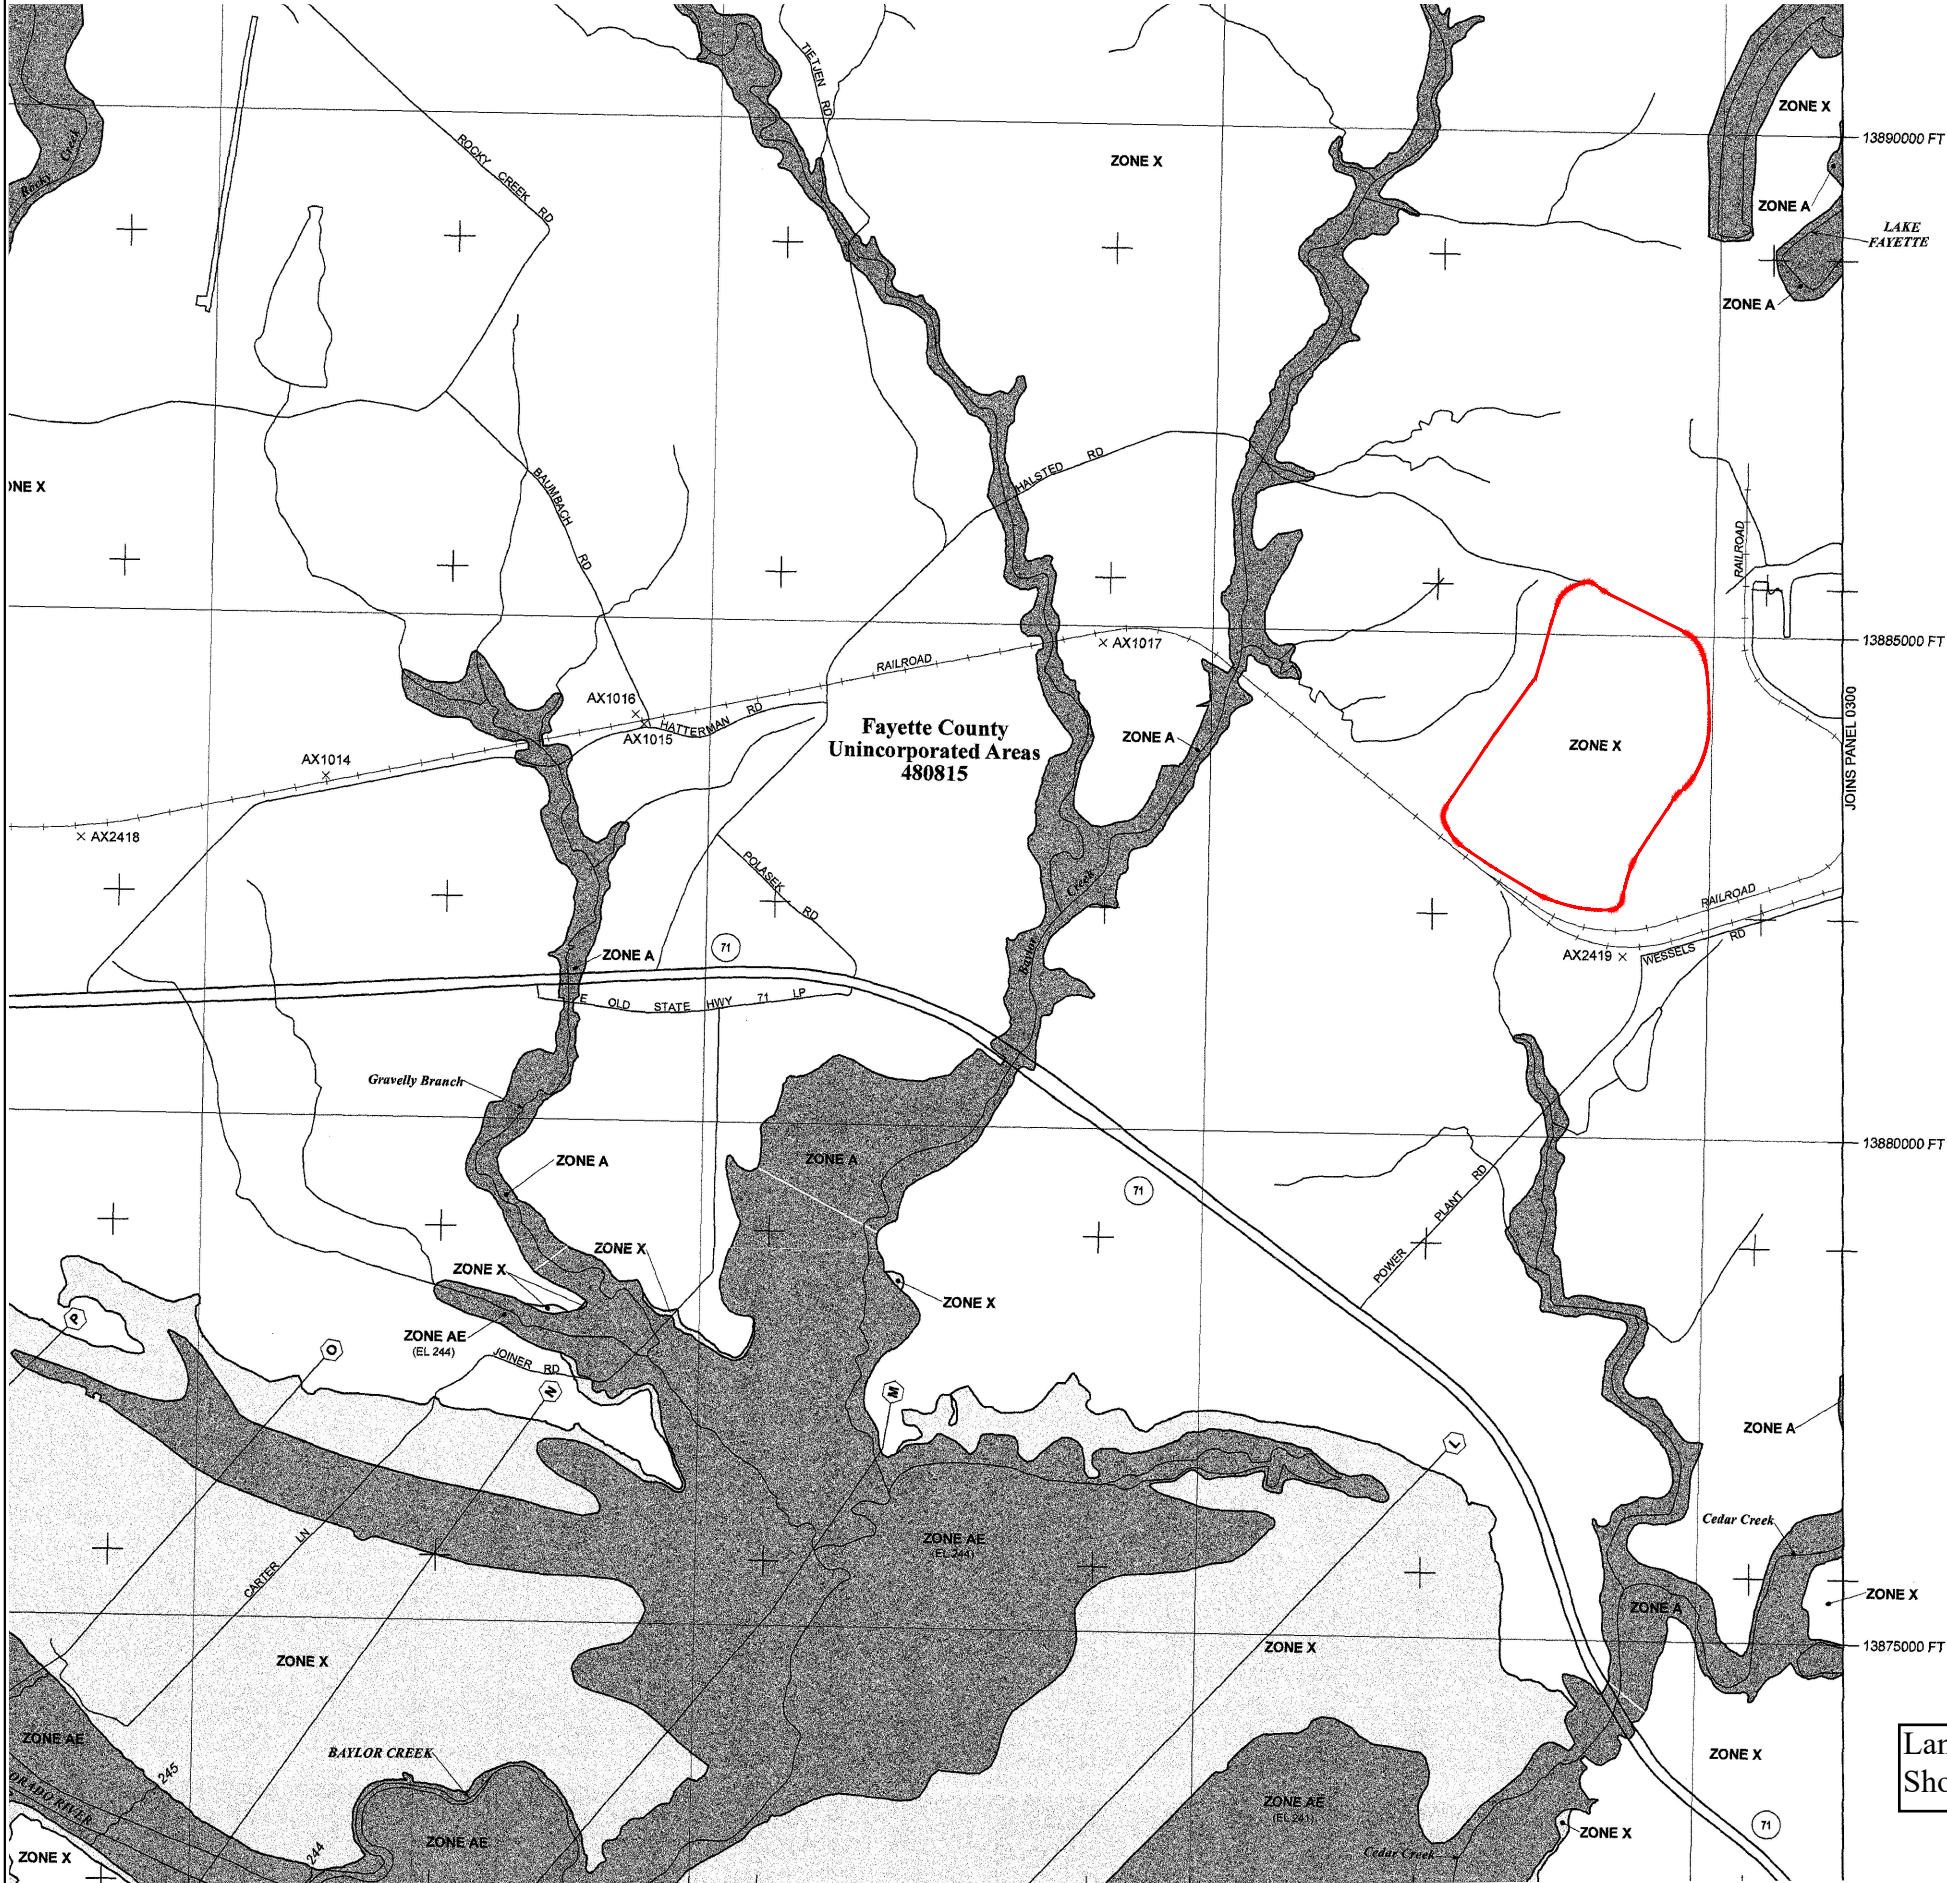
**SPECIAL FLOOD HAZARD AREAS (SFHAs) SUBJECT TO INUNDATION BY THE 1% ANNUAL CHANCE FLOOD**

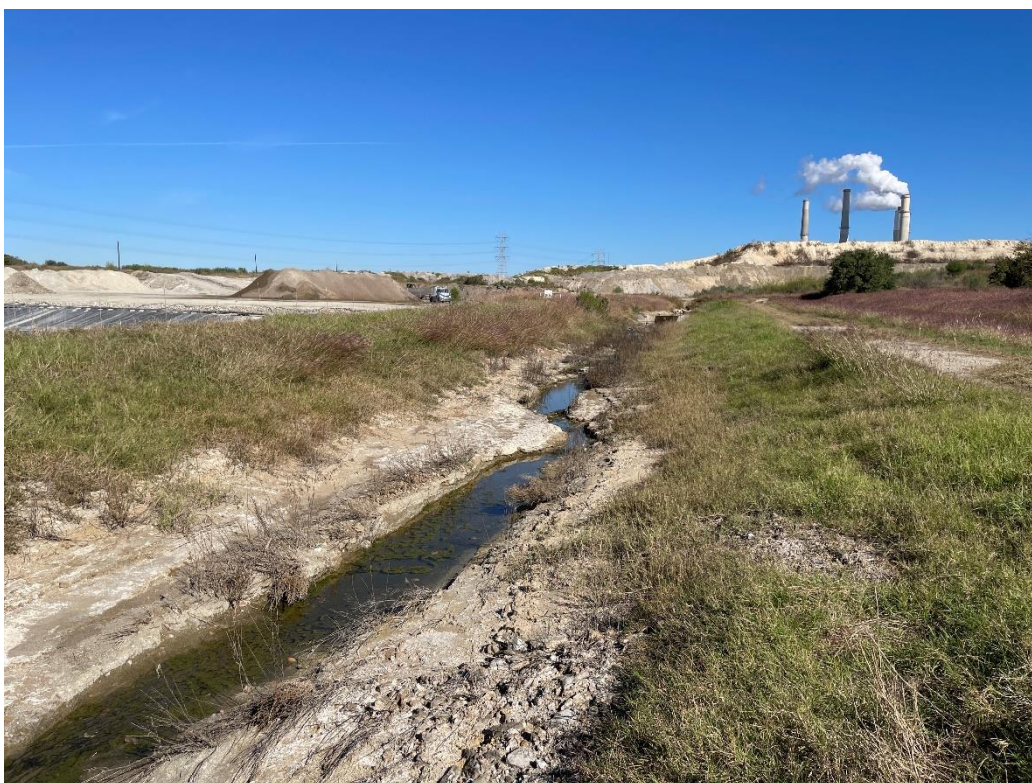
**Photo 4.** Existing runoff channel in project area.
