# OVERVIEW OF FALL 2018 FLOOD

# Inflows to the Highland Lakes in 2018

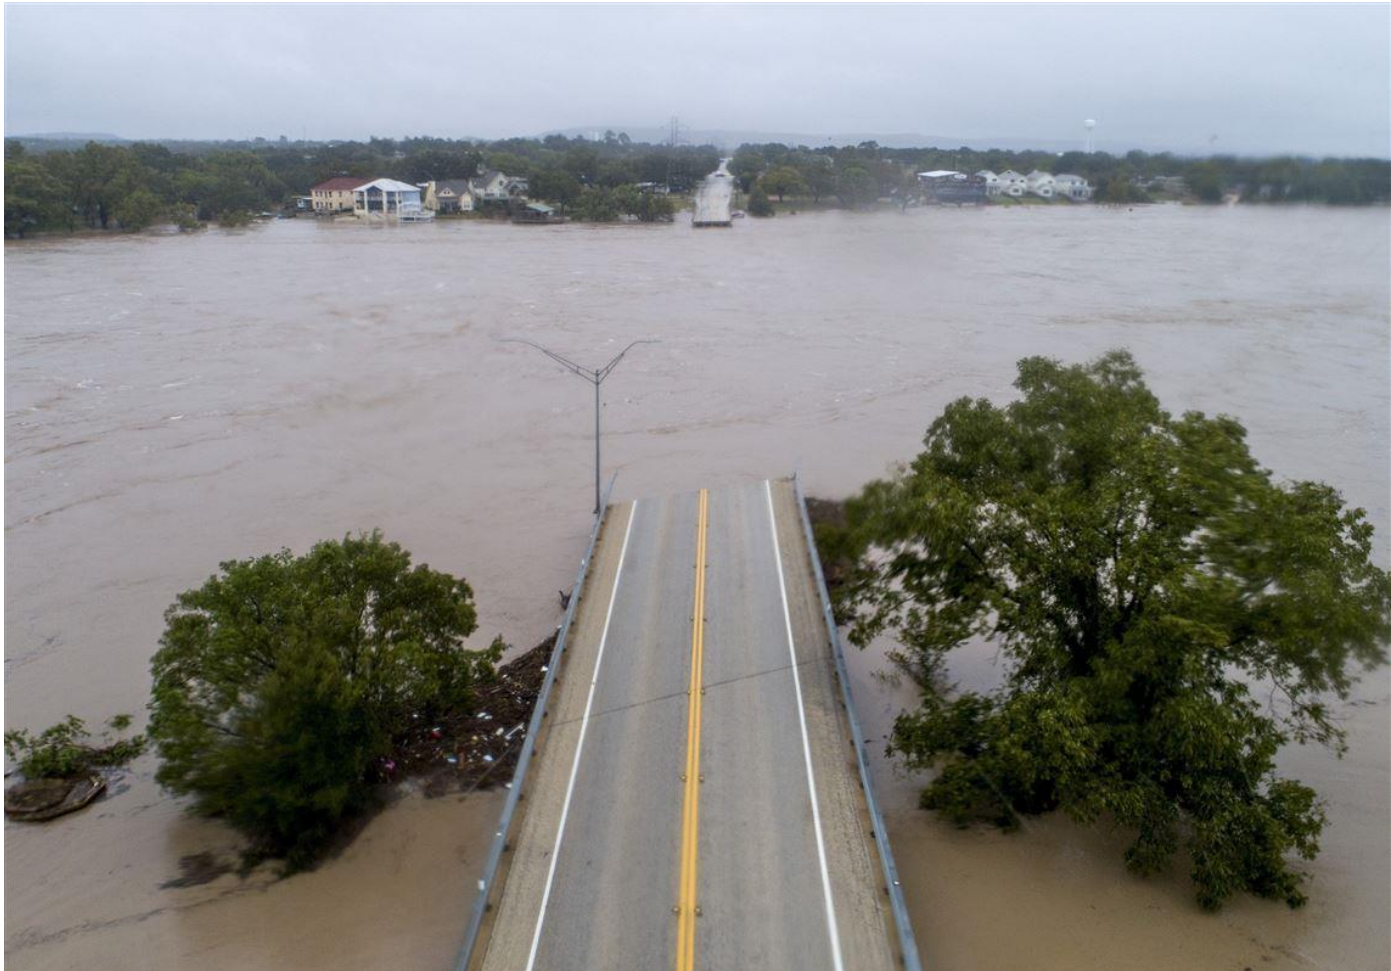
Llano River at RR 2900 bridge in Kingsland on Oct. 16, 2018  
(photo credit: Jay Janner, Austin American-Statesman via AP)

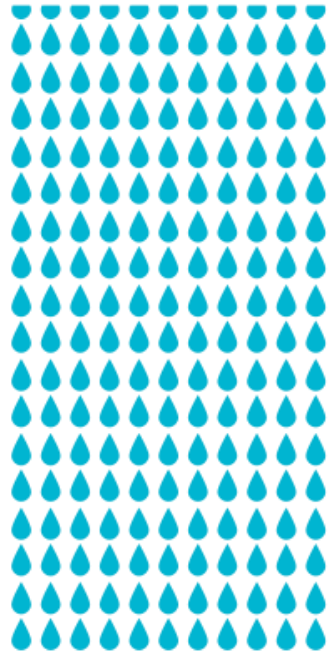
# Water Passed Through Lake LBJ

**990,000**  
ACRE-FEET

Water passed  
through Lake LBJ  
from Oct. 15-23

**113,420**  
ACRE-FEET

Volume of Lake LBJ  
from top of dead pool  
to top of operating range

The equivalent of  
more than eight Lake LBJs  
passed through  
during the second flood
