Mansfield Dam Floodgate Rehabilitation Project

Mansfield Dam

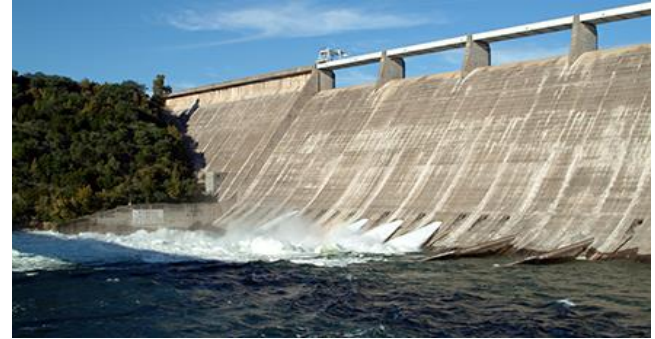
Mansfield Dam during flood operations in May 2016.

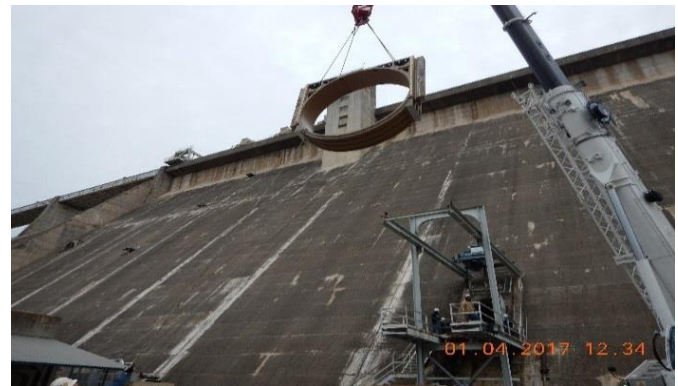
Removing the floodgates is no easy task. When the dam was under construction, crews used large cranes to install the floodgates because the top half of the dam was not yet in place. Workers today are constrained by the dam's existing structure, and must use heavy-duty hoists and rail carts to remove floodgates. In some cases, crews have less than an inch of leeway as they disassemble and remove large pieces of the floodgate.

Mansfield Dam rehabilitation project, January 2017.

After removing the floodgate assembly, crews refurbish each gate piece by piece. The floodgate motor is sent off to be refurbished by a contractor, while LCRA crews clean and replace other components. Various gate parts are sandblasted, coated and/or machined as needed.

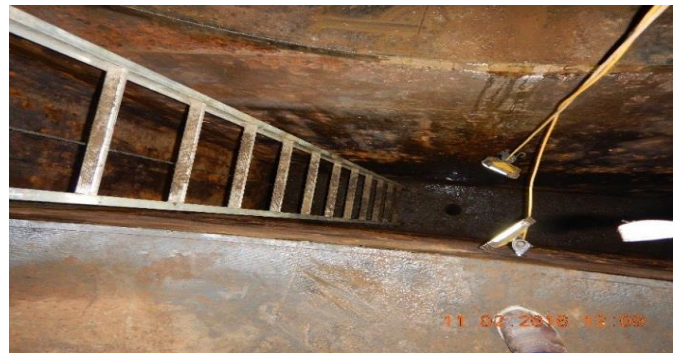
Crews must perform some of the rehab work in the small, narrow floodgate slots.

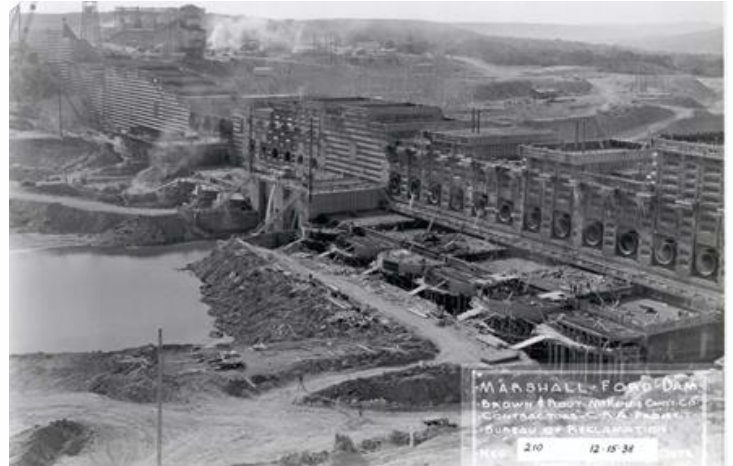
Mansfield Dam construction, 1938. (LCRA Archives W00170)

During construction of the dam in 1938, Central Texas saw yet another historic rainfall. In July, rains flooded the Colorado River near Austin, causing it to reach flood stage and flow at a rate of 260,000 cfs, or 7 billion gallons an hour. In response to the flood, the height of Mansfield Dam was raised 78 feet, to 278 feet, where it remains today.

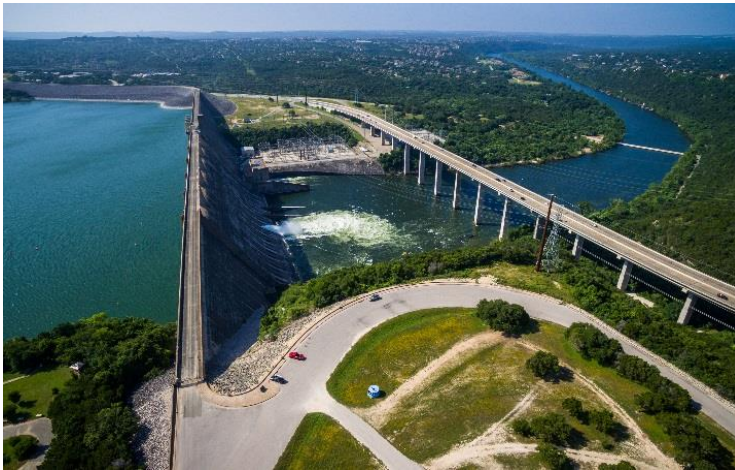
Mansfield Dam during flood operations in May 2016.

lake exceeds 681 feet msl, LCRA makes floodgate releases under protocol in the U.S. Army Corps of Engineers Water Control Manual for Mansfield Dam and Lake Travis, The amount and duration of the releases vary, depending upon the weather and flood conditions above and below the dam.
